The 3 March 2020 Cookeville, Tennessee Tornado Damage Report

Jason M. Lopez ^{a,*}, Franklin T. Lombardo ^b

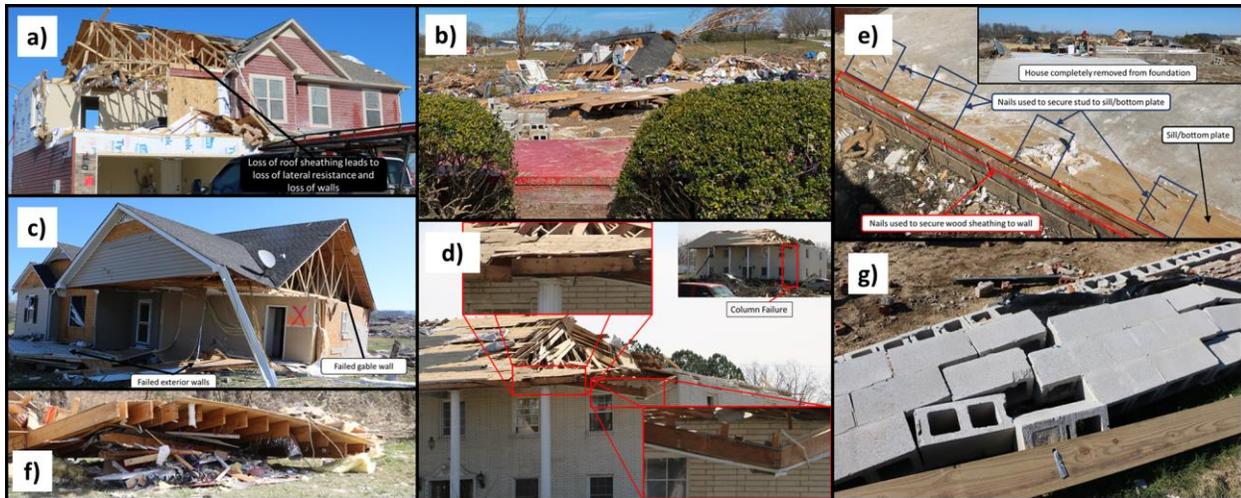
The damage progression of a house usually begins with the loss of roof cover then is followed by roof sheathing loss. Roof sheathing acts as diaphragm that provides lateral resistance for the house and transfers the load to the walls (Figure 1a). Thus, it is important to properly secure roof sheathing against vertical uplift forces to retain the lateral resistances provided by the panels. If the roof sheathing is properly secured to the roof structure, the sheathing will remain attached, and the loads will transfer through the truss and to the walls. This is where the roof to wall connections is critical, if roof to wall connections fail, the roof structure can be lifted off the walls and thrown, which could lead to wall collapse (Figure 1b). Figure 1c is another example of weak roof to wall and sill plate to foundation connections. Figure 1d shows another example of roof failure due to poor connections between the column and the porch beams.

It is very common to see sill plates securely connected to the foundation with anchor bolts. Many times, after a tornado, when houses are destroyed and removed from the foundation, the sill plates anchored to the foundation are the only remaining component of the house (Figure 1e). Typically, when a wood-framed wall is constructed, the bottom plate of the wall is attached to the stud using face nail connection through the bottom plate and is embedded into the end grain of the stud. For constructability, this connection securely holds the wall together standing and bracing of the walls. The wood sheathing on walls serves to provide lateral in-plane shear resistance to the wall, (i.e., shear wall). Figure 1e illustrates that the inadequacy of only using face nails to studs through sill plate and exterior wood sheathing to resist uplift from a tornado.

It was very common for houses built in Cookeville to have a stem wall CMU foundation. A sill plate was anchored either using a flat metal strap or an j-anchor bolt to the top of the CMU. Built on top of the sill plate is the floor joist system. Figure 1f shows a typical floor joist to sill plate connection found in Cookeville. Experimental research has found that toe-nails alone are inadequate in providing a continuous secure load path under extreme loading (Morrison and Kopp

2011). For the structure in Figure 1f, the wall section above this portion of the floor joists was completely failed, thus the load path was broken before the loads reached the toe-nail connections.

Inadequate installation of foundation straps was found in various houses (Figure 1g). The foundation strap shown in Figure 1g was inserted into a partially filled cell of a concrete masonry unit (CMU). Foundation straps can provide a method of a continuous load path from a rim joist to the concrete footer, but they are not meant to hold CMU together.

Figure 1. Observed damaged from Cookeville Tornado. a) roof sheathing loss, b) wall collapse, c) wall failure, d) porch beam failure, e) wall detachment from bottom plate, f) floor system detachment, g) stem wall collapse.

Load paths are well understood by engineers, but every year we continue to observe similar damage done by tornadoes. Most of the structures observed were built before the implementation of modern building codes, but some were not. The common theme with all these structures is the break down of the load path in the structures and not component failure. Most of the damage observed in the Cookeville could have been mitigated with the addition of metal straps to tie together the different structural systems. This area of Tennessee would greatly benefit from new building code adoption and stricter building code enforcement.
