Sewers as a Source and Sink of Chlorinated-Solvent Groundwater Contamination, Marine Corps Recruit Depot, Parris Island, South Carolina

Don A. Vroblesky, Matthew D. Petkewich, Mark A. Lowery, and James E. Landmeyer

REFERENCE: Proceedings of the 2010 South Carolina Water Resources Conference, held October 13-14, 2010, at the Columbia Metropolitan Convention Center

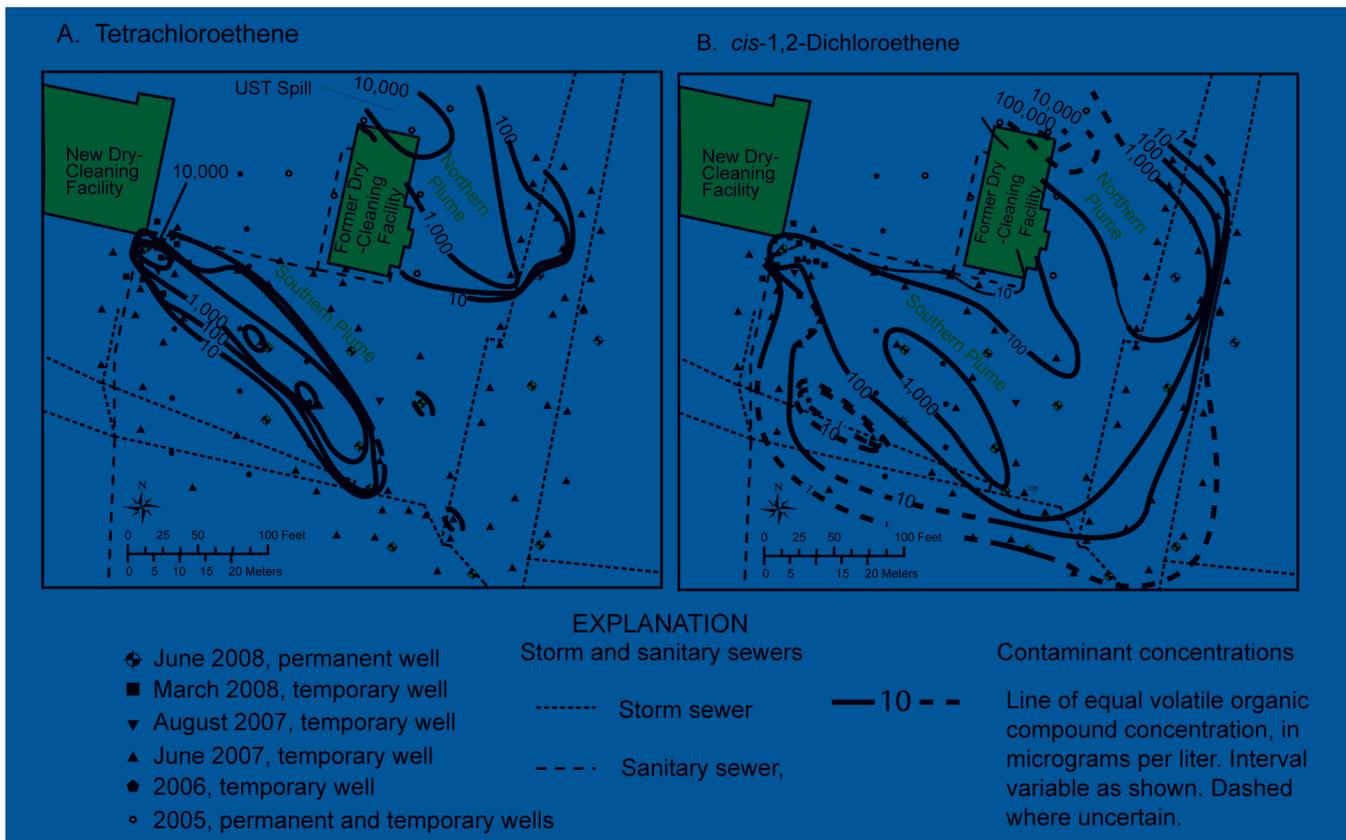
Figure 1. Tetrachloroethene and *cis*-1,2-dichloroethene in groundwater and locations of storm and sanitary sewers, Site 45, Marine Corps Recruit Depot, Parris Island, South Carolina, 2005-2008.

The aquifer at the southeastern corner of the new dry-cleaning facility, where the section of the sanitary sewer was removed, contained the greatest PCE concentrations (Fig. 1), the greatest PCE/daughter-product ratios, and the lightest PCE carbon compound-specific stable isotope values in the southern plume. The direction of groundwater flow is to the southeast and the chemical data indicate that the area where the sanitary sewer was removed contains the most concentrated and least degraded parent compound in the southern plume. The southeastern corner of the new dry cleaning facility is, therefore, the likely source area for the southern plume.

Data indicate that storm sewers also intercept contamination in the southern plume. Chlorinated solvents were detected in water from STS05 (30 µg/L of PCE, 100 µg/L of TCE, 70 µg/L of *c*DCE, and 7 µg/L VC of in June 2007). Thus, it appears that the storm drain below the water table in the down-gradient parts of the plume is a discharge zone for groundwater contamination (Fig. 1).

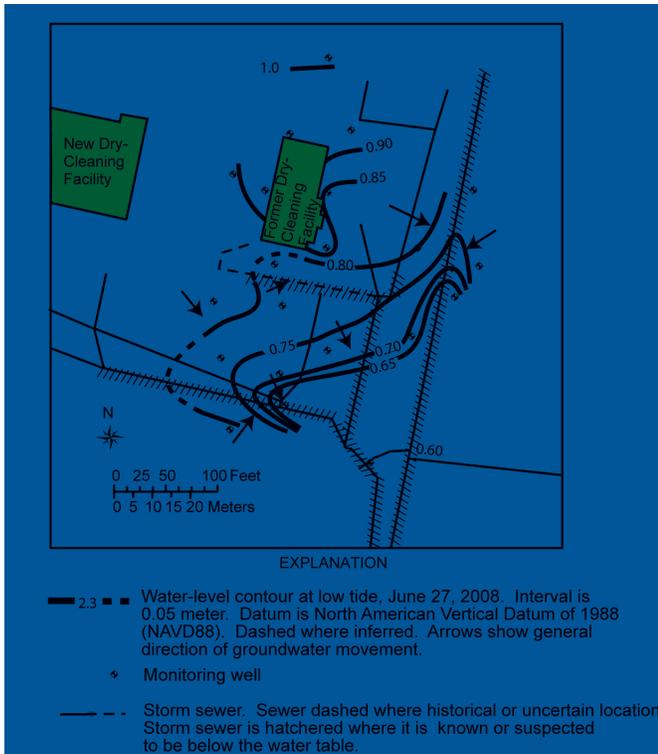
Site 45 are below the high-tide level and below the groundwater levels. The groundwater contours in the surficial aquifer show strong curvature toward some of the storm sewers where the inverts of the sewers are deeper than the water table (Fig. 2). These data show that groundwater discharges to the storm-sewer system in those areas. Once in the storm sewer, water discharges to Ballast Creek, about 463 m from Site 45.

Figure 2. Water table, Site 45, Marine Corps recruit Depot, Parris Island, South Carolina.

VOC detections in the storm sewer indicate that groundwater contamination in the northern plume discharges sections of the storm sewer below the water table. In addition, the curvature of water-table contours around parts of the storm sewer below the water table indicates movement of groundwater to the storm drain from both sides (Fig. 2).
