Analysis of Slope Failure on Cochrane Road, Dominica Prior to Hurricane Maria

A Thesis
Presented to
the Graduate School of
Clemson University

In Partial Fulfillment
of the Requirements for the Degree
Master of Science
Hydrogeology

by
Audrey Fisher
May 2018

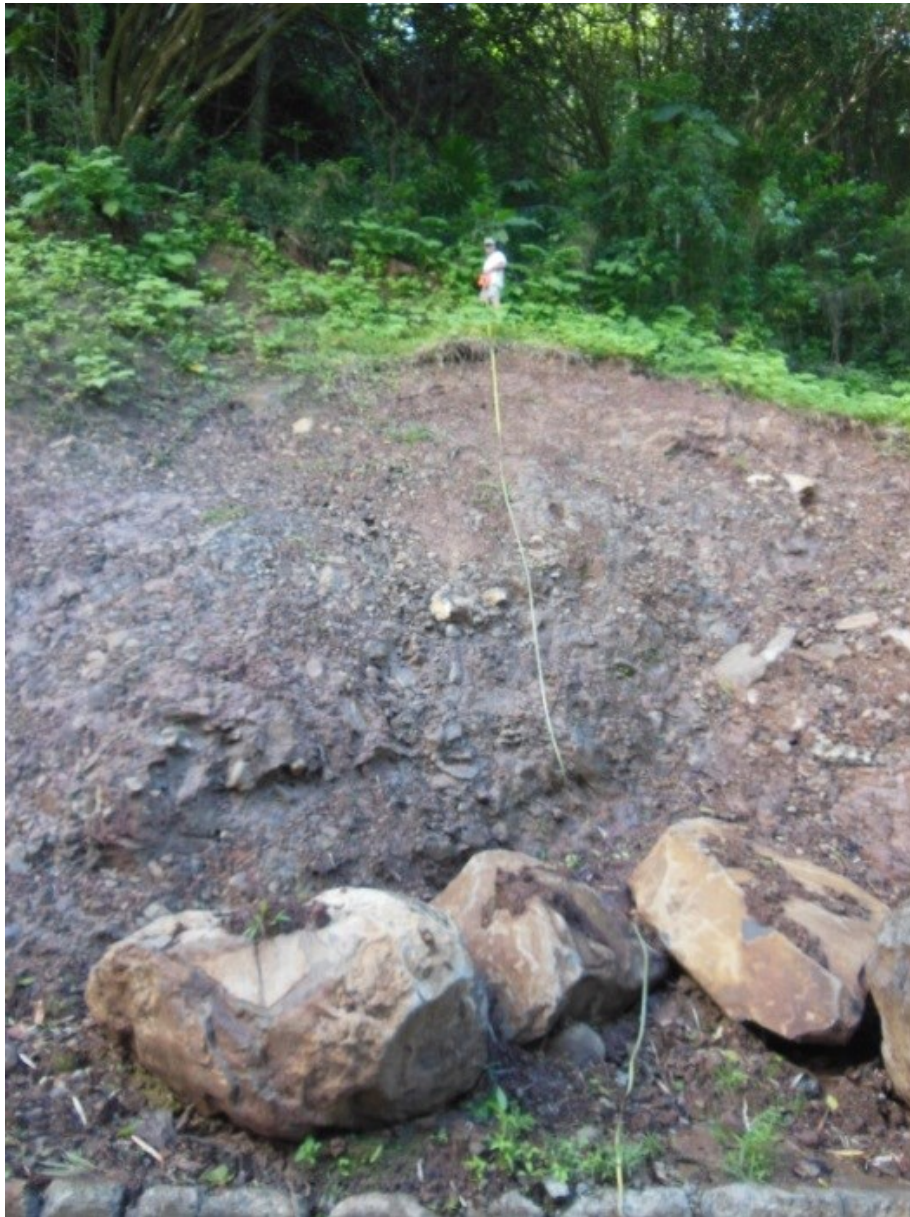
Starting at the intersection with the Imperial Road and heading uphill, CR1 was the first slide encountered. Its width was measured at the bottom near the road as 131 feet wide with a length of 53 feet along the slope using the highest point (Figure 3.6 and Figure 3.7). The slope angle was 40 to 45 degrees. About 2 to 3 feet of material had been removed during the failure. The top and sides of the slide consisted of small overhangs with hanging roots. The slope was un-vegetated with a variety of material ranging from large boulders to clay-sized ash (Figure 3.8). Due to its fresh and un-vegetated appearance, it is assumed this slope failed during Hurricane Erica in 2015.

Figure 3.6: Slide CR1 is shown with a man at the top of the slide measuring the length from the base to the highest point. The top of the slide is at the boundary between the vegetated and un-vegetated areas. At the base of the picture is the curb of the road with large boulders resting just above it.

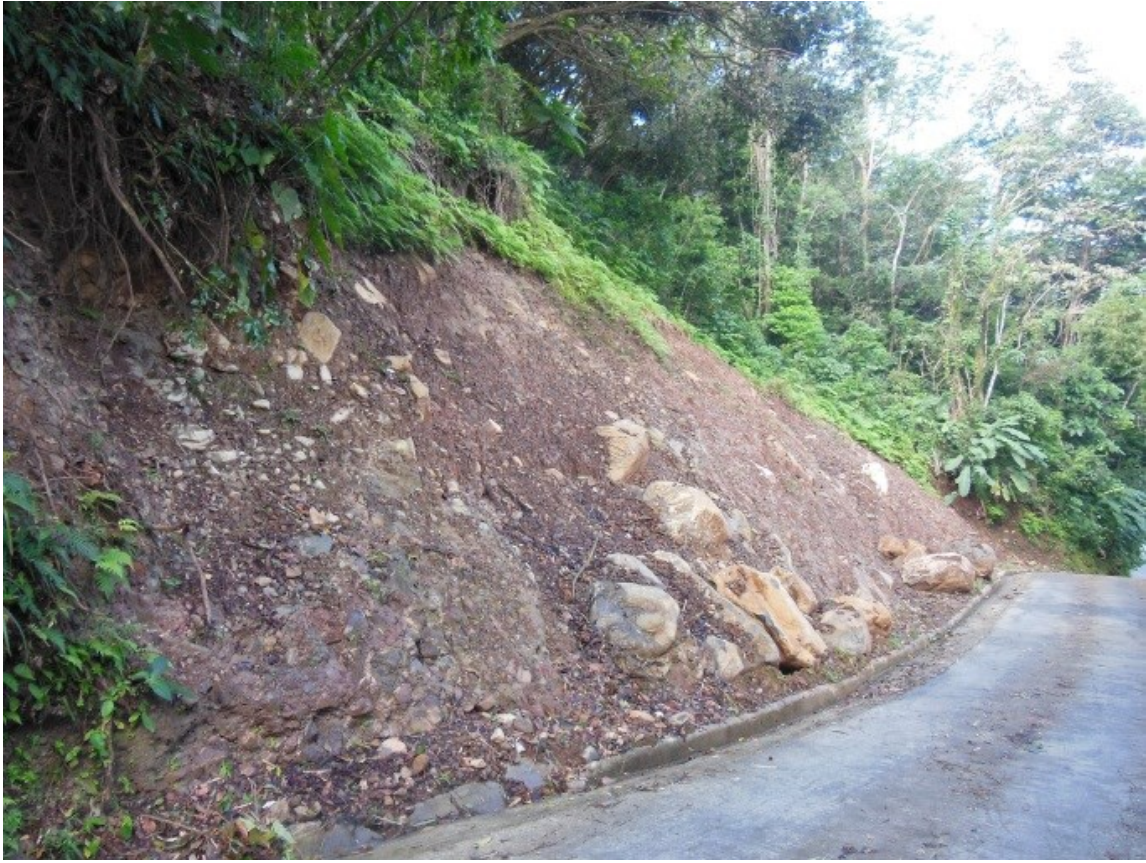
Figure 3.7: View of CR1 from the far right side of the slide. CR1 is the un-vegetated surface. In the top left of the picture there are small overhangs with roots and in the mid-right of the picture are the large boulders that were shown in Figure 3.6. They are partially buried in the soil.

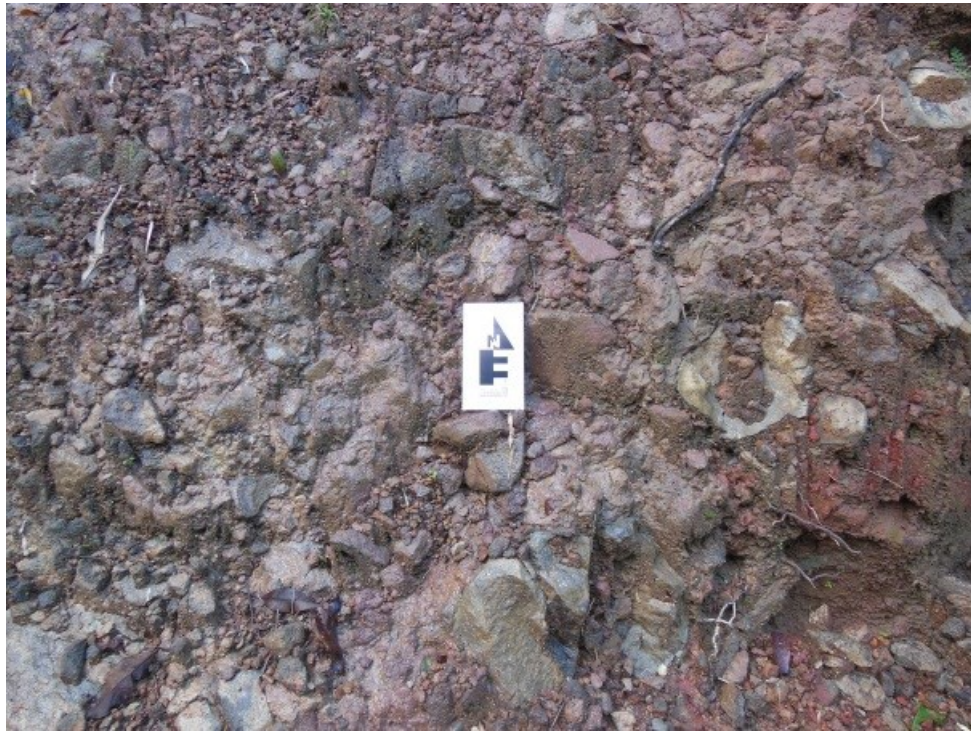
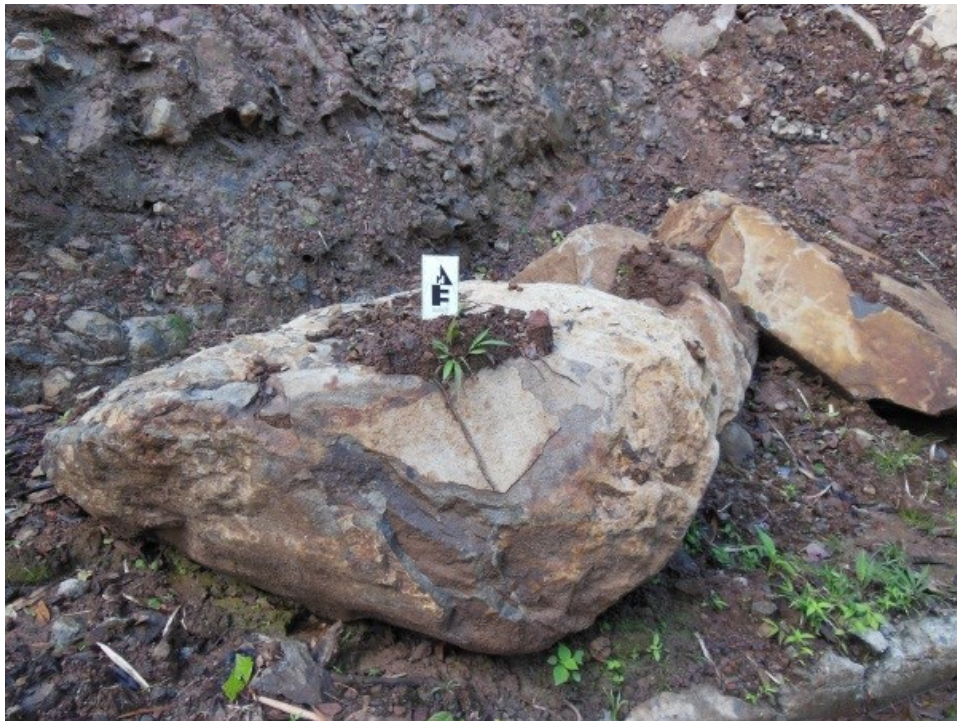
Figure 3.8: Range of CR1 material pictured with a 3 by 6 inch scale (outline of the card)
The top photo shows cobbles surround by clay sized ash. The bottom photo shows the large boulders at the bottom of the slope.

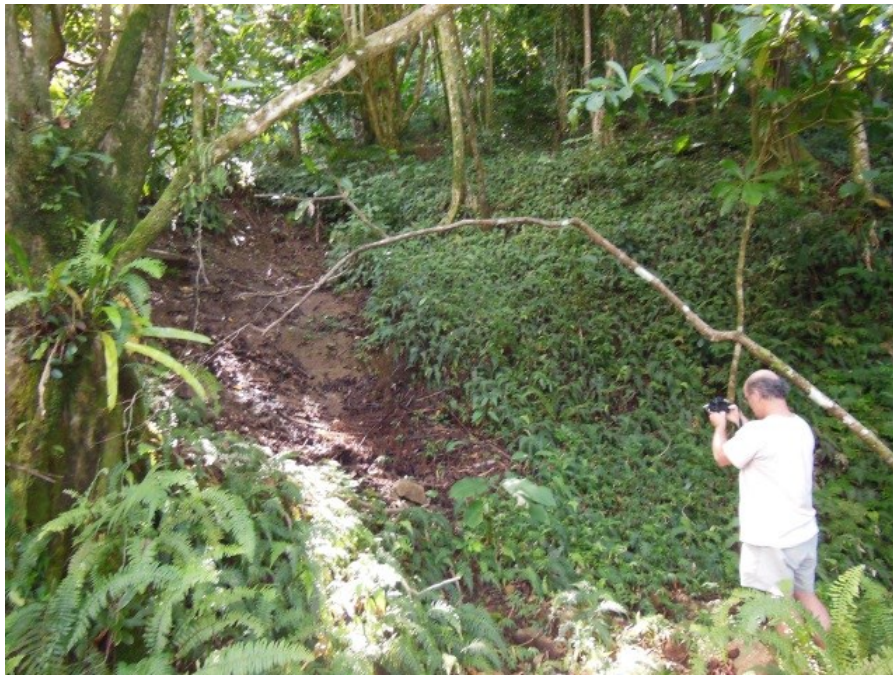
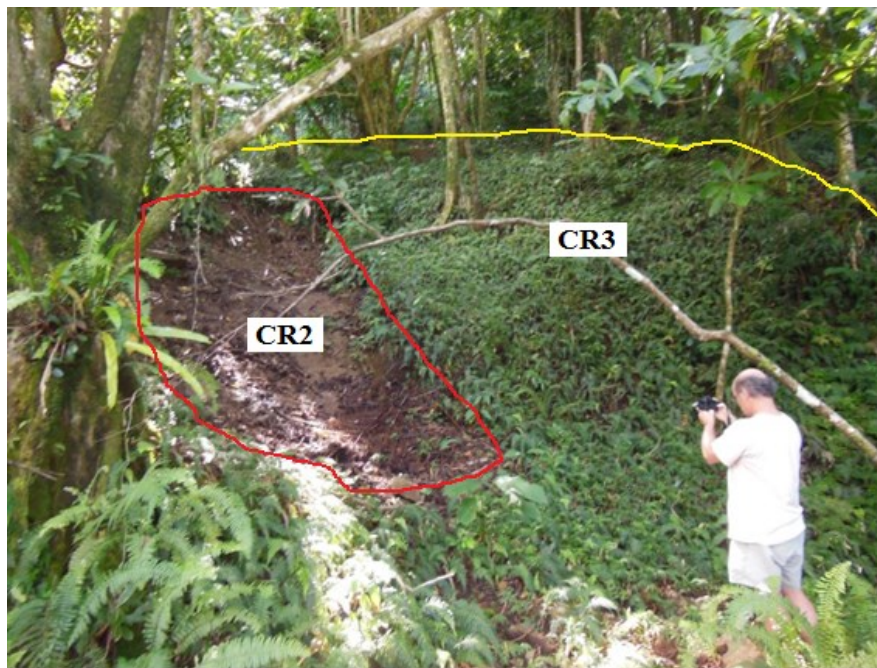
Figure 3.9: Slides CR2 (un-vegetated area on the left) and CR3 (vegetated area on the right, top of the scarp outline in yellow) shown with a person for scale. The bottom photograph is an annotated version of the top photograph to show where CR2 and CR3 are positioned. CR3 has a small scarp further uphill.

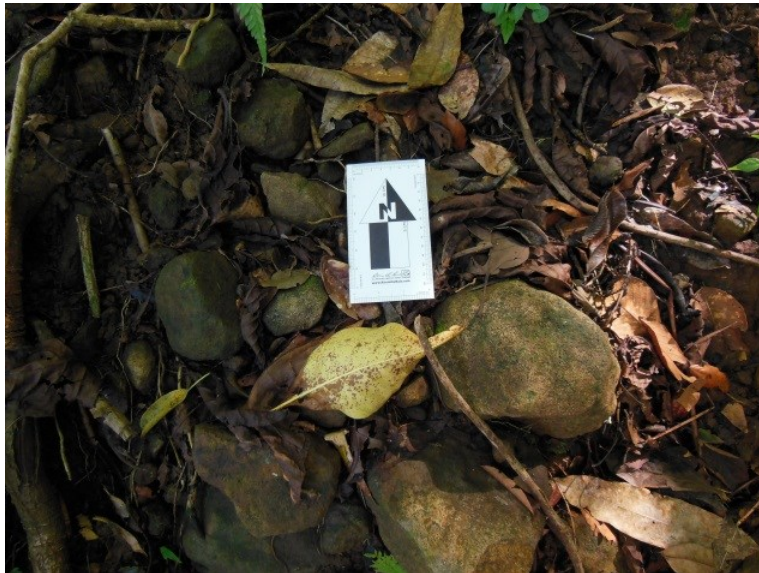
Figure 3.12: Clay sized to cobble material found on slide CR2 pictured with a 3x6 inch scale (outline of card). The leaves cover much of the clay sized material.

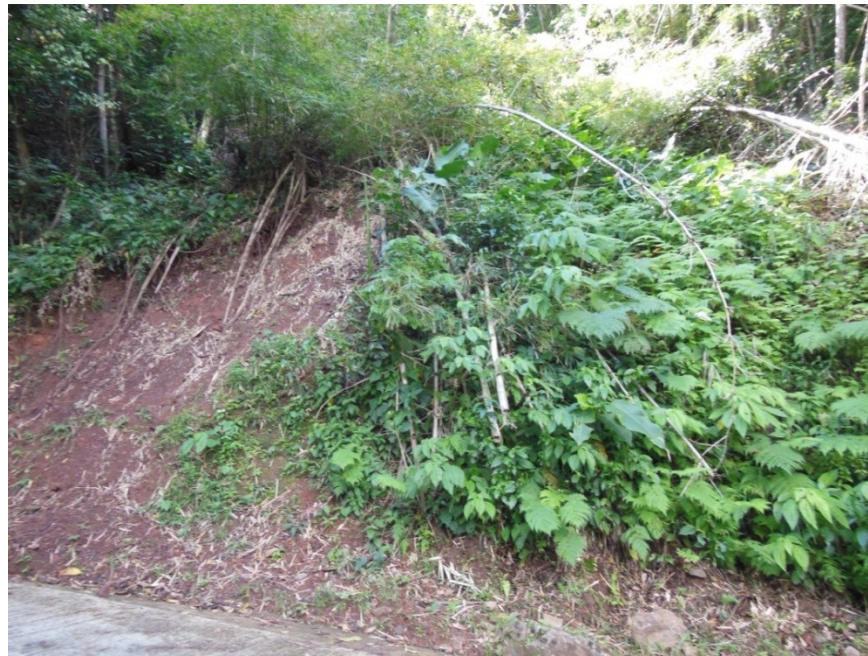
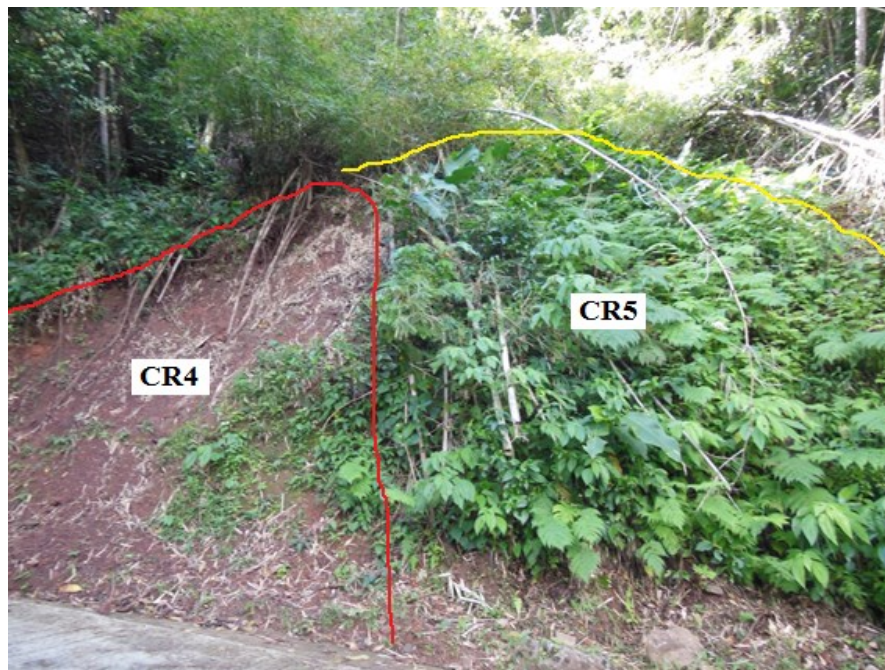
Slides at sites CR4 and CR5 (Figure 3.13) are located about 700 feet (213 m) up the road from CR2 and CR3. CR4 (Figure 3.14) is a recent failure that occurred as a result of Hurricane Erika that had cut into the older and vegetated CR5 failure (Figure 3.15). The failed material from these slides had been deposited in the roadway and been bulldozed into piles on the downslope side of the road (Figure 3.16). This pile consisted of cobbles less than 20 cm and clay clasts of 5 cm or less in diameter (Figure 3.17). The bottom width of CR4 is 19 ft and the angle of the slope is 40-45 degrees. The slide was too steep to climb, so a length measurement was not taken but is estimated at 20 ft. CR5 had large amounts of tall brush and fallen trees on it, so an accurate slope angle could not be taken, but it is estimated that it was close to that of CR4 around 40 to 45 degrees.

Figure 3.13: Slide CR4 on the left with a non-vegetated, fresh dirt surface (outlined in red) and slide CR5 on the right with a vegetated surface (outlined in yellow). CR4 has hanging roots and the top and a small area of regrowth on the right. CR5 is covered in tall leafy brush and some skinny trees that had fallen down.

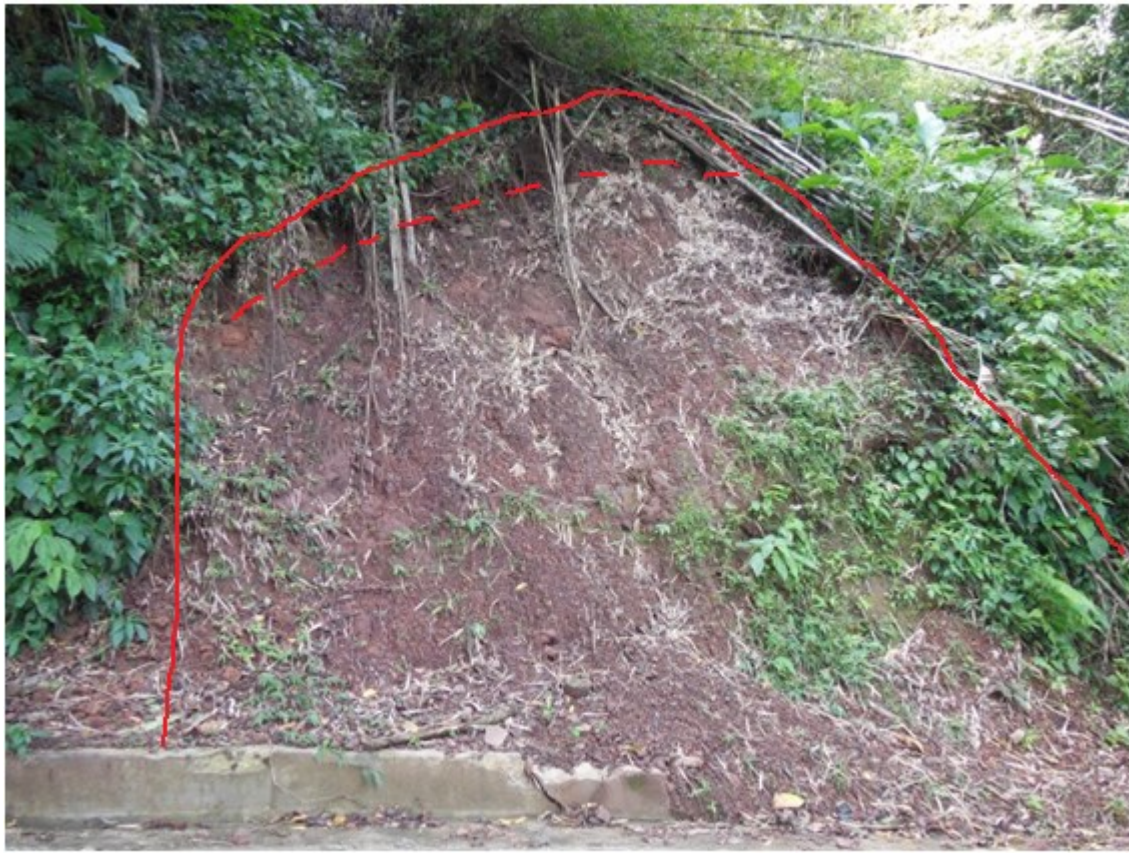
Figure 3.14 Un-vegetated slide surface of CR4 (outlined in solid red). At the top of the slide there is a small scarp (between the solid and dashed red lines) with long hanging roots and on the right most portion of the slide there is a small area of regrowth.

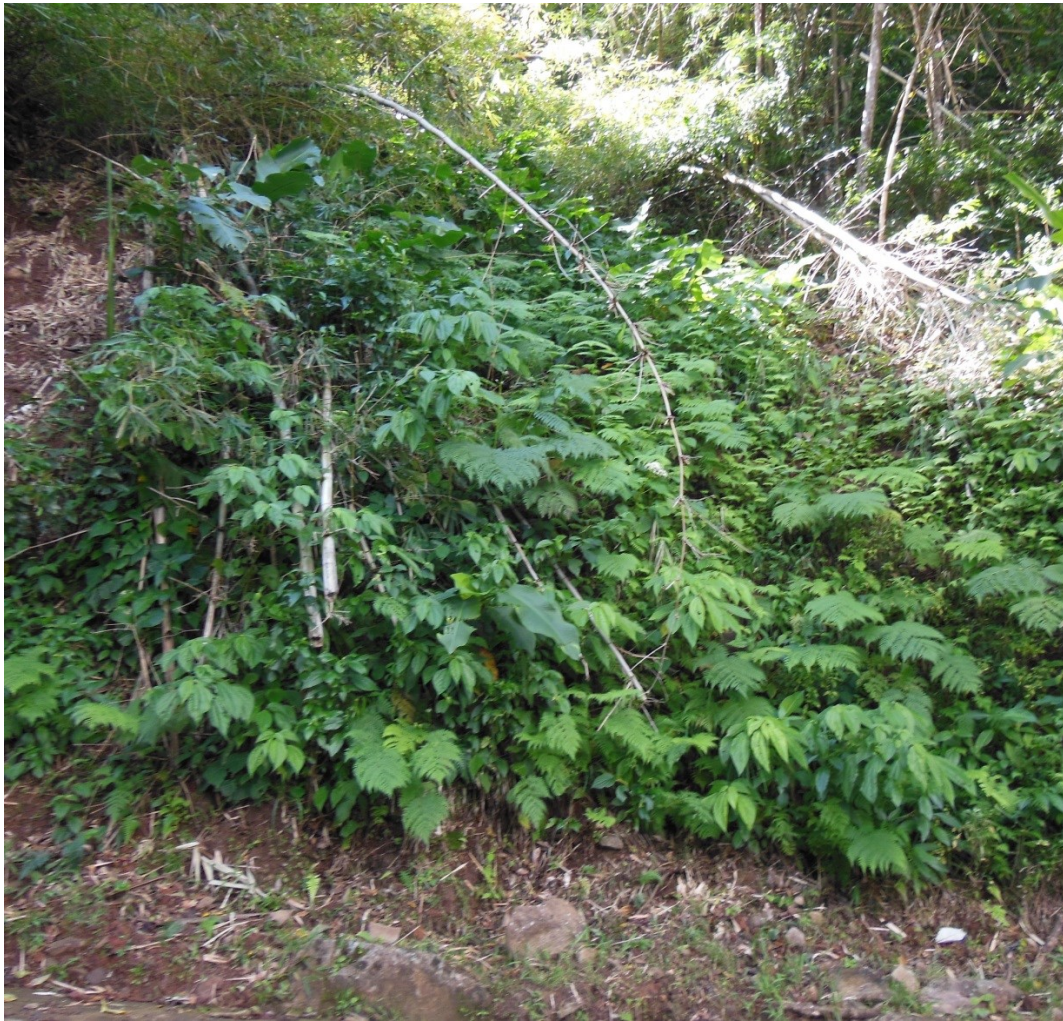
Figure 3.15: Slide CR5 covered in tall leafy brush. The vegetation on this slope is markedly different than what is found on the surrounding slopes, suggesting that this slope failed, lost its vegetation, and then regrew new vegetation

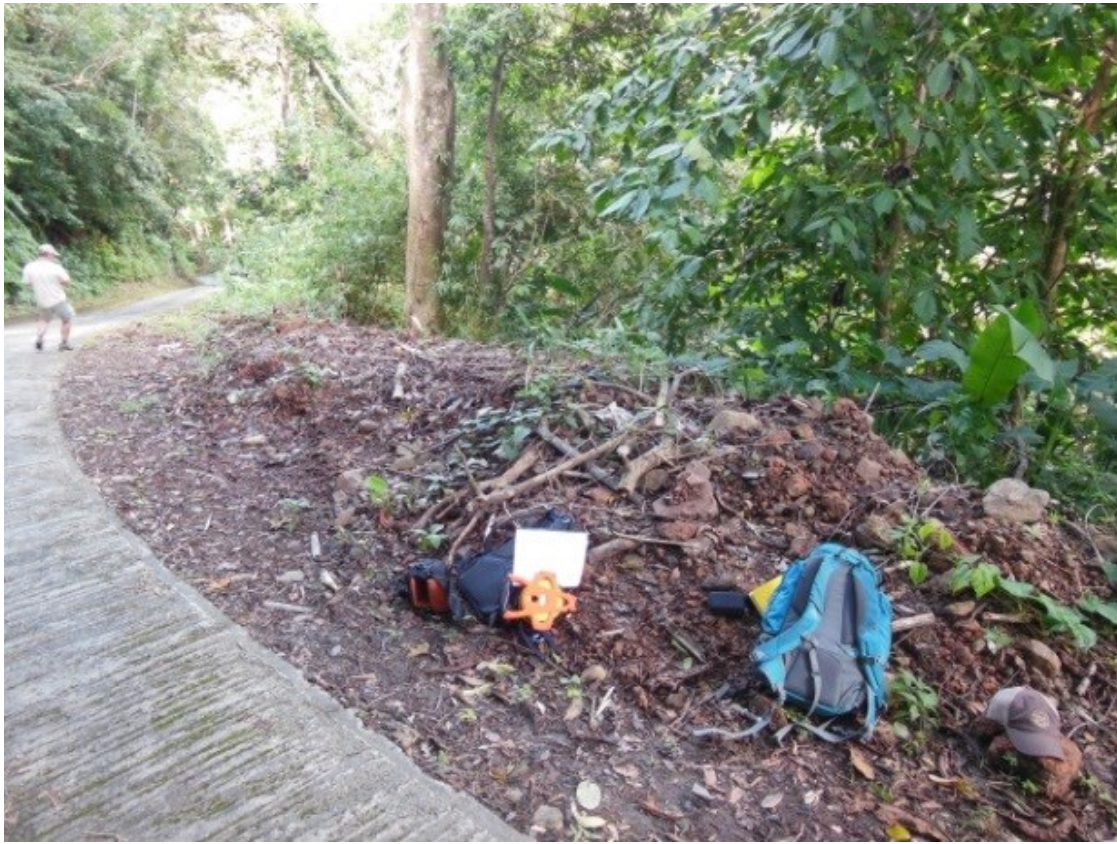
Figure 3.16: Pile of material from slides CR4 and CR5 that was bulldozed across the road.

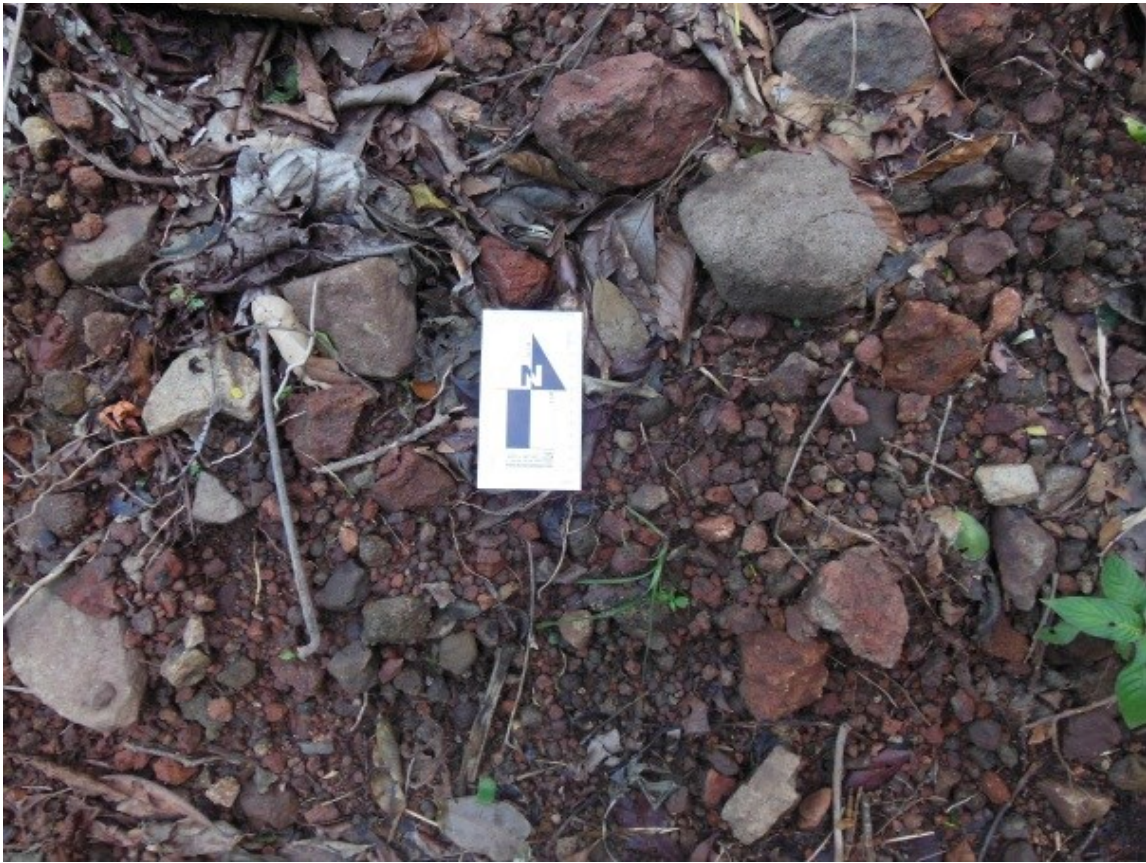
Figure 3.17: CR4 and CR5 material consisting of cobbles less than 20 cm and clay clasts of 5 cm or less in diameter pictured with a 3x6 inch scale (outline of card).

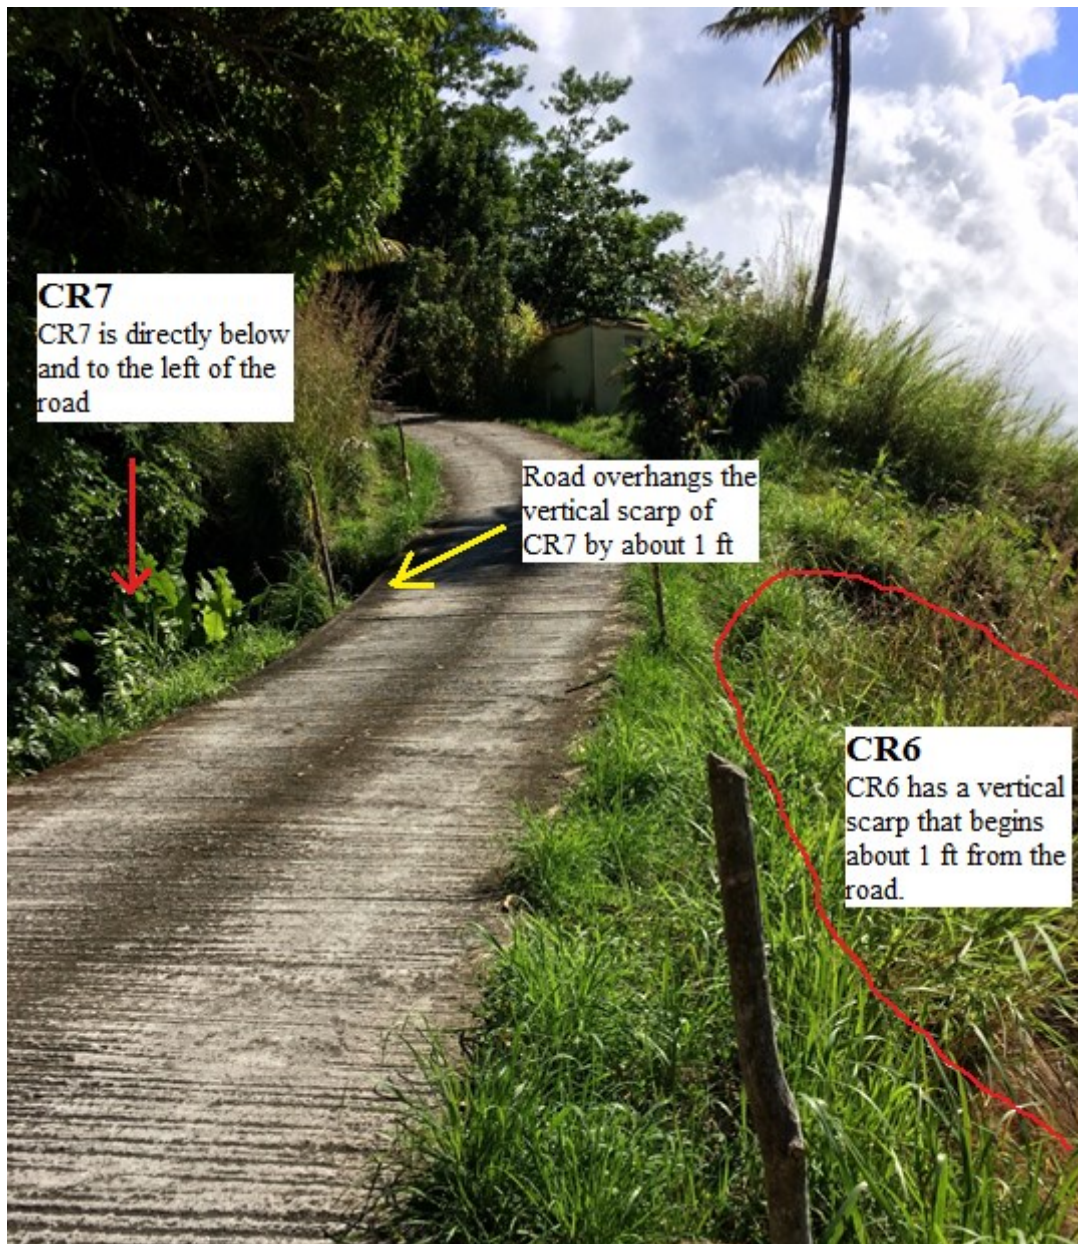
Figure 3.18: Portion of Cochrane Road that is on a narrow ridge with slope failures on either side. CR6 is located on the right side of the road and begins about 1 ft from the road. CR7 is located on the left side of the road. A portion of the road overhangs CR7's scarp by about 1 ft.

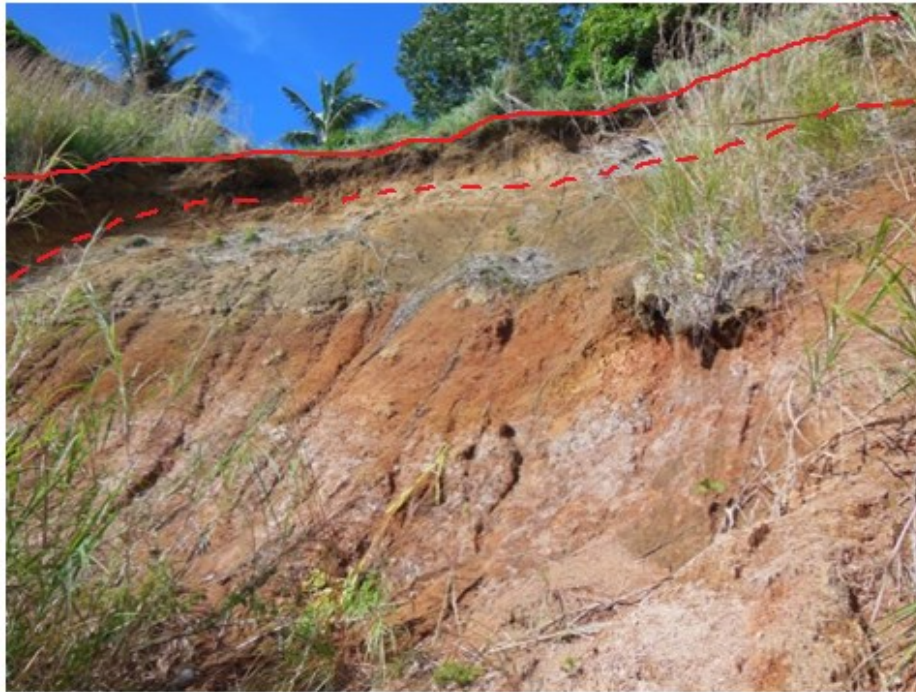
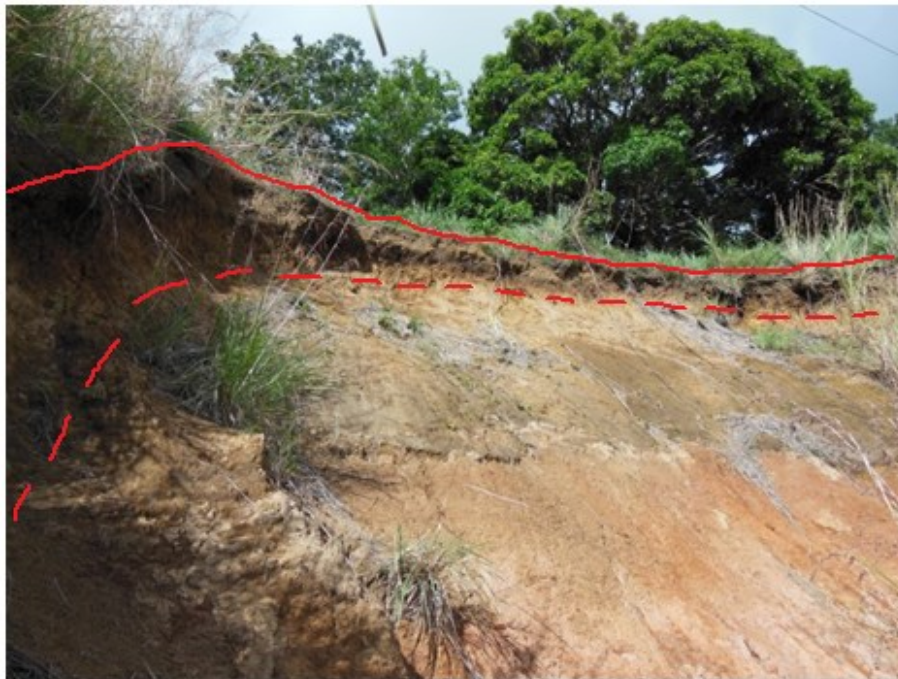
Figure 3.19: Views of CR6 taken from the bottom right (top photo) and bottom left (bottom photo) of the slide. There is a 5 ft vertical scarp (outlined in red) at the top of the slide. Lemongrass is present at the top, sides, and bottom of the slide. Cochrane Road is located about 1 ft back from the top of the slide.

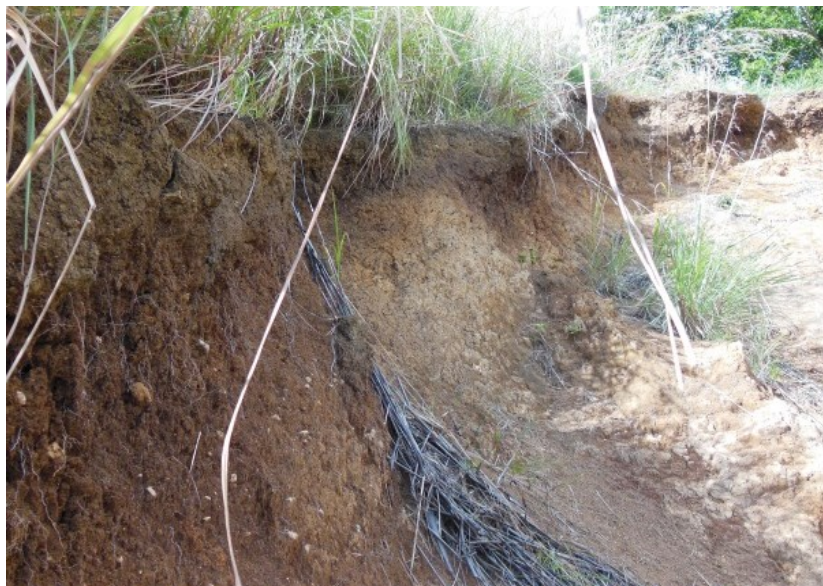
Figure 3.21: Left side of the CR6 failure surface shown 5 ft below the intact slope to the left of the slide.

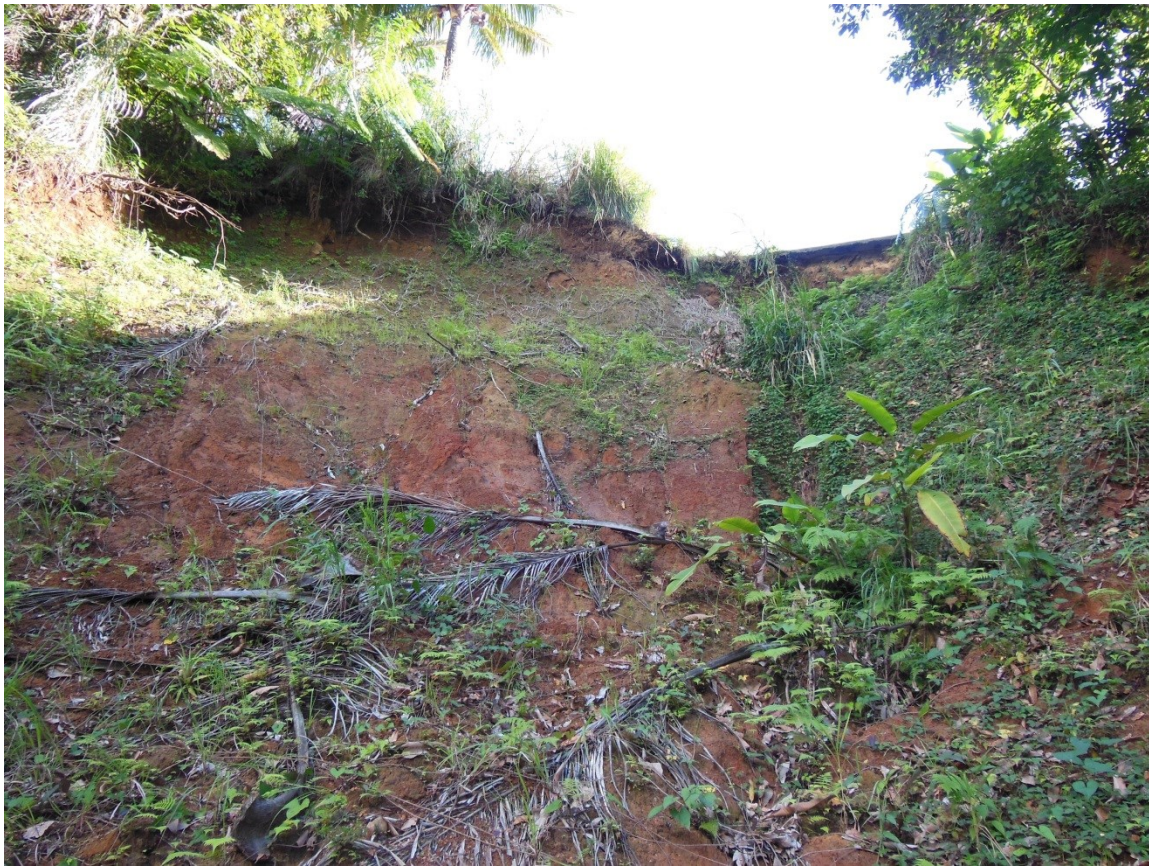
Figure 3.22: View of the CR7 slide surface with the road overhanging at the top. Portions of the slide surface are revegetated.

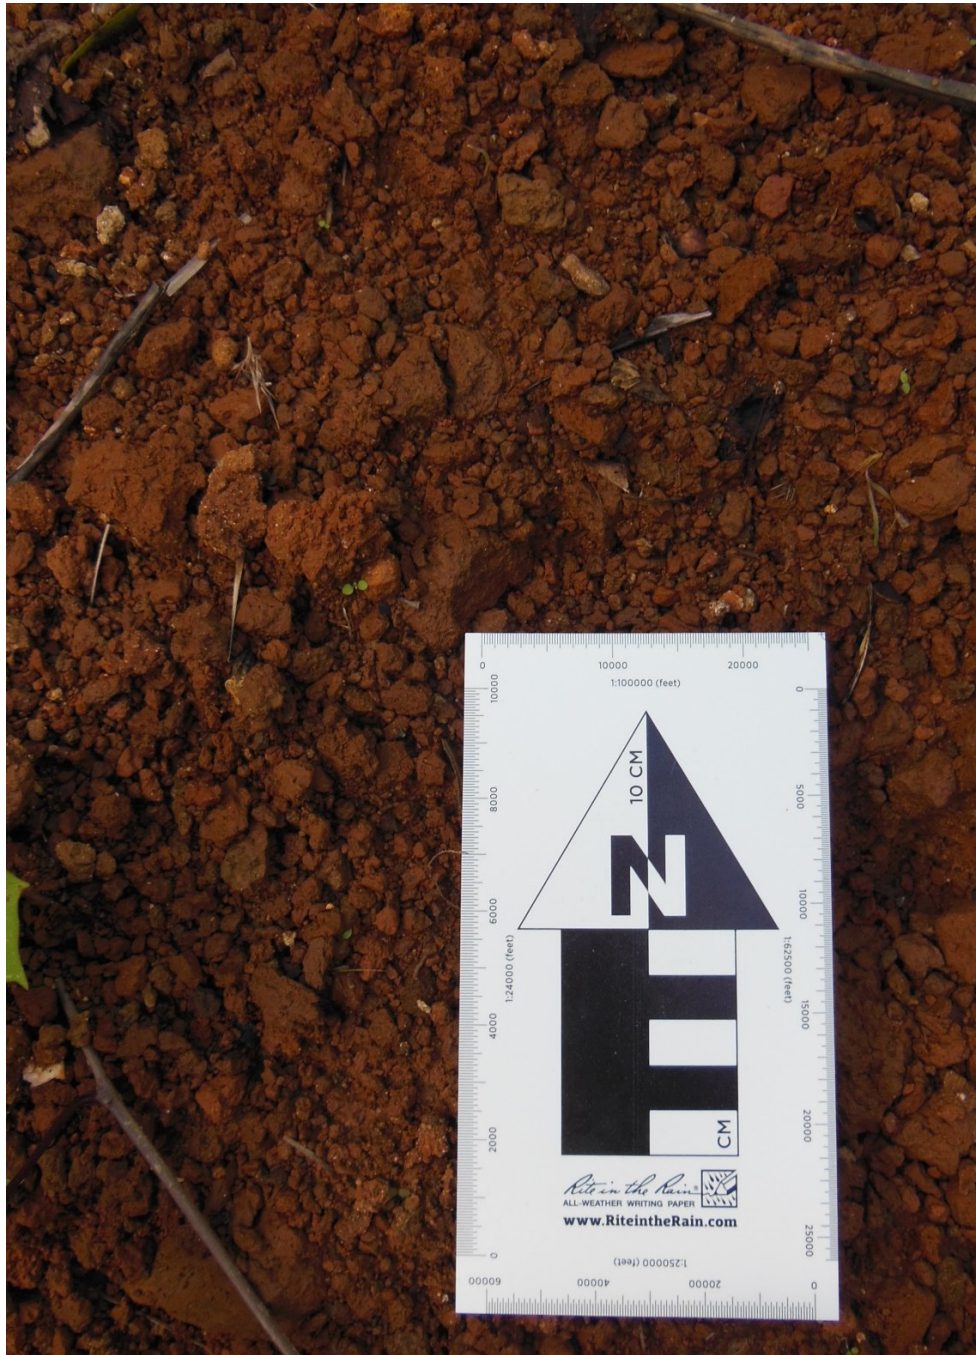
Figure 3.23: Material from CR7 consisting of small rocks and clay clasts about 3 cm or less in diameter shown with a 3x6 inch scale (outline of card).
