Clemson University
Bishop Materials Laboratory

Research Report | December 2019

**Standardized Waterproof Testing of
Plastic Based Material Flooring
(PBM Flooring)**

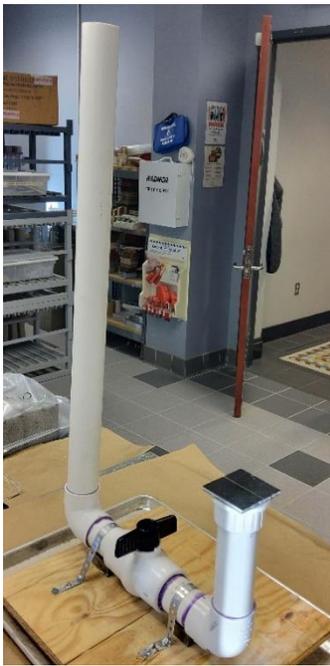
Figure 5.3.1: ASTM D4068 apparatus with specimen installed

ASTM D4068 requires that hydrostatic pressure be applied to test specimens using a PVC pipe with an inner diameter of 51 mm and a water column of 610 mm. A ball valve was installed in the apparatus to isolate the test specimens from the hydrostatic pressure (Figure 5.3.1) prior to the test commencing. The ball valve created two distinct zones, a specimen side and a hydrostatic pressure side. With the ball valve closed, water was added to the apparatus on the specimen side such that the water level was equal to the height of the specimen holder. On the hydrostatic pressure side, water was added such that the water level was 610 mm above the water level of the specimen side.

Following preparation of each test assembly, the valve was opened to apply hydrostatic pressure to the floor covering specimen's wear surface. Per ASTM D4068, any water leakage constitutes a failure of the subject material. For the purposes of this report, testing was allowed to continue for 10 minutes after the first signs of water leaking so that the volume of water leaking per unit time could be determined for each specimen.

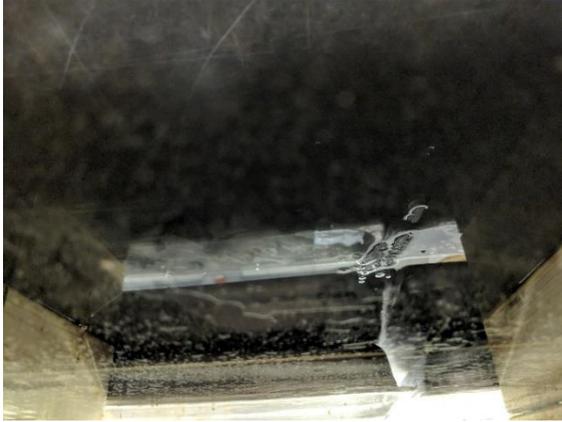
Figure 6.2.1: Water penetrating the flooring seam (seen from below the acrylic testing apparatus)

All 10 PBM floor covering products began leaking immediately upon initiating the test (well before reaching the required water level of 20 cm). As shown in Table 6.2.1, the measured rates of leakage ranged from 0.49 to 7.54 liters per hour (0.13 to 1.99 gallons per hour). For each assembly, water leakage was observed in three locations: (1) through the seams to underneath the floor covering (Figure 6.2.1); (2) into the seams and exiting at the edges of the assembly (Figure 6.2.2); and (3) into the seams and exiting atop the assembly, outside of the sealed containment box (Figure 6.2.3).

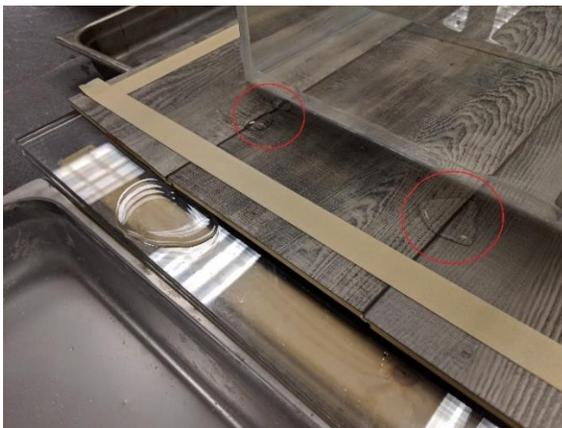
Figure 6.2.3: Water penetration into the seams and exiting atop the assembly, outside the sealed containment box

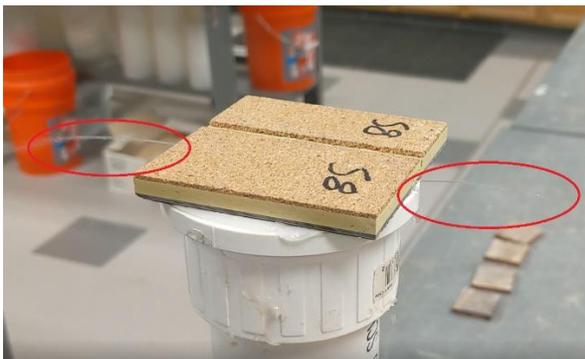
Figure 6.3.1: Water penetrating the seam and exiting from the edges

All 10 PBM floor coverings tested began leaking immediately after initiating the test. As shown in table 6.3.1, measured leakage ranged from 0.38 to 2.43 liters per hour (0.1 to 0.64 gallons per hour). All PBM floor covering products tested leaked through the seam with water exiting from the edges of the seam (figure 6.3.1). Additionally, some specimens leaked through the center seam to the back of the floor covering. (figure 6.3.2).

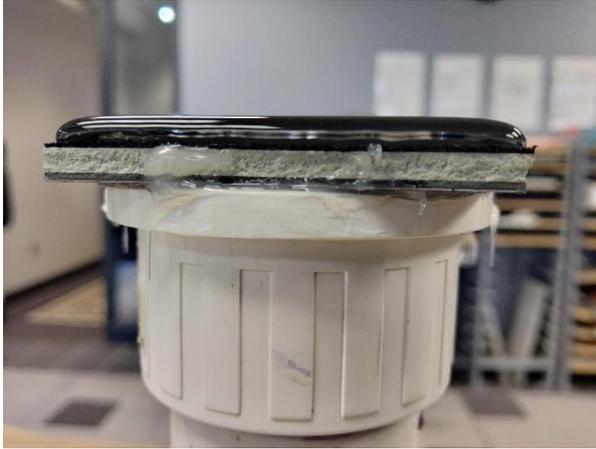
Figure 6.3.2: Water penetrating the seam and leaking to the back of the specimen
