Evaluation of Shallow Hydraulic Fractures Characterized Using Geophysical Methods

A Thesis
Presented to
the Graduate School of
Clemson University

In Partial Fulfillment
Of the Requirements for the Degree
Masters of Science
Hydrogeology

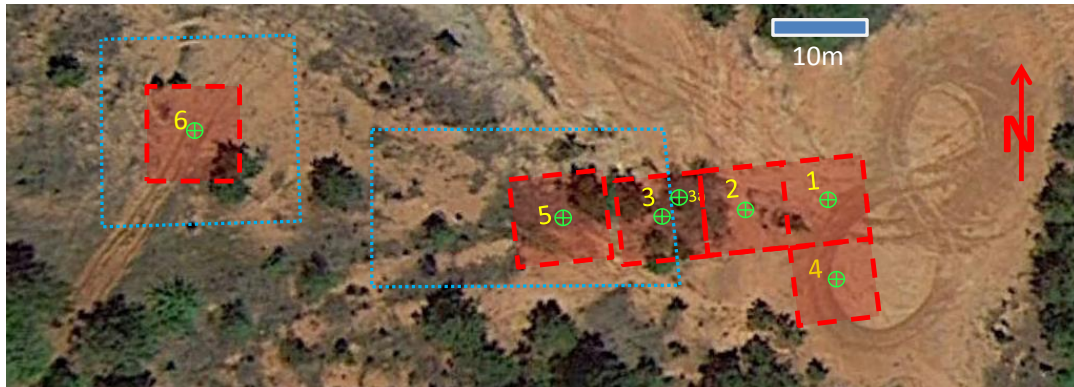
Figure 6: Map view of locations of the six test cells used in this study. Outlines of the cells are in red. Injection wells are marked with a green cross. Blue dashed lines are wire coils surrounding Cells 5 and 6.

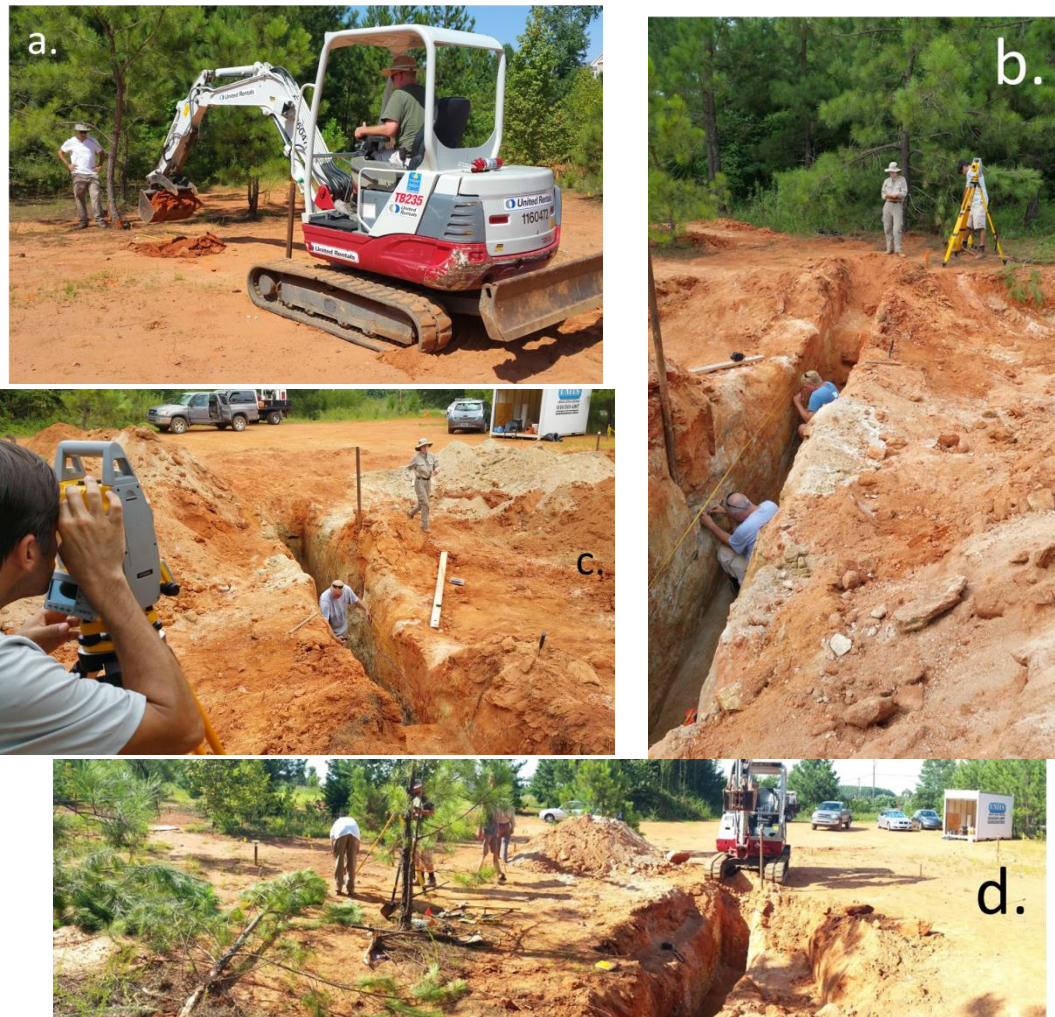
Figure 10: Excavation of Cell 2. a.) Backhoe used to dig trenches b.) Trench 1 exposing hydraulic fracture in Cell 2 c.) Surveying Trench 1 in Cell 2 d.) panorama of field site during excavation

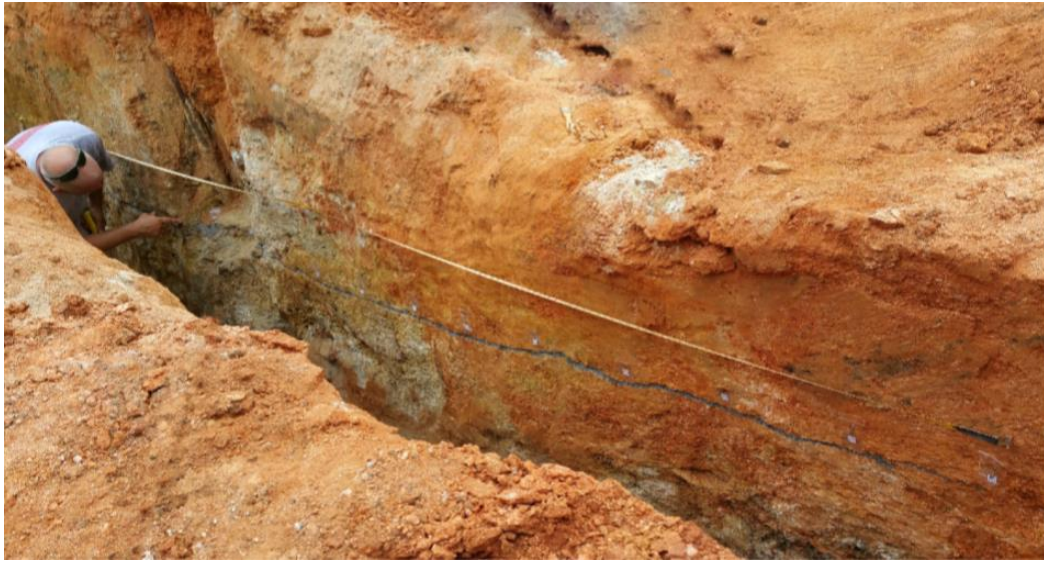
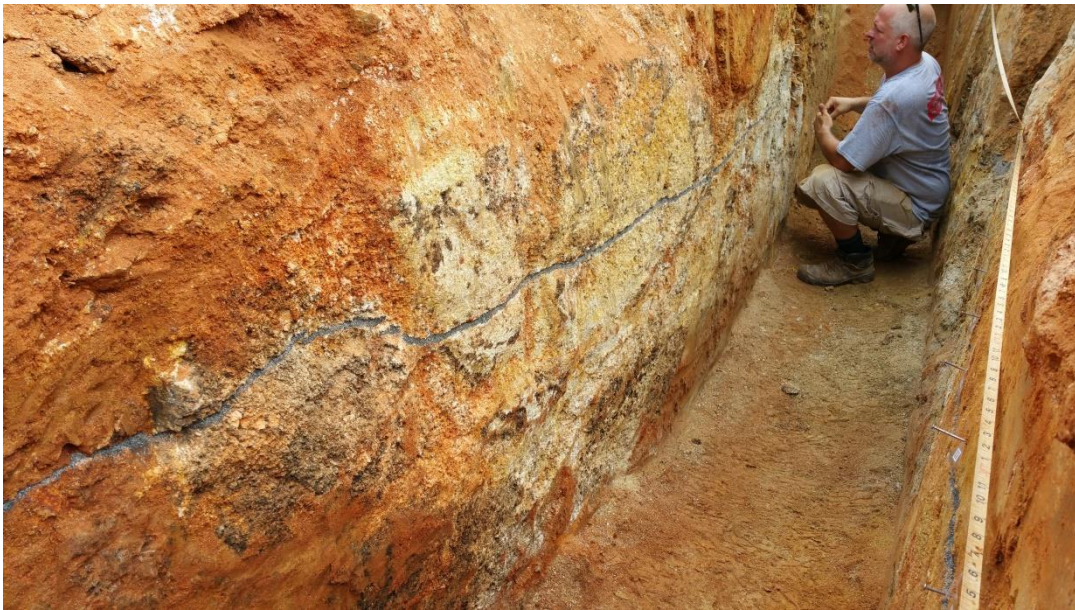
Figure 11: Trench 1 showing hydraulic fracture in Cell 2. a) East wall of Trench 1. Injection casing is on the upper left side. Yellow band is a measuring tape above the fracture. Small white squares above the fracture are 1 cm x 1 cm scales for close pictures. b) Trace of the fracture on the west wall of Cell 2.

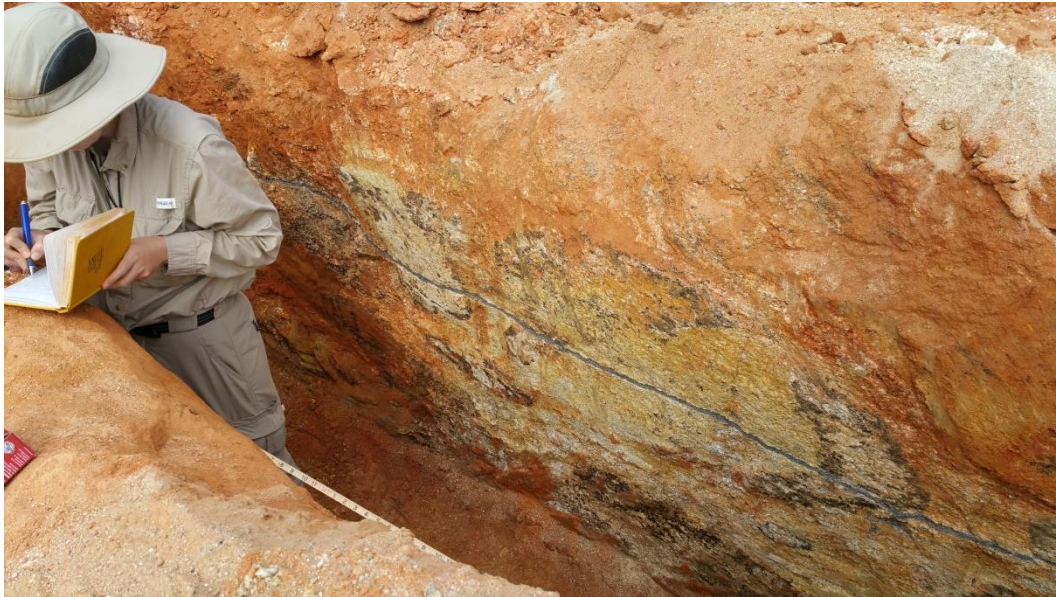
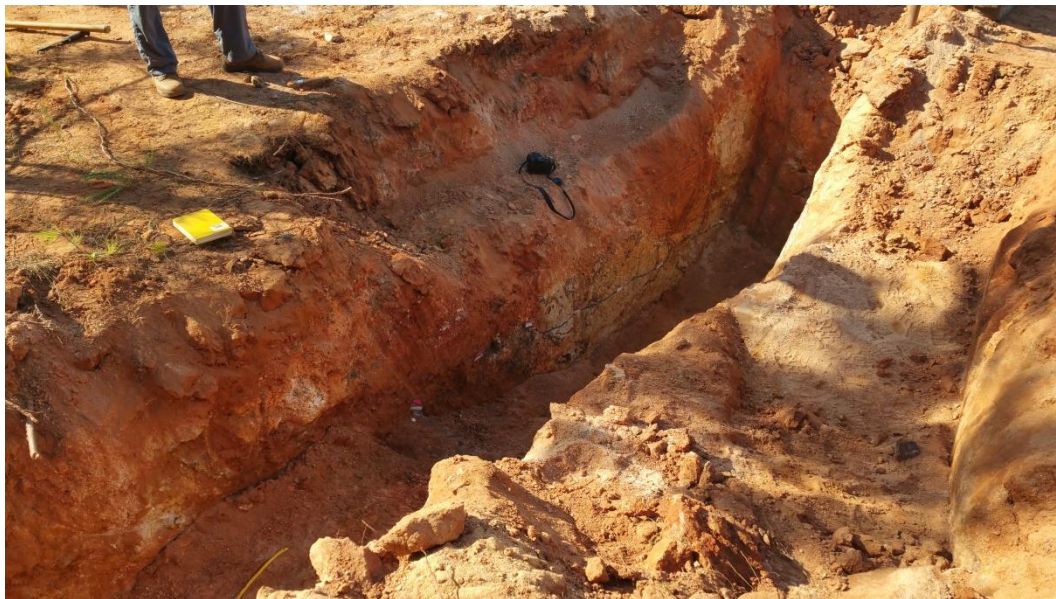
Figure 12: Mapping Cell 2 Trench 1. a) East side of Trench 1. b) West side of Trench 1.

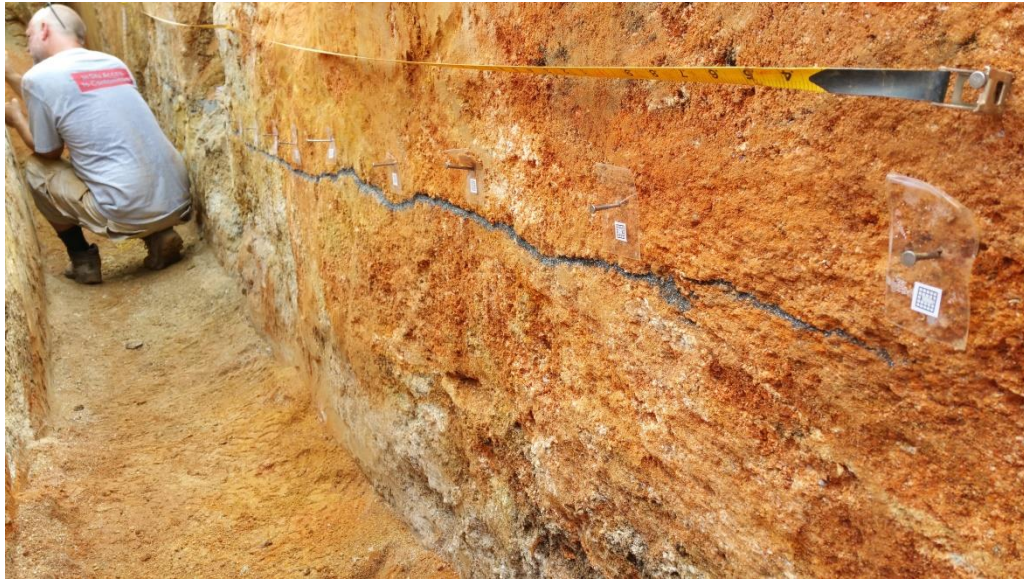
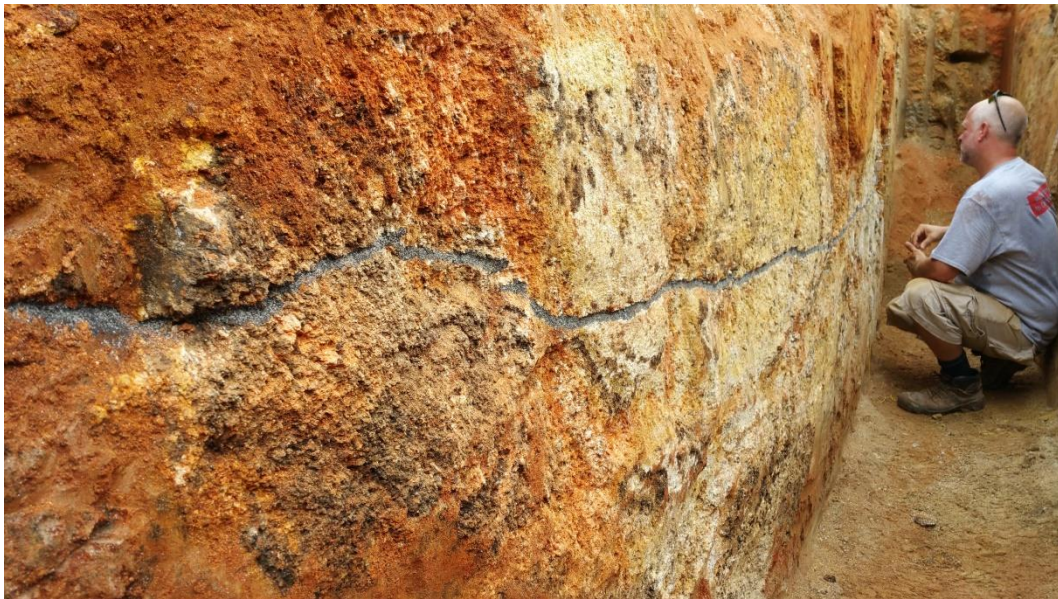
a)

b)

Figure 13: Mapping hydraulic fracture in Trench 1. a) Fracture trace exposed on east wall of Trench 1 in Cell 2. White squares are 1 cm x 1 cm scales spaced one foot apart along the fracture. Horizontal datum defined by measuring tape starting at southern tip of fracture. b) West wall of Cell 2 Trench 1.

At the beginning of the mapping phase of the project, a horizontal scale was established by attaching a measuring tape to the wall of the trench. This reference measuring tape extended from the tip of the fracture at one end of the trench to tip of the fracture at the opposite end of the trench. In Cell 2 Trench 1, the zero foot mark of the tape was always placed at the south end of the trench. In Cell 2 Trench 2, Cell 2 Trench 3, and Cell 4 Trench 1, the zero foot mark was always placed at the east end of the trench. Markers were placed on the walls of the trench every foot or 0.3 meters along a tape. The reflective markers were 1.0 cm x 1.0 cm squares with internal gradations of 2 mm. A small piece of reflective tape was placed in the center of these squares to make them reflective. The markers were placed 2.5 cm above the fracture, and survey data of the fracture was then taken with an optical transit station. The transit station was then used to record the location of the fracture within the trench. This process was repeated for each wall of the trenches where the fracture was present. These data were analyzed to create cross sections of the fractures. The distribution of proppant was observed in the cells with the coke breeze and sand proppant to determine if the components separated.

Photographs were taken of the walls of the trenches that were combined into panorama scenes by stitching together multiple pictures. The majority of the photographs were taken with a Panasonic Lumix 10 Megapixel camera. Some of the photos were taken with the camera held by hand and supported by the photographer's hip, and the rest were taken with a tripod. The photographs were made at three different scales. For the largest scale photos, the camera employed a wide angle lens and was held about 0.4 meters from the trench wall. This field of view included both the fracture and the reference tape measure positioned above the fracture. The field of view of each photo was chosen to ensure that it overlapped with each of the surrounding photos. A second set of photographs were taken at approximately half the distance of the large scale photos. These small scale pictures showed more detail, but the reference tape was out of the field of view of most of the pictures. This resulted in a large-scale photo being used to determine the location of each of the small-scale photos. Some photographs were taken even closer to the wall to provide an even greater degree of detail.

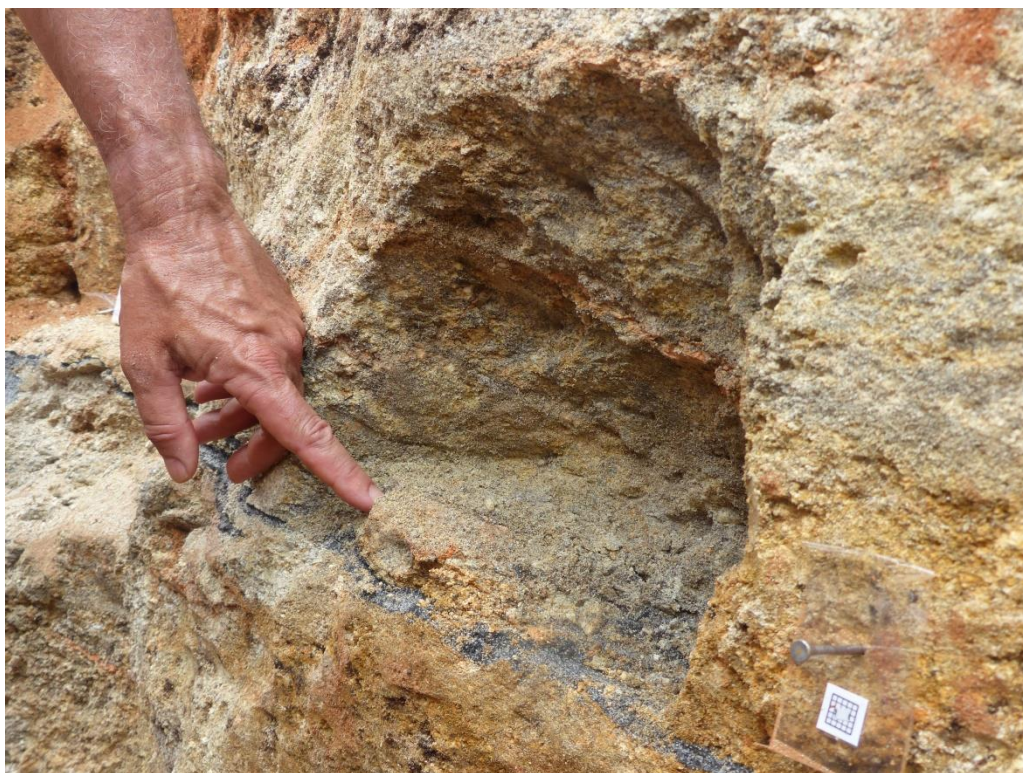
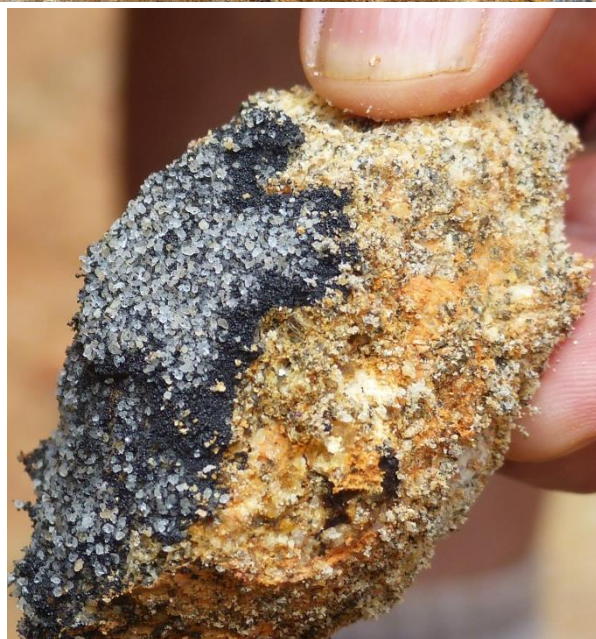
Figure 27: Images of the excavation of the upper surface of the fracture in Cell 2 Trench 1 SE Wall at the eight ft. mark. a) Excavation of the upper surface of the fracture. b) Sample of the upper surface of the fracture. Pure coke breeze present as a layer at the interface between the fracture and the wall rock.

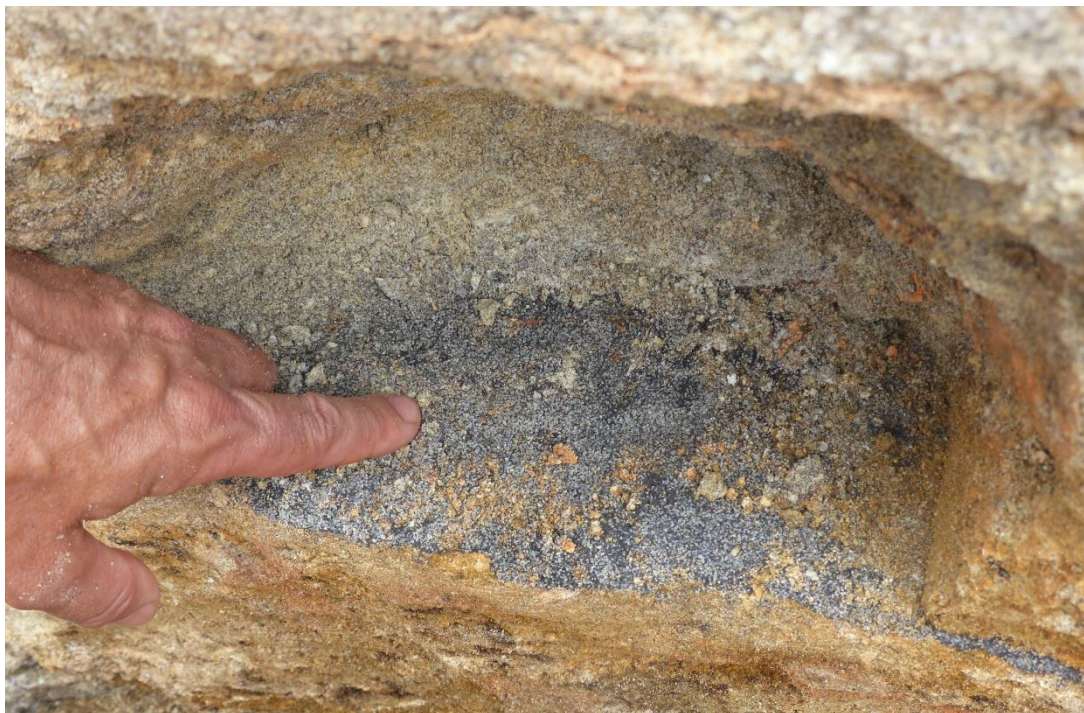
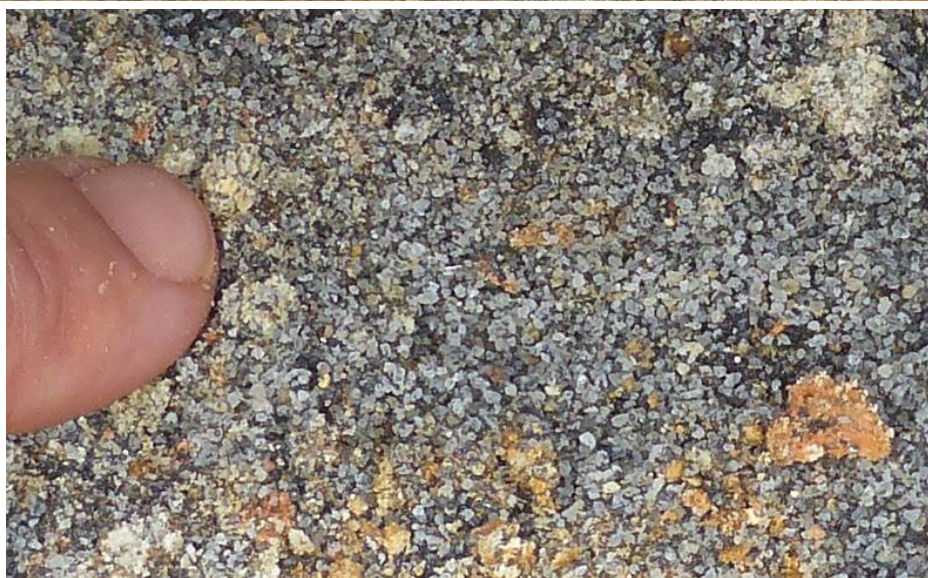
Figure 28: Cell 2 Trench 1 SE Wall at the eight ft. mark. a) Image of the middle proppant layer. b) Close up photo of the middle layer of proppant. This layer is a mixture of sand and coke breeze. Both images were taken at the same location as the image in Figure 27 except that additional proppant has been removed to reveal the middle proppant layer.

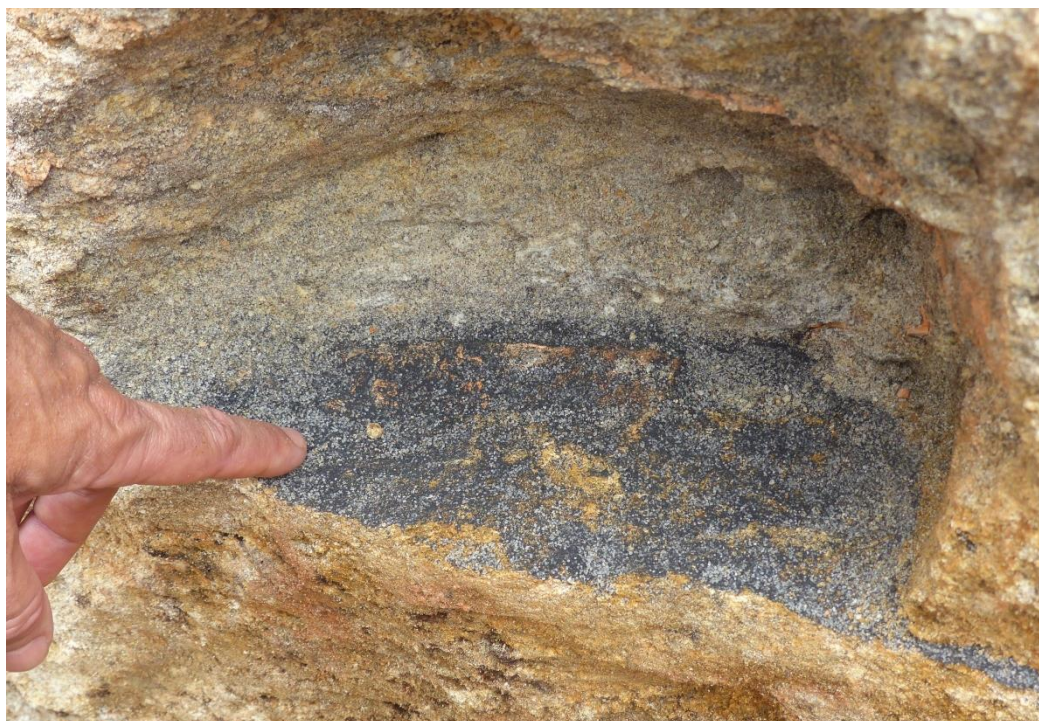
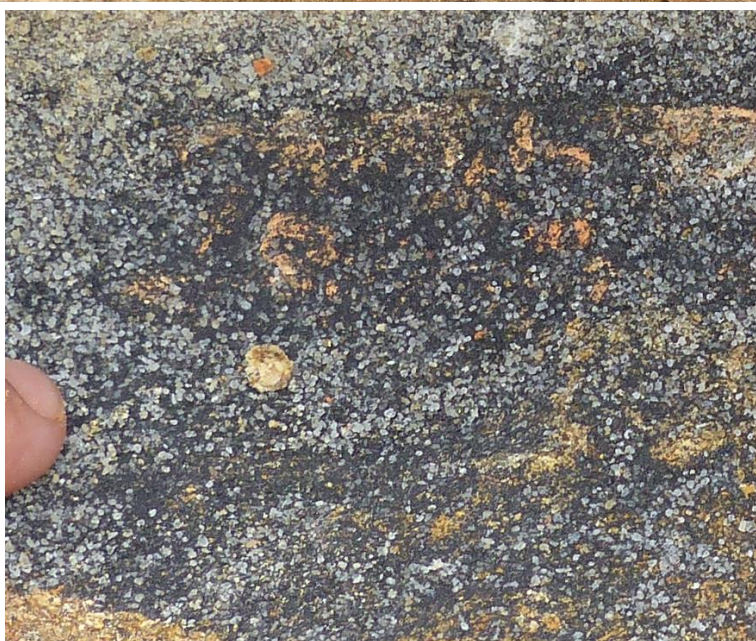
Figure 29: Cell 2 Trench 1 SE Wall at the eight ft. mark. a) Image of the bottom of the proppant. b) Close up photo of the bottom of the proppant layer. The proppant is nearly pure coke breeze. Both images were taken at the same location as the image in Figure 28 except that additional proppant has been removed to reveal the bottom proppant layer.

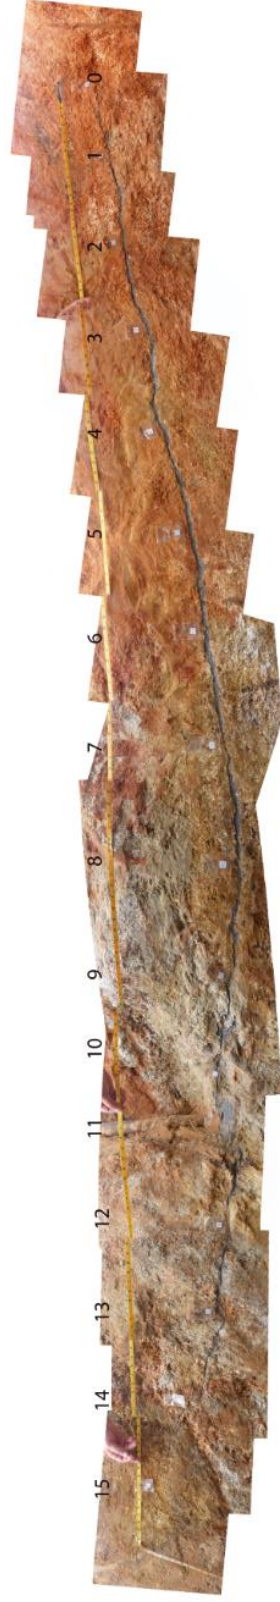
Figure 34: Photo mosaic panorama created of Cell 2 Trench 1 SE Wall. The fracture is the dark black band that traverses the panorama. The reference tape measure is located at the top of the picture, and the numbers mark each foot along the tape. The injection well and the notch are located at the eleven ft. mark.
