Out of the Woods: Facilitating Stewardship of Historic Resources in the National Forest Service

OUT OF THE WOODS: FACILITATING STEWARDSHIP OF HISTORIC
RESOURCES IN THE NATIONAL FOREST SERVICE

A Thesis
Presented to
the Graduate School of
Clemson University and the College of Charleston

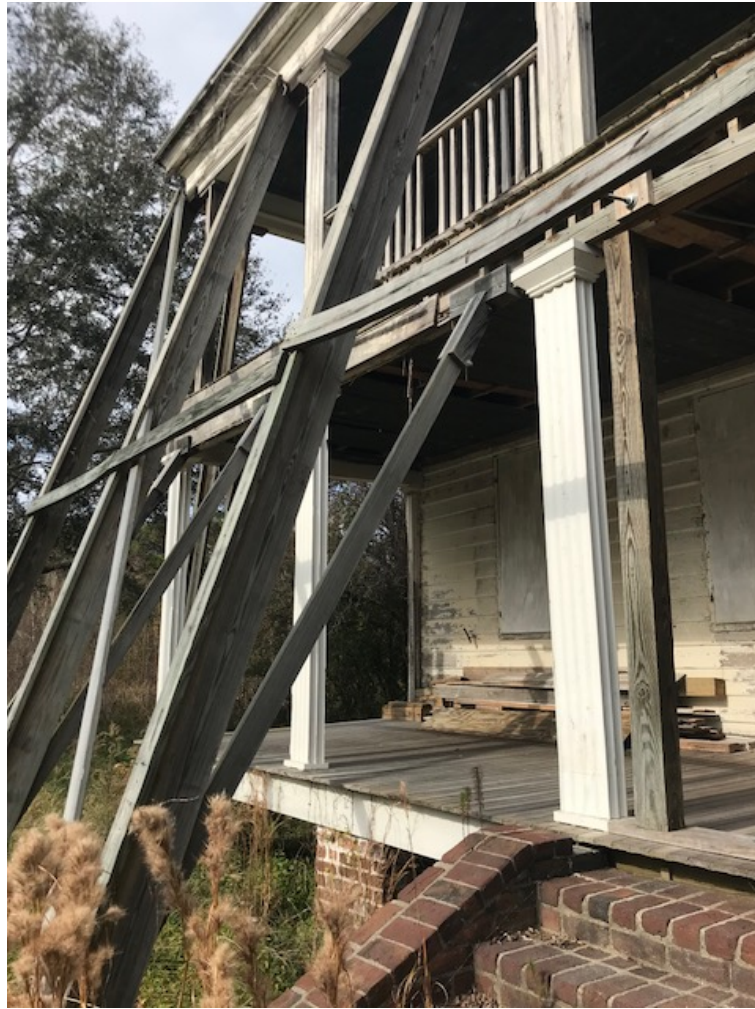
Figure 1.2 – Tibwin porch. This photograph is an example of poor site conditions, a 1, on a 1 – 5 scale of methodology, as the porch is not structurally sound on its own and must be supported with additional shored lumber (*Image from author*).

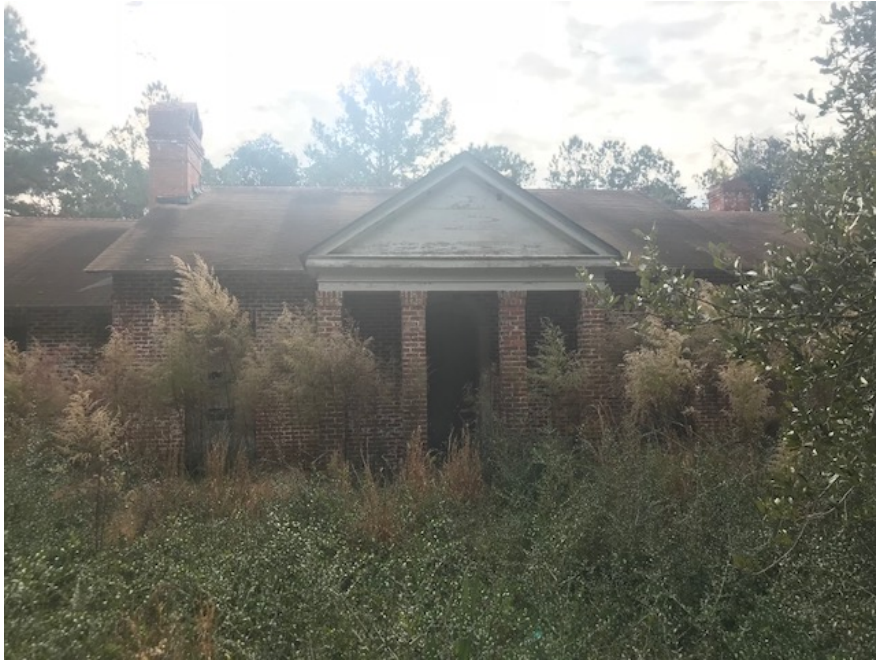
Figure 1.3 – *Walnut Grove front facade*. This photograph is an example of a good site condition, a 3, on a 1 – 5 scale of methodology, as the façade appears structurally sound but is covered with excessive vegetation, making a closer assessment impossible (*Image from author*).

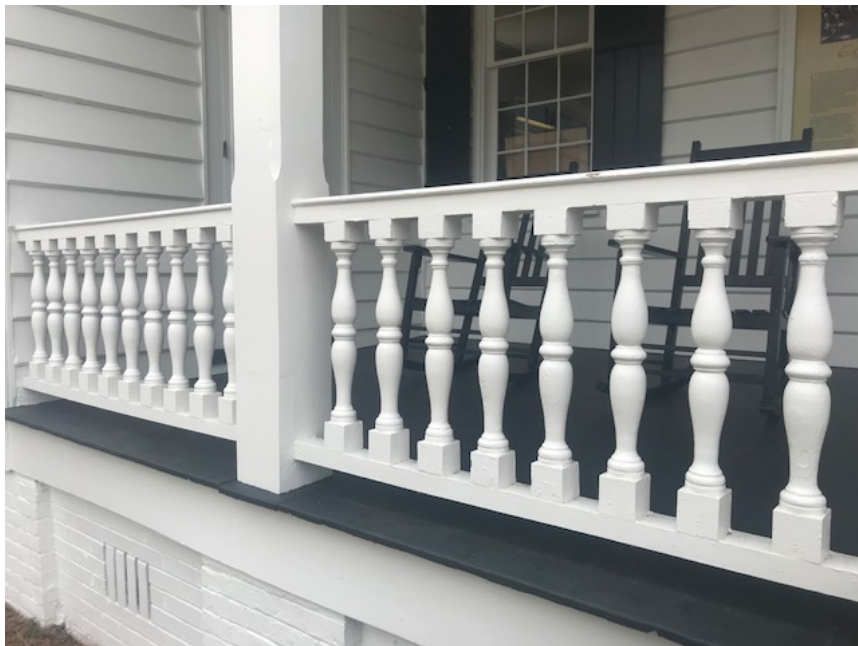
Figure 1.4 – *Charles Pinckney House porch balustrade*. This photograph is an example of an excellent site condition, a 5, on a 1 – 5 scale of methodology, as the porch has been completely restored and contains no structural or material flaws (*Image from author*). Note: the condition is a 5 here, though the integrity of the fabric has been compromised. This serves as a reminder that other factors apart from construction are important in preservation.

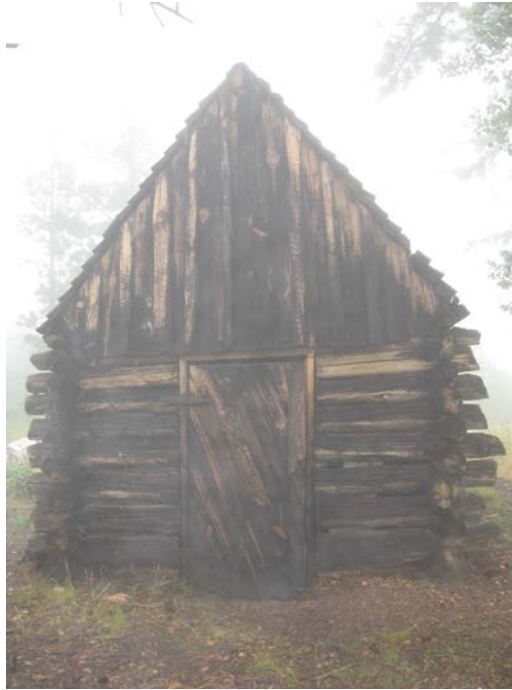
Figure 2.1 – *Greenland Lake Salt Cabin*. This photograph shows an example of a historical site left to the elements, due to a lack of funding from NPS (Image from Nathan Betcher).

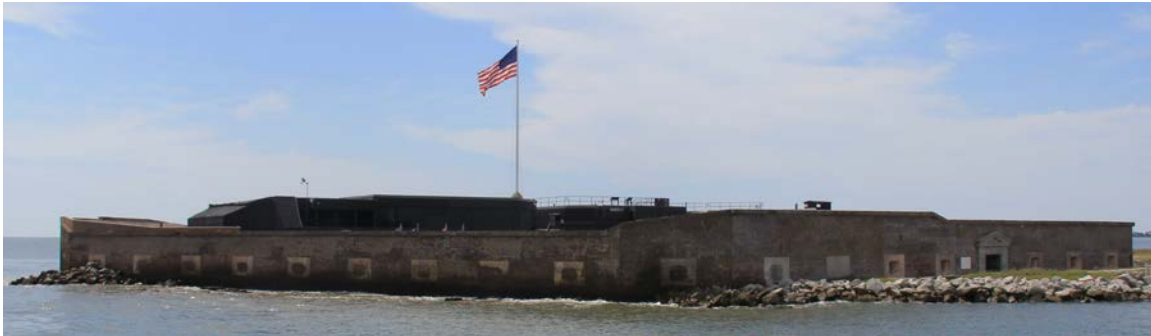
Figure 3.4 – Fort Sumter today This photograph shows Fort Sumter from the Charleston Harbor (*Image from NPS*).

A fraction of the original gun mounts remain today, the soldiers' barracks surrounding the Fort were never replaced, and only a few low walls remain of the once grand Fort. The Fort has been purposely maintained as a ruin and is now facing issues of erosion and rising sea levels as it sits in the middle of the Harbor. The Fort was declared a national historic monument in 1948 and became part of the National Parks system.³⁵

Fort Sumter is also under NPS maintenance and scored an overall average of 4.42 on its conditions assessment. Fort Sumter's location in the middle of the Charleston Harbor makes it more prone to water damage, resulting in its lower overall score. As Fort Sumter was built as a fortification, it has no porches or chimneys, meaning these building components were not scored. The roof and floor systems at Fort Sumter both received a 5, as they have been preserved to the condition in which they were found and have no visible material loss. Fort Sumter's building envelope scored a 4 as it is in overall good condition but there is material loss on one exterior wall. Fort Sumter's decorative elements scored a 5 as what simple elements are present are in excellent condition. The wall system at Fort Sumter scored a 4 as it is overall in good condition but there is some material loss on an outer seawall. The staircases at Fort Sumter scored a 5 as they have been fully rebuilt for visitor use. The foundation at Fort Sumter scored a 3 as parts of Battery Huger's foundation are crumbling.

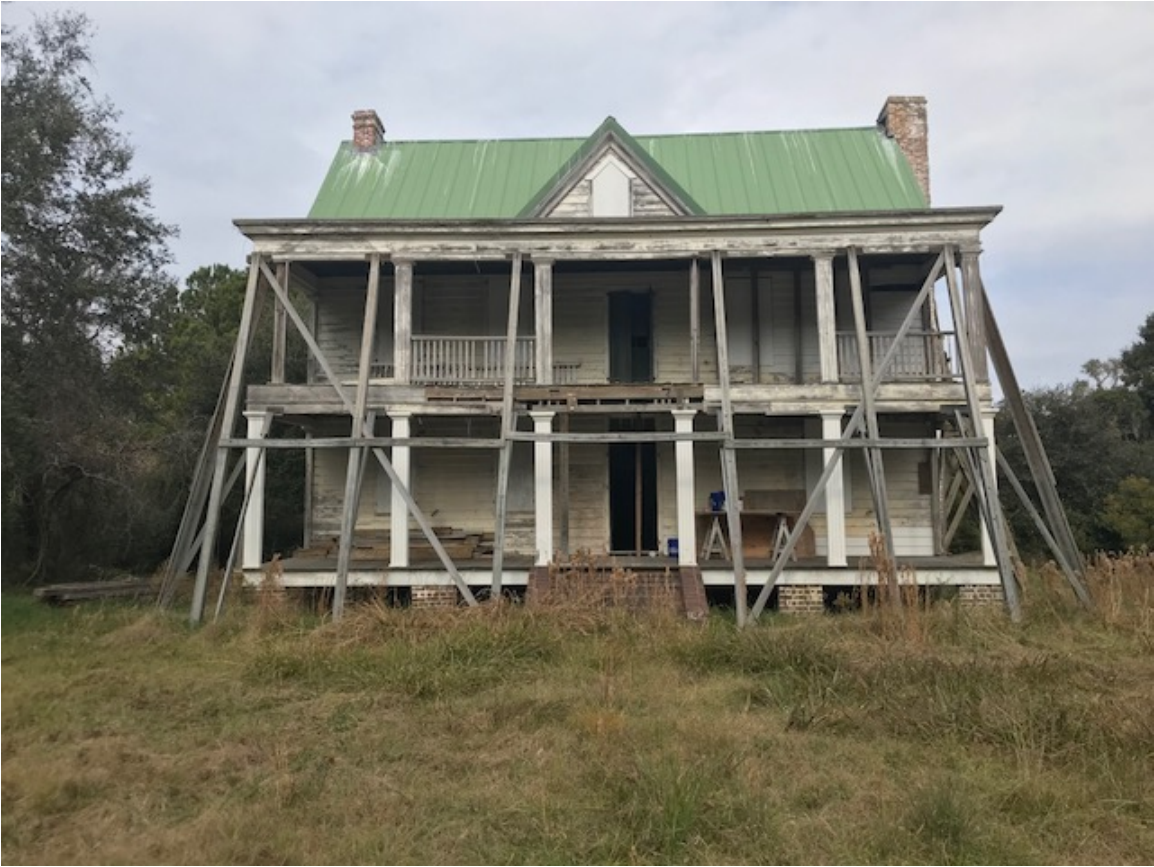
Overall Thoughts: Material loss is one of the largest threats as the structure is in dire need of repairs and stabilization and poses a risk of total loss/ building failure; animals in the building are a nuisance that must be dealt with as there are many droppings along the stairs; the entire structure needs to be secured as it is open to the elements and public currently. The roof and foundation stand in contrast to the remainder of the building and are in excellent condition.

Figure A.1 – *Tibwin Plantation Tibwin as it appears today (Image from author).*

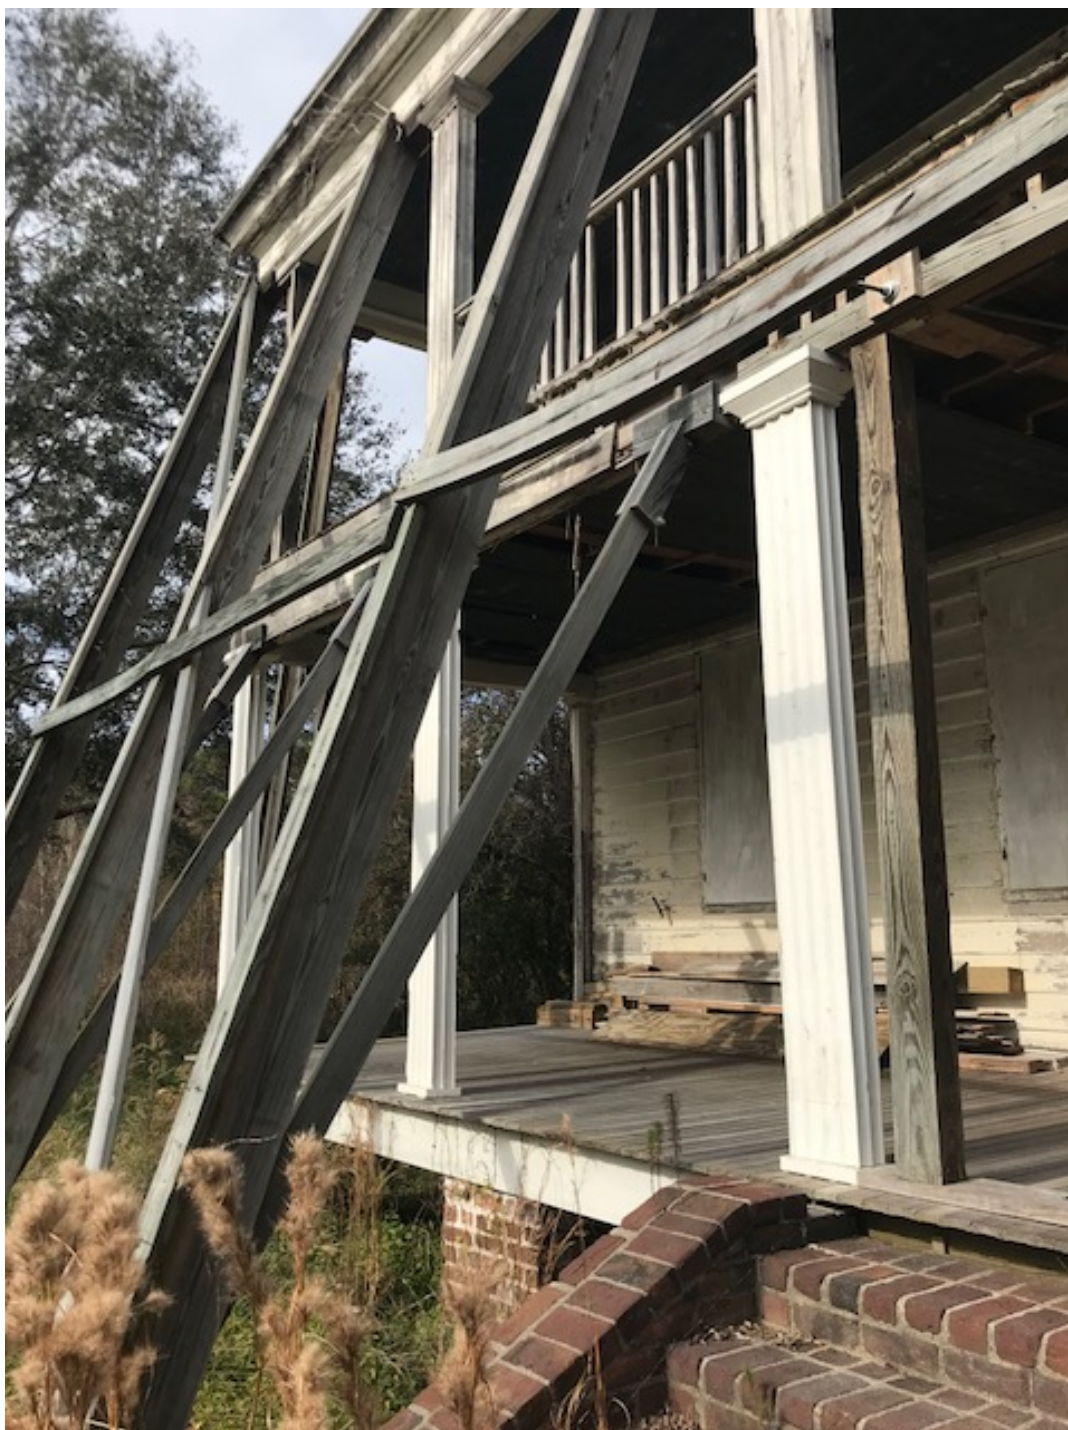
Figure A.2 – Tibwin porch supports Tibwin’s front porch is in need of structural repair (*Image from author*).

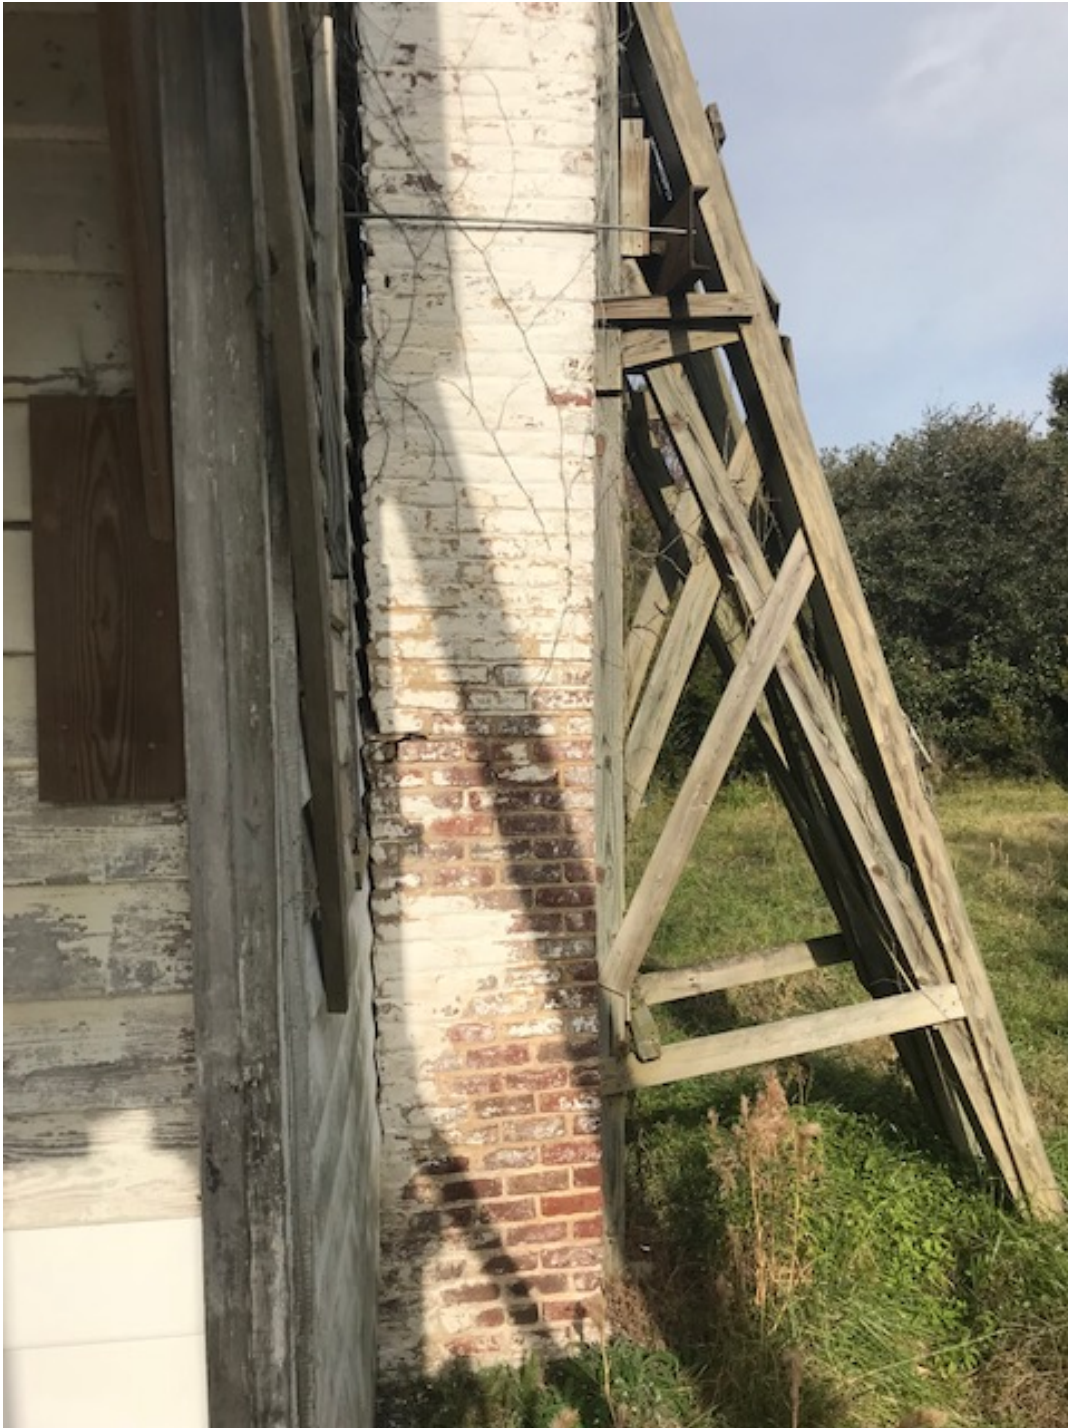
Figure A.3 – *Tibwin chimney support* Tibwin's chimneys are pulling apart from the house (*Image from author*).

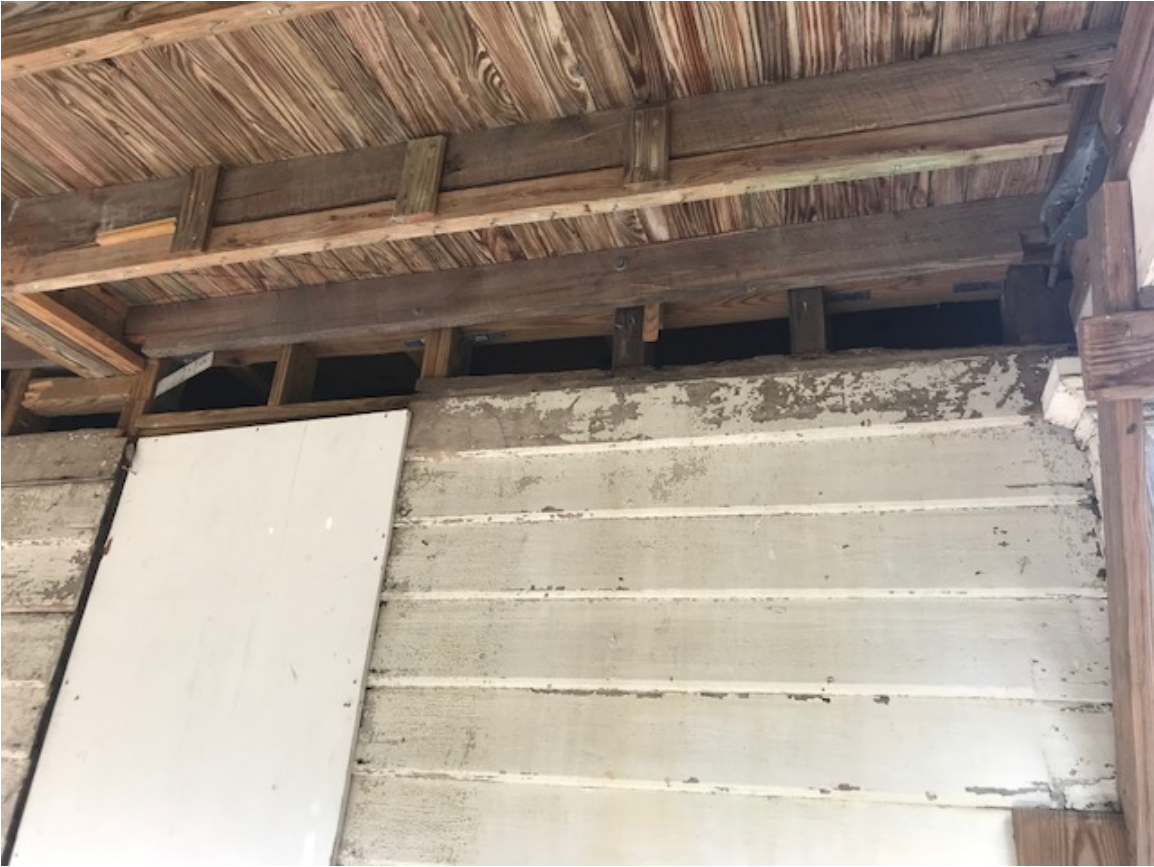
Figure A.4 – Tibwin holes in building envelope Although it has been mothballed, Tibwin has several spaces open to the elements and in need of repair (*Image from author*).

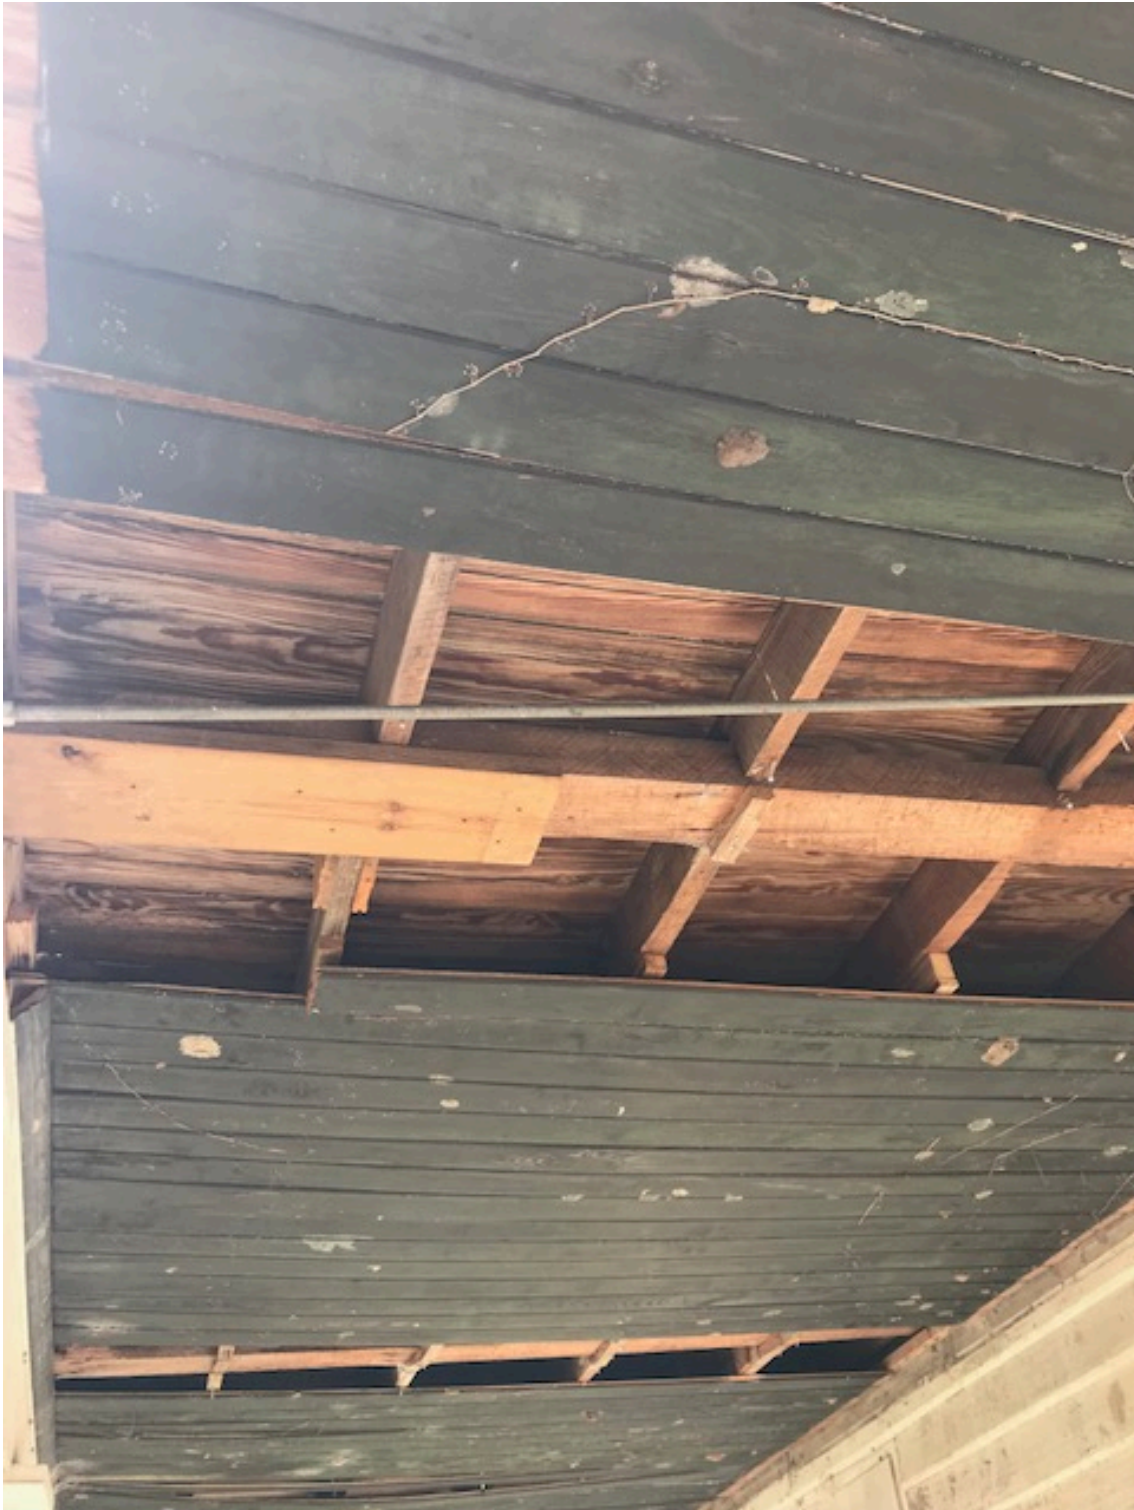
Figure A.5 – Tibwin porch roof Tibwin's porch roof is in need of repair (*Image from author*).

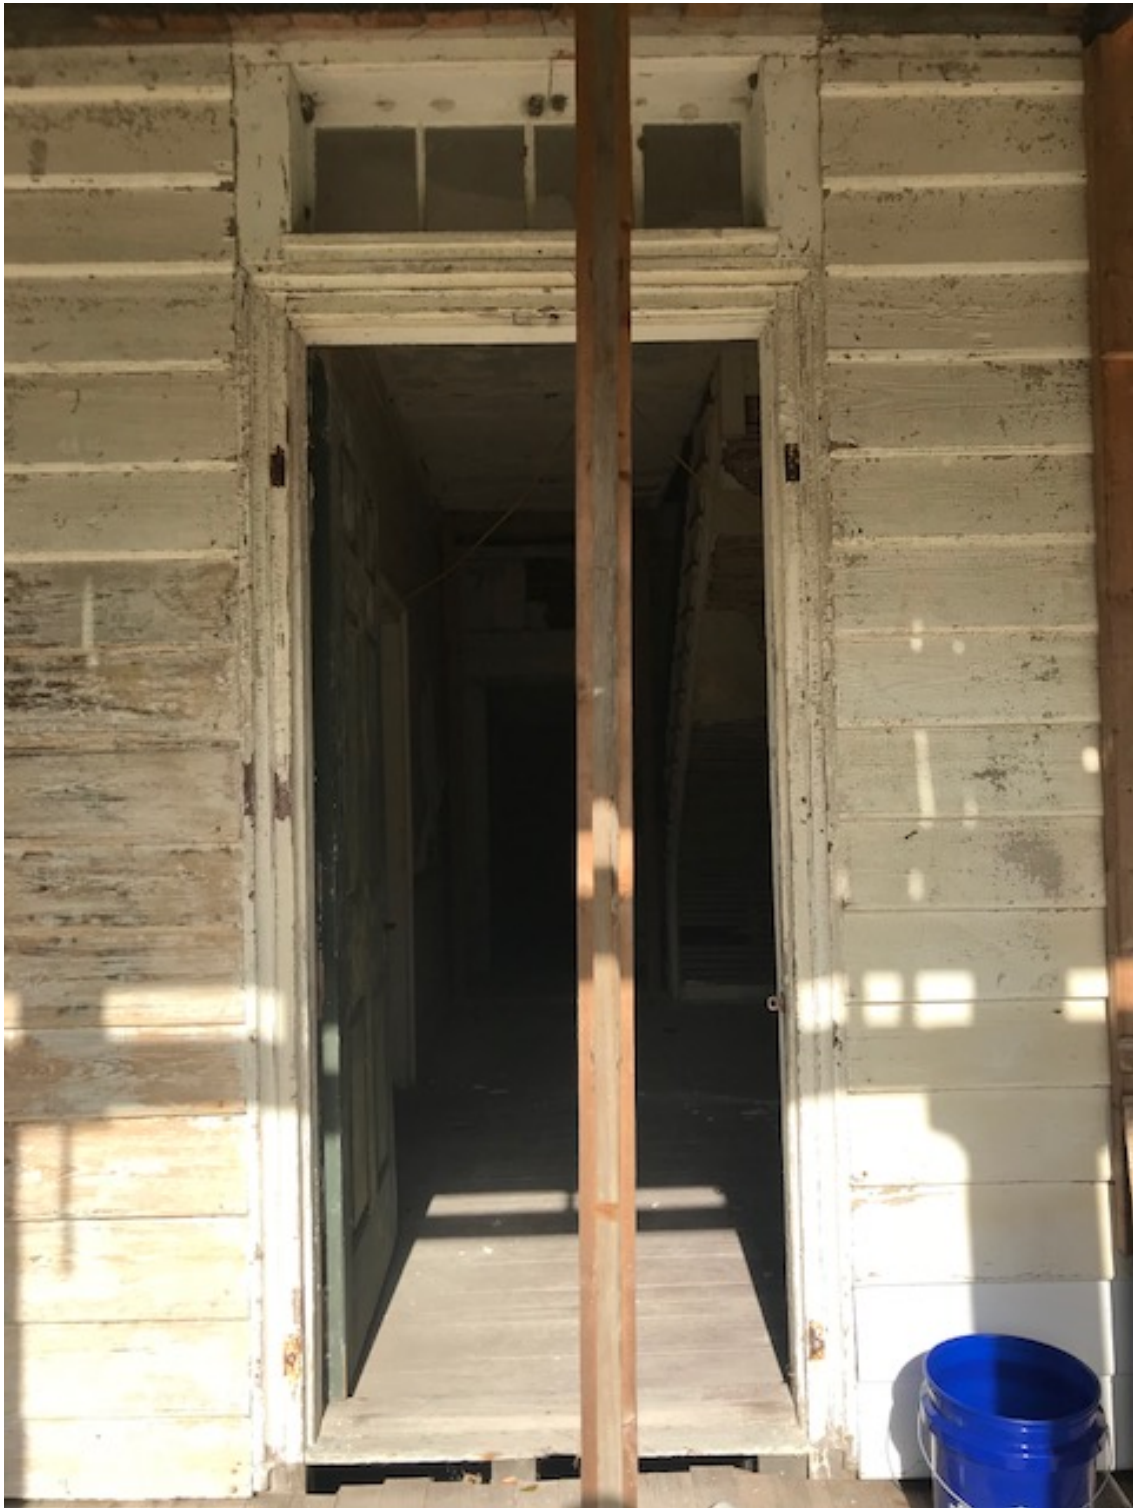
Figure A.6 – *Entrance to Tibwin* The front entrance to Tibwin (*Image from author*).

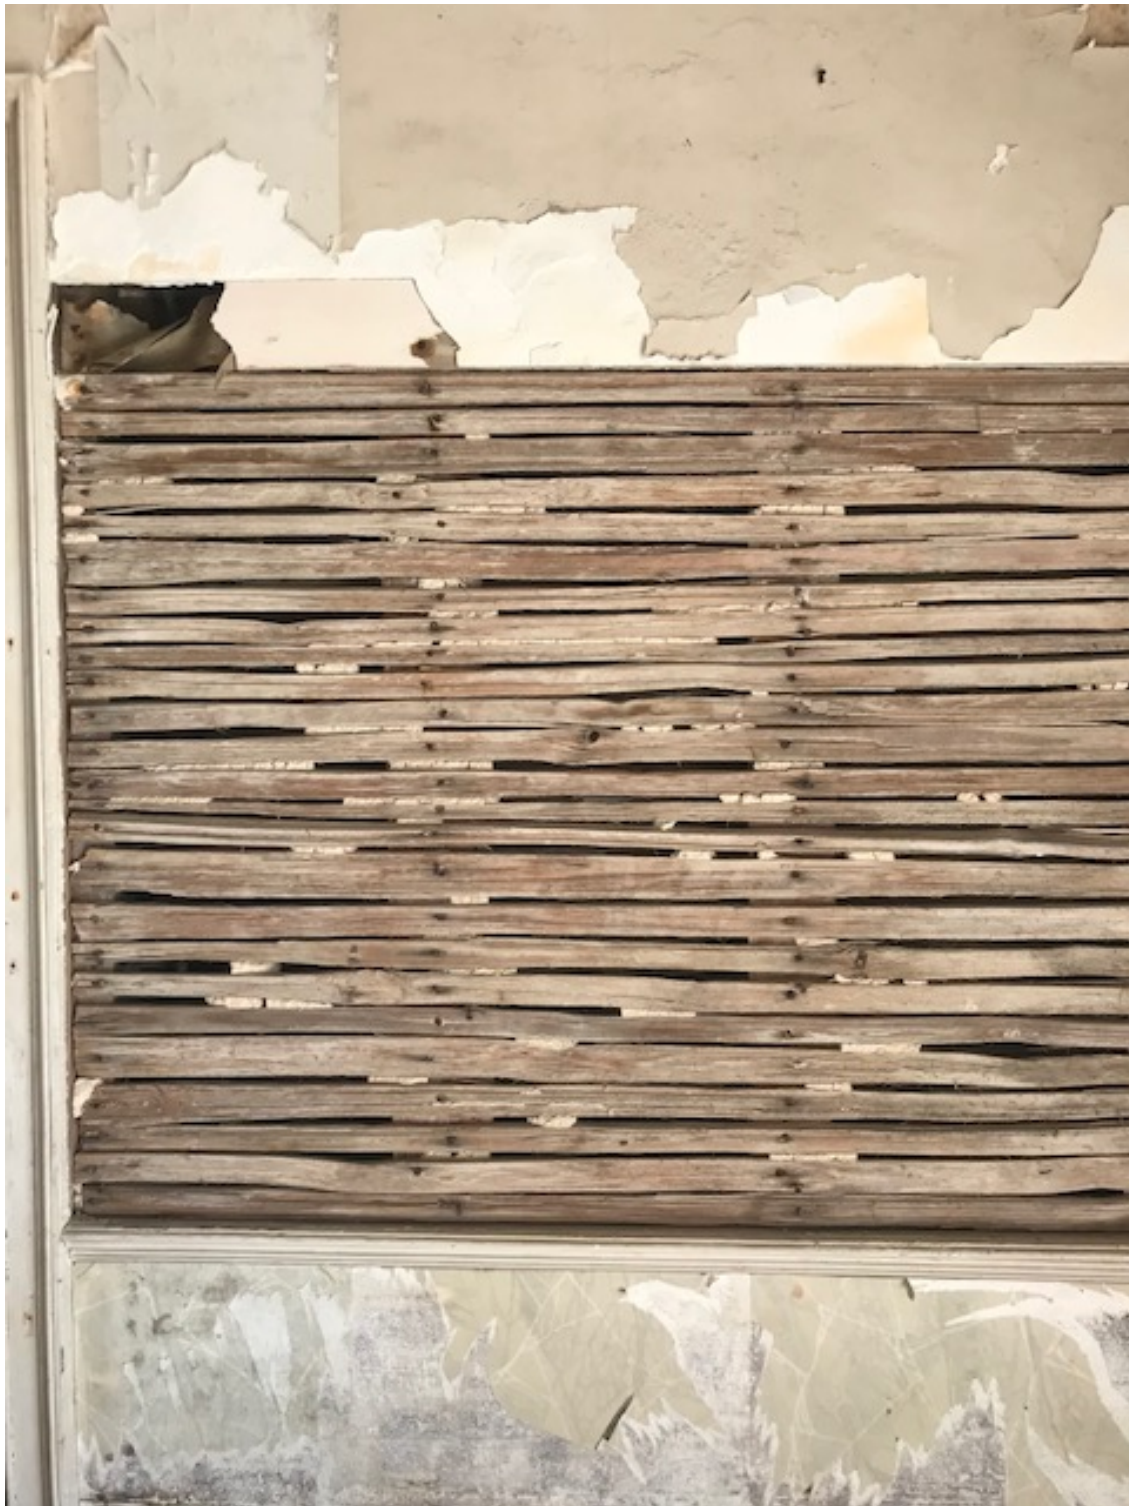
Figure A.7 – Lath at Tibwin The plaster at Tibwin has moved removed in large sections, damage from it being a movie set in the 1980s (*Image from author*).

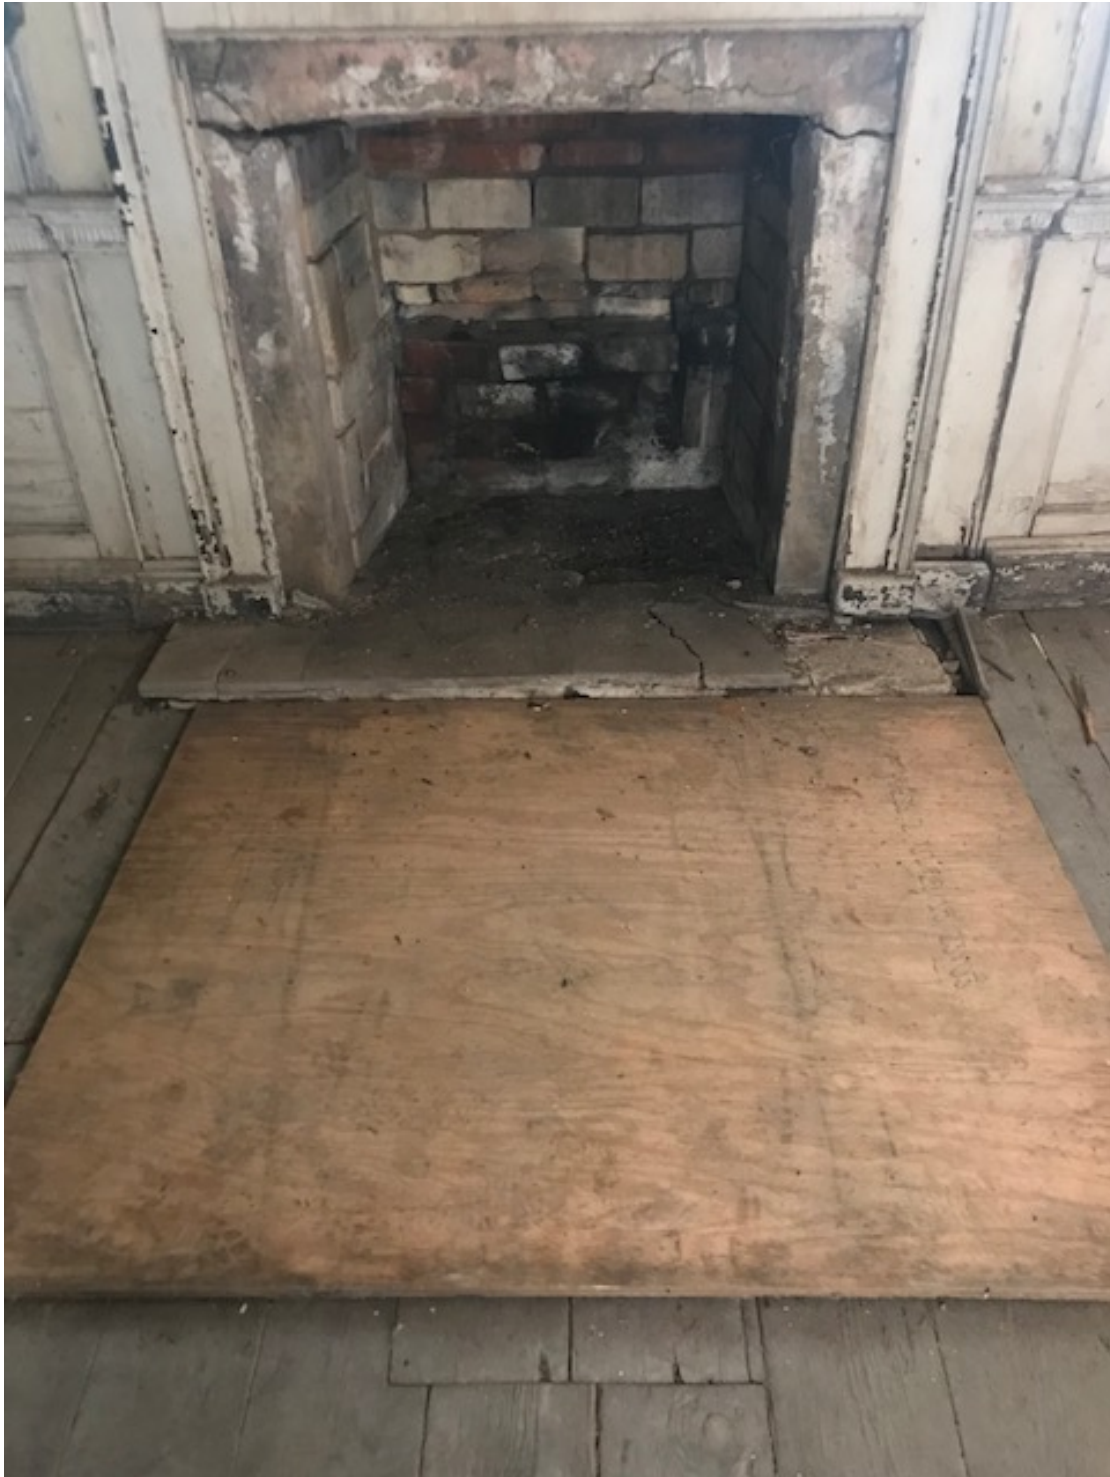
Figure A.8 – *Damage to living room floor in Tibwin* Tibwin has damage to its building envelope and the original floor has been replaced in parts (*Image from author*).

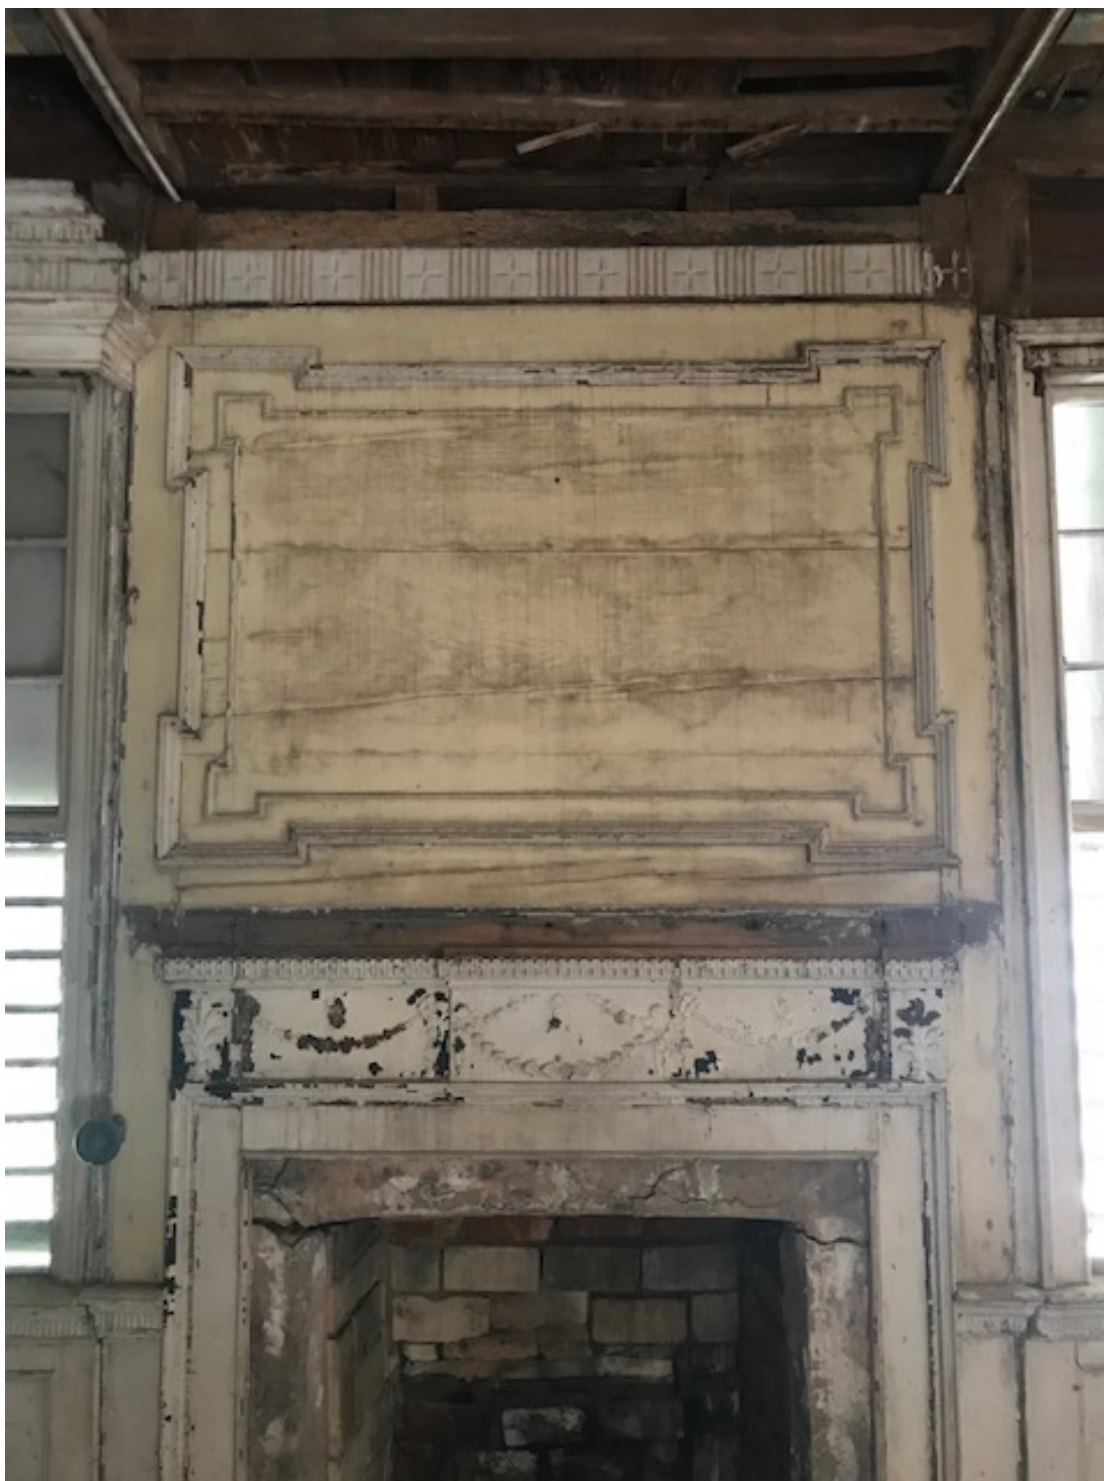
Figure A.9 – Stolen fireplace mantel in Tibwin living room The federal mantelpiece from the living room in Tibwin was stolen while under the care of the USFS (*Image from author*).

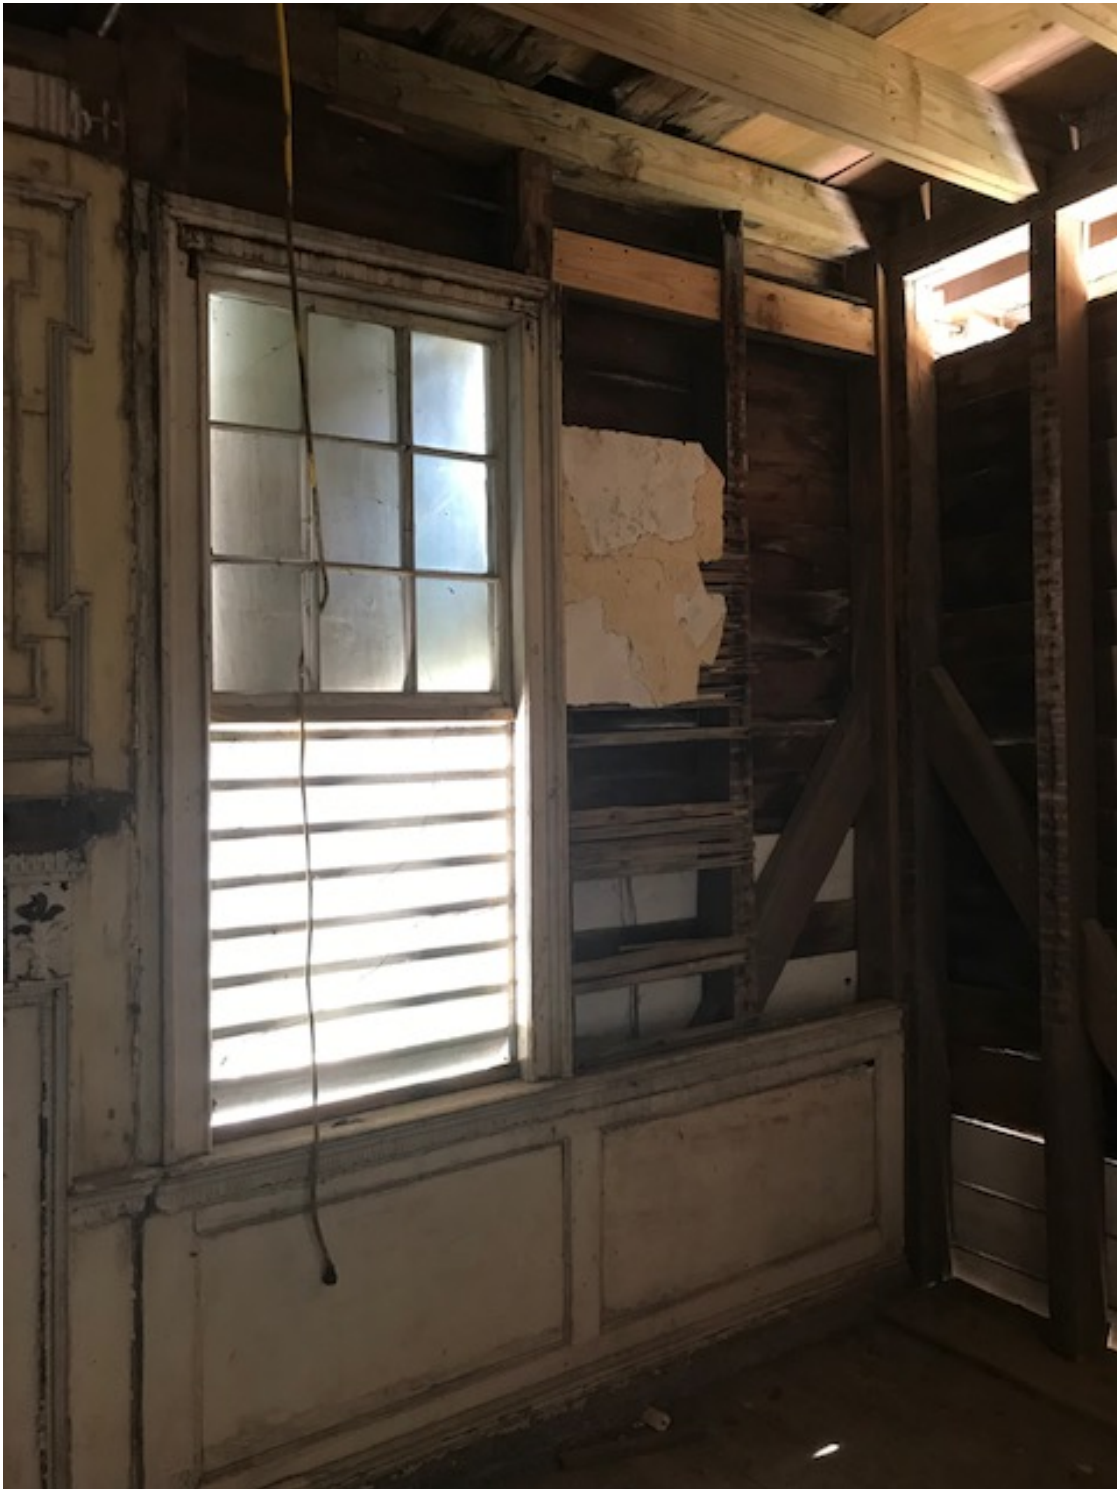
Figure A.10 – *Tibwin living room mothballed* This image shows vents placed over the living room windows for mothballing by the USFS (*Image from author*).

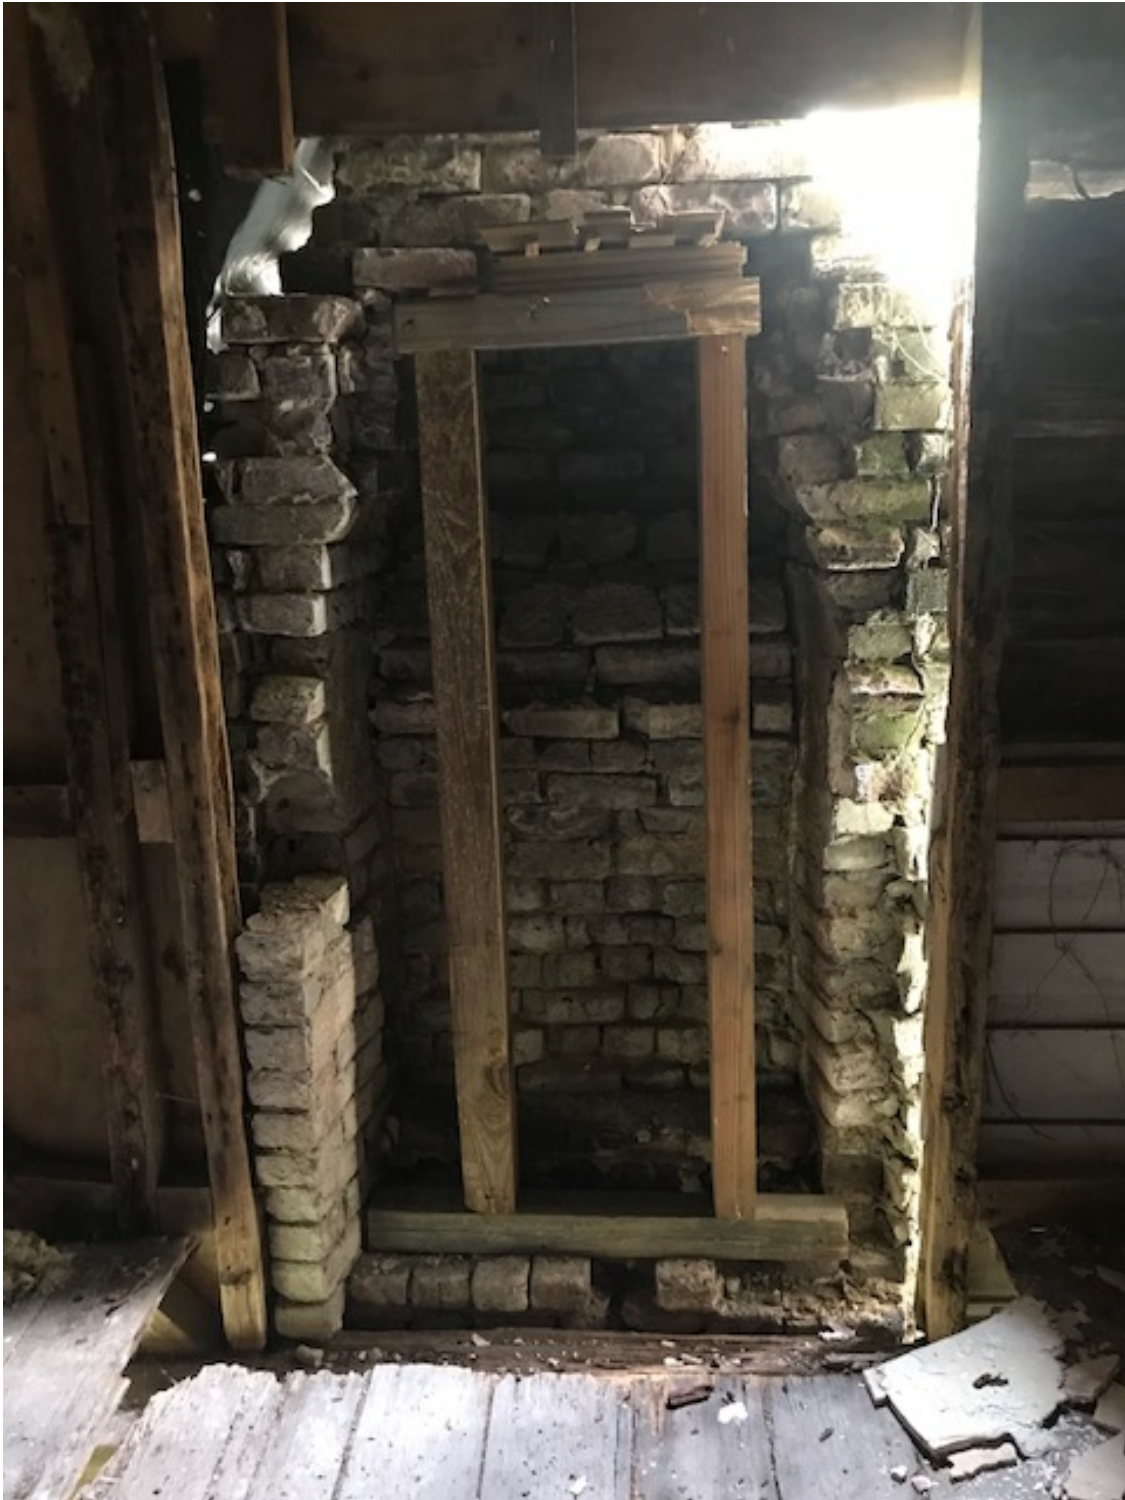
Figure A.11 – Tibwin fireplace damage This image shows a fireplace in Tibwin physically separating from the main house (*Image from author*).

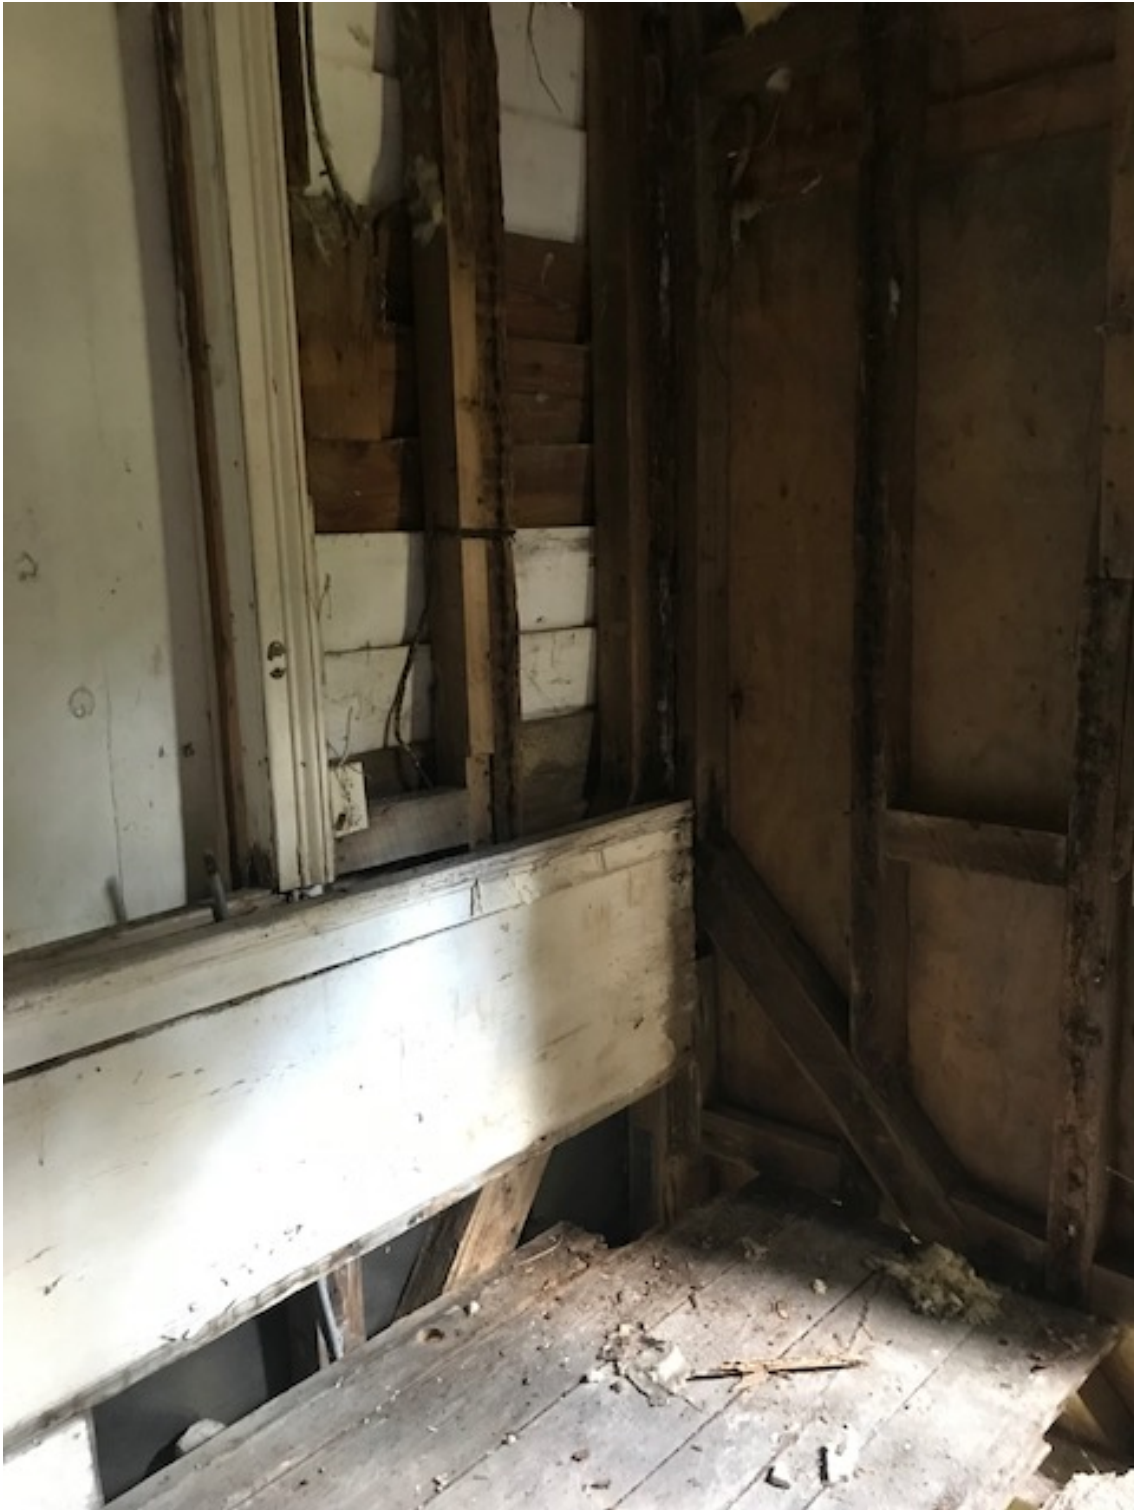
Figure A.12 – Tibwin wall damage This image shows damage to walls at Tibwin (*Image from author*).
