Out of the Woods: Facilitating Stewardship of Historic Resources in the National Forest Service

OUT OF THE WOODS: FACILITATING STEWARDSHIP OF HISTORIC
RESOURCES IN THE NATIONAL FOREST SERVICE

A Thesis
Presented to
the Graduate School of
Clemson University and the College of Charleston

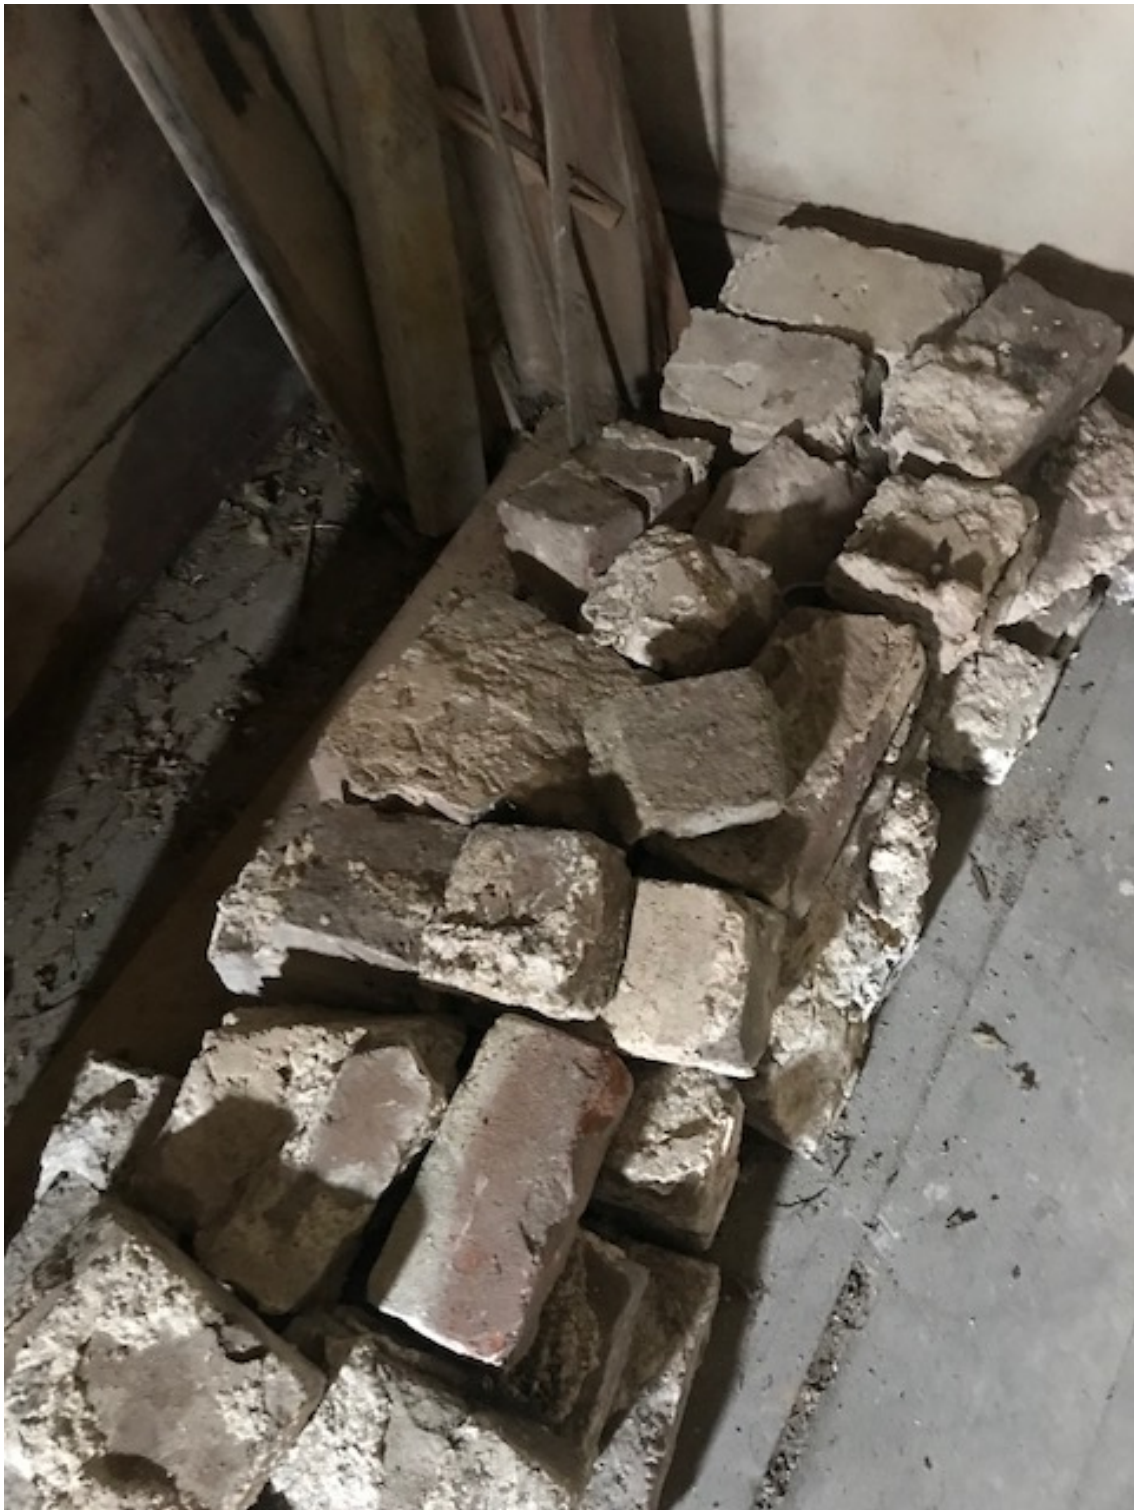
Figure A.13 – Tibwin fallen bricks This image shows bricks stacked along the floor that have fallen from the damaged chimney at Tibwin (*Image from author*).

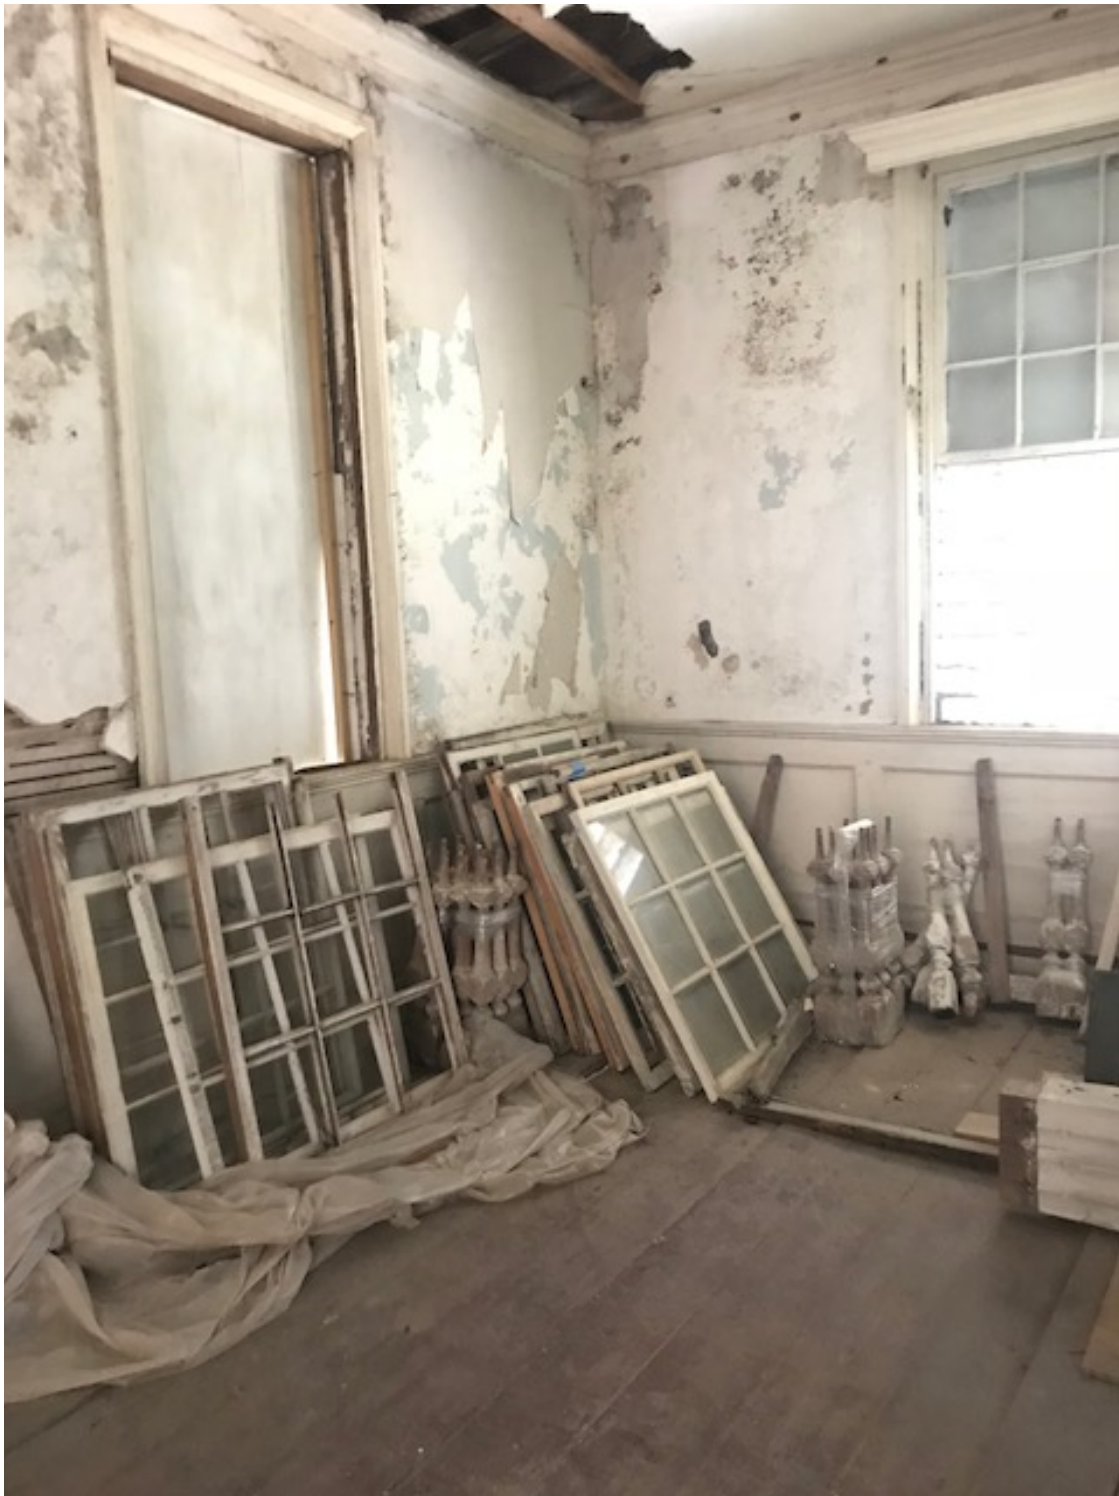
Figure A.14 – *Tibwin windows stacked* Windows from Tibwin were removed by the USFS in order to properly mothball the building (*Image from author*).

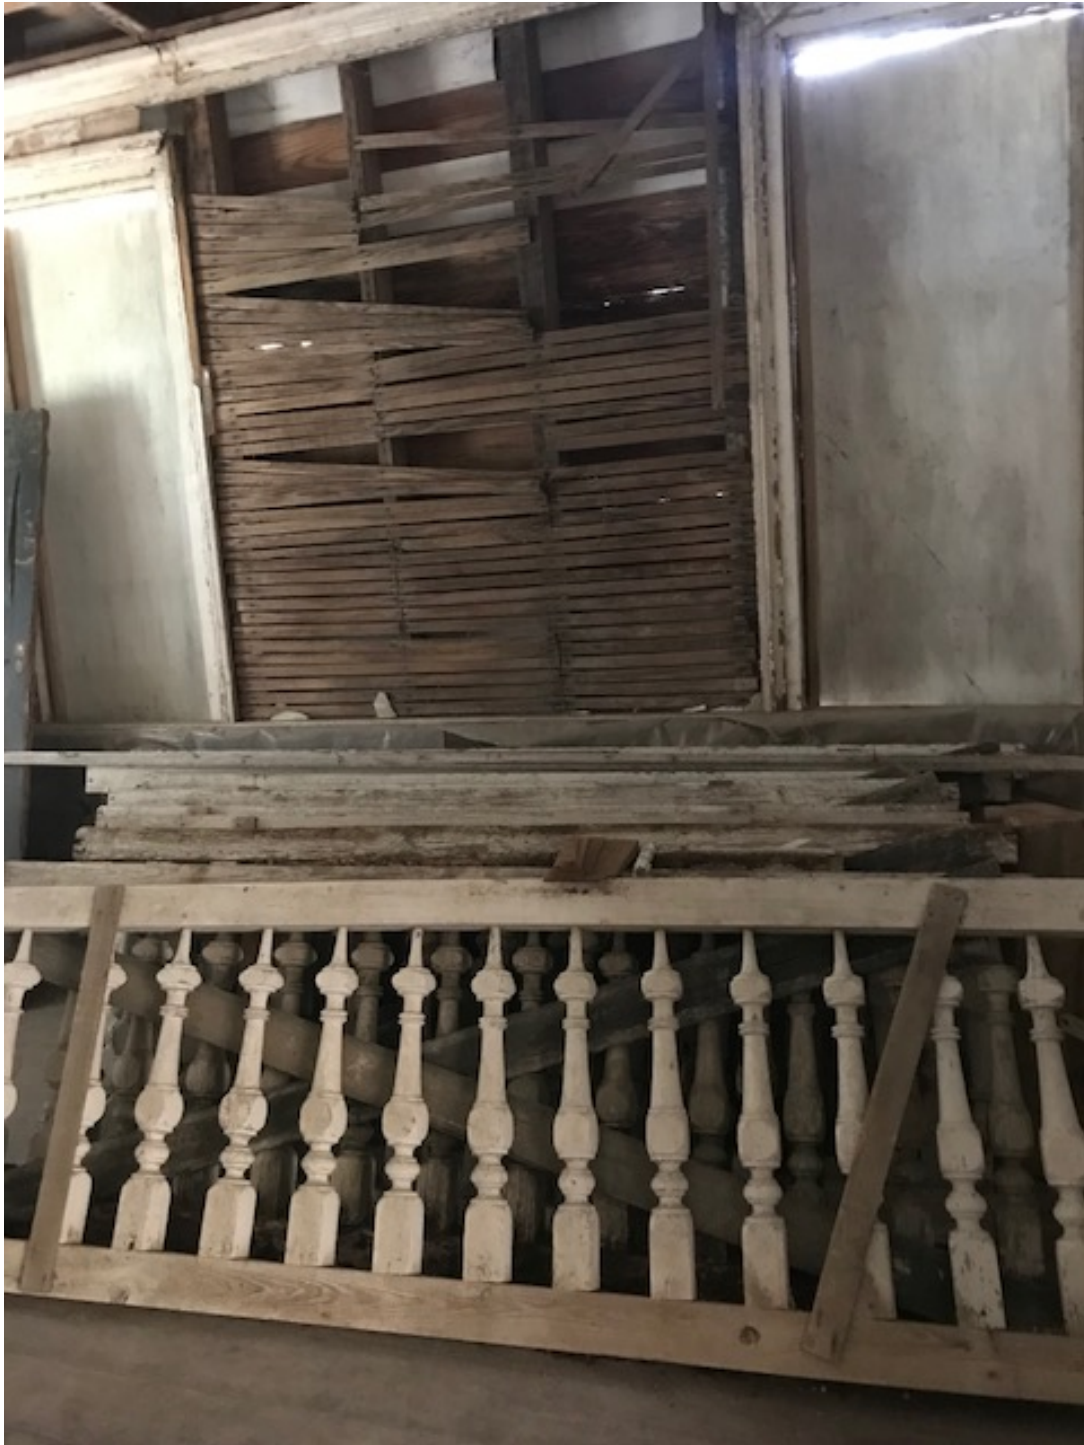
Figure A.15 – *Tibwin porch railings* Porch balustrades from Tibwin were removed and stacked in the drawing room (*Image from author*).

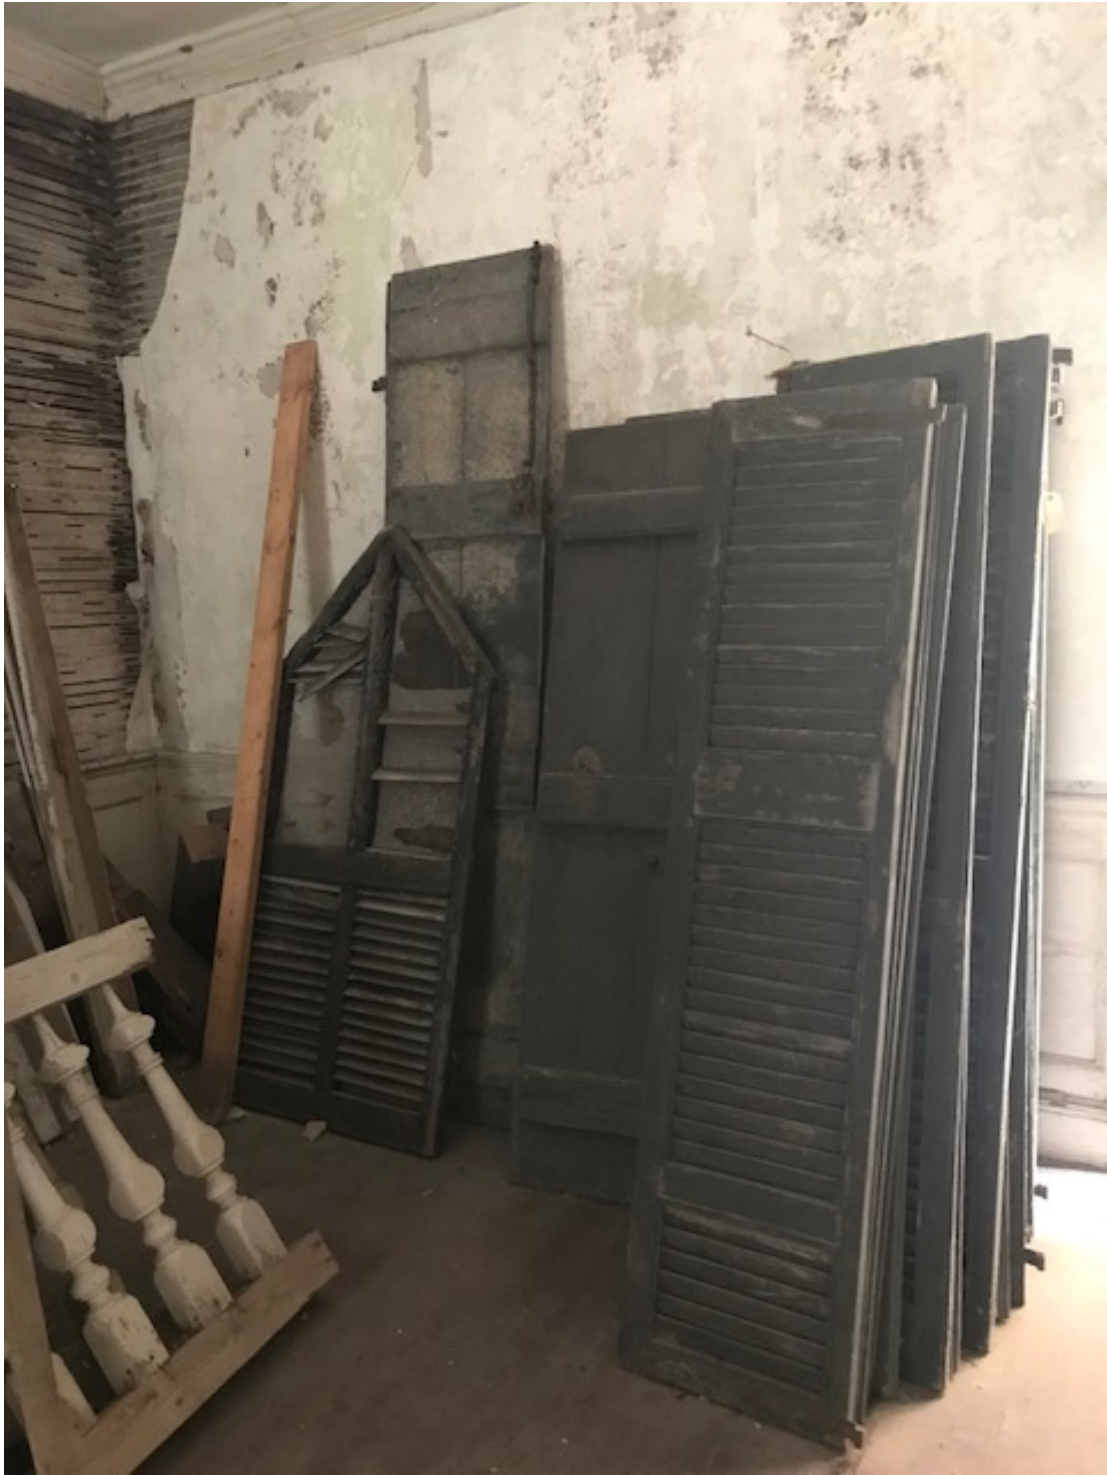
Figure A.16 – Tibwin shutters Shutters from Tibwin were removed and stacked in the drawing room (Image from author).

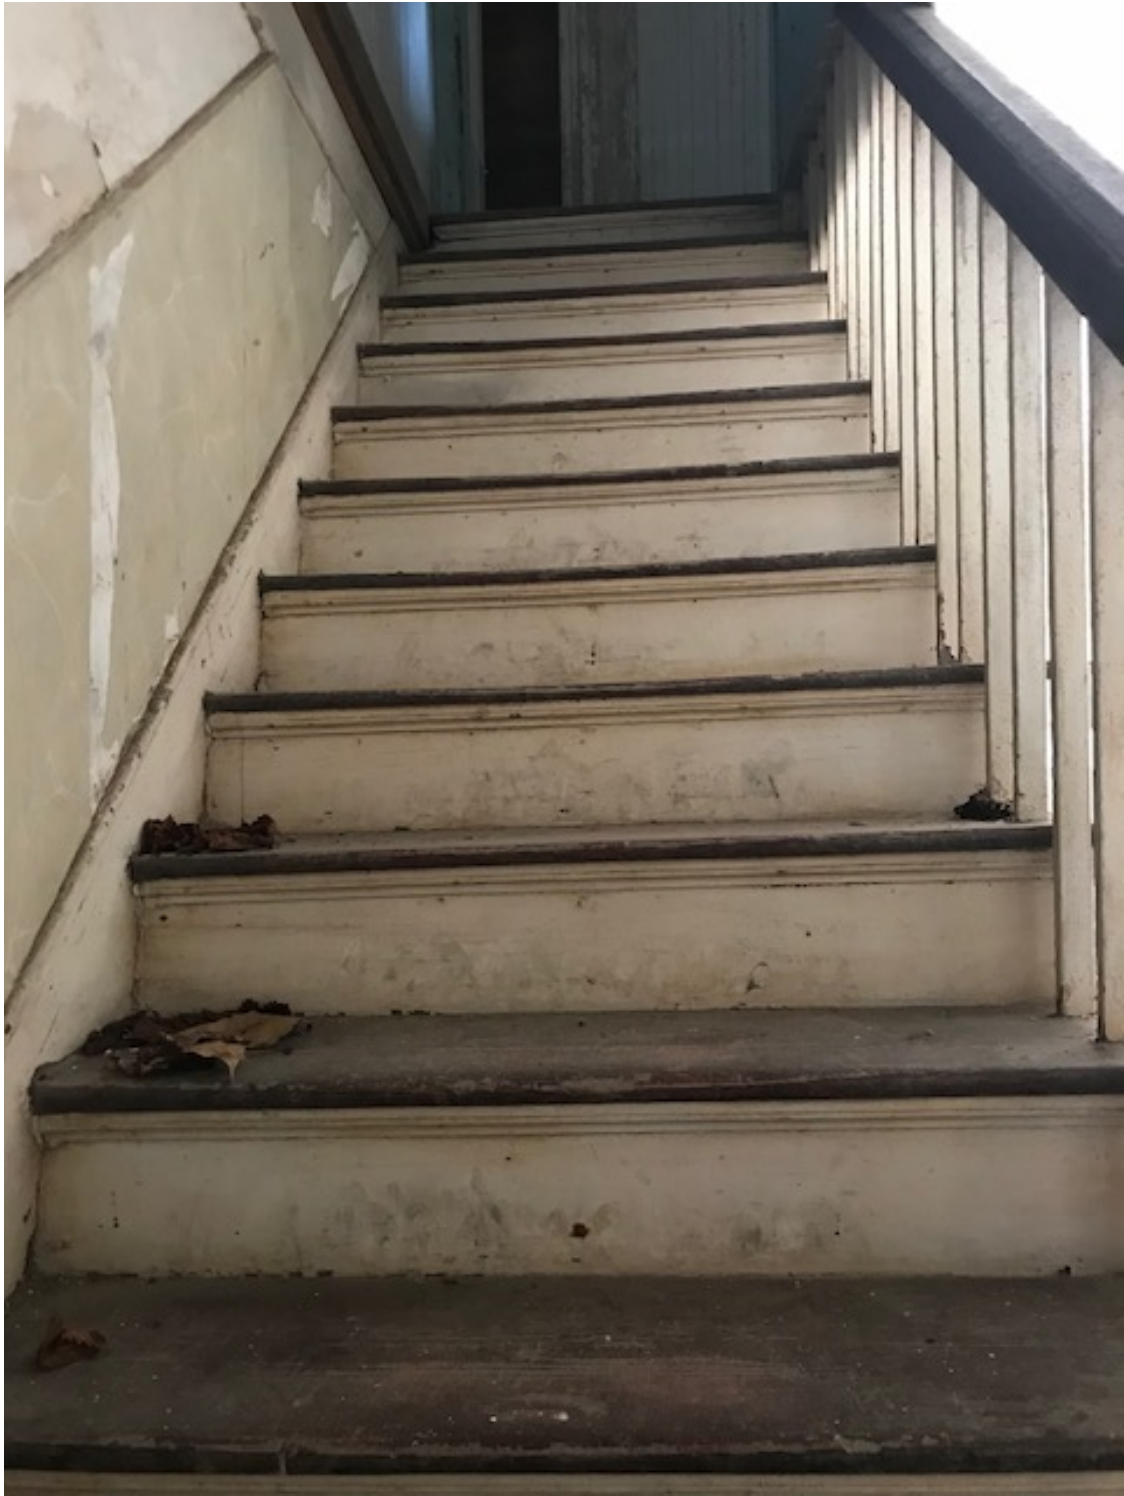
Figure A.17 – Tibwin stairs Animal droppings are visible along the stairs at Tibwin, indicating better need for protection from elements (*Image from author*).

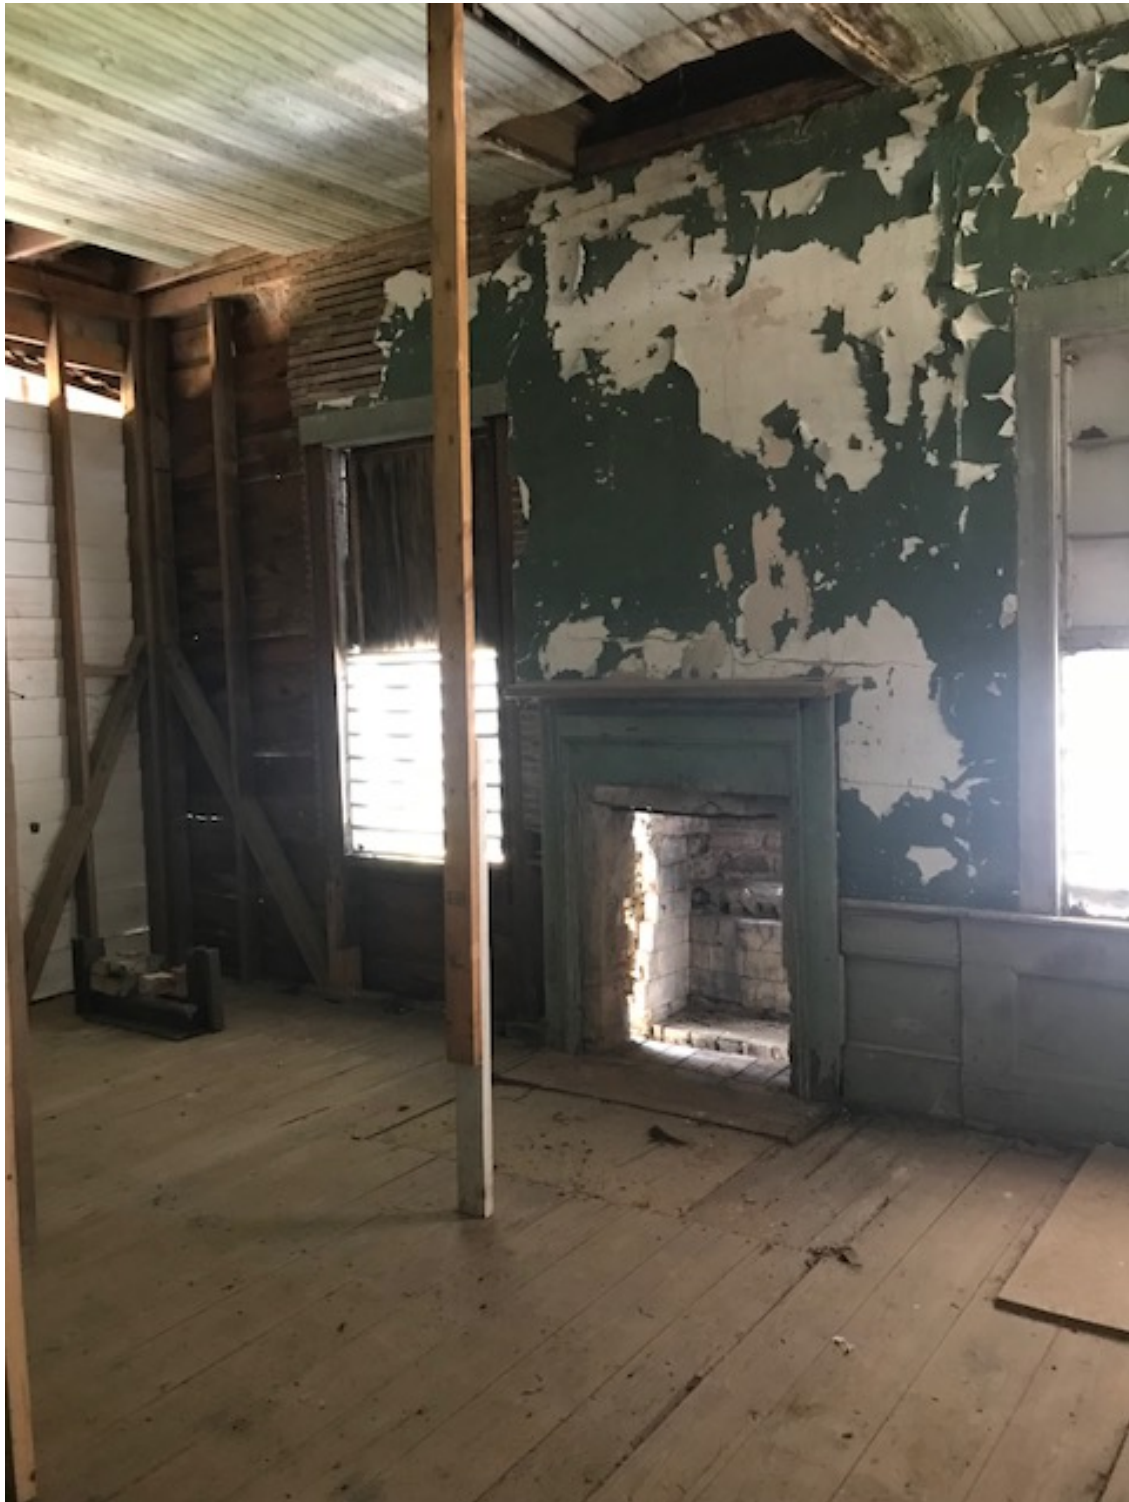
Figure A.18 – *Second story support at Tibwin* A sagging ceiling on the second floor gets some structural help from a piece of dimensional lumber (*Image from author*).

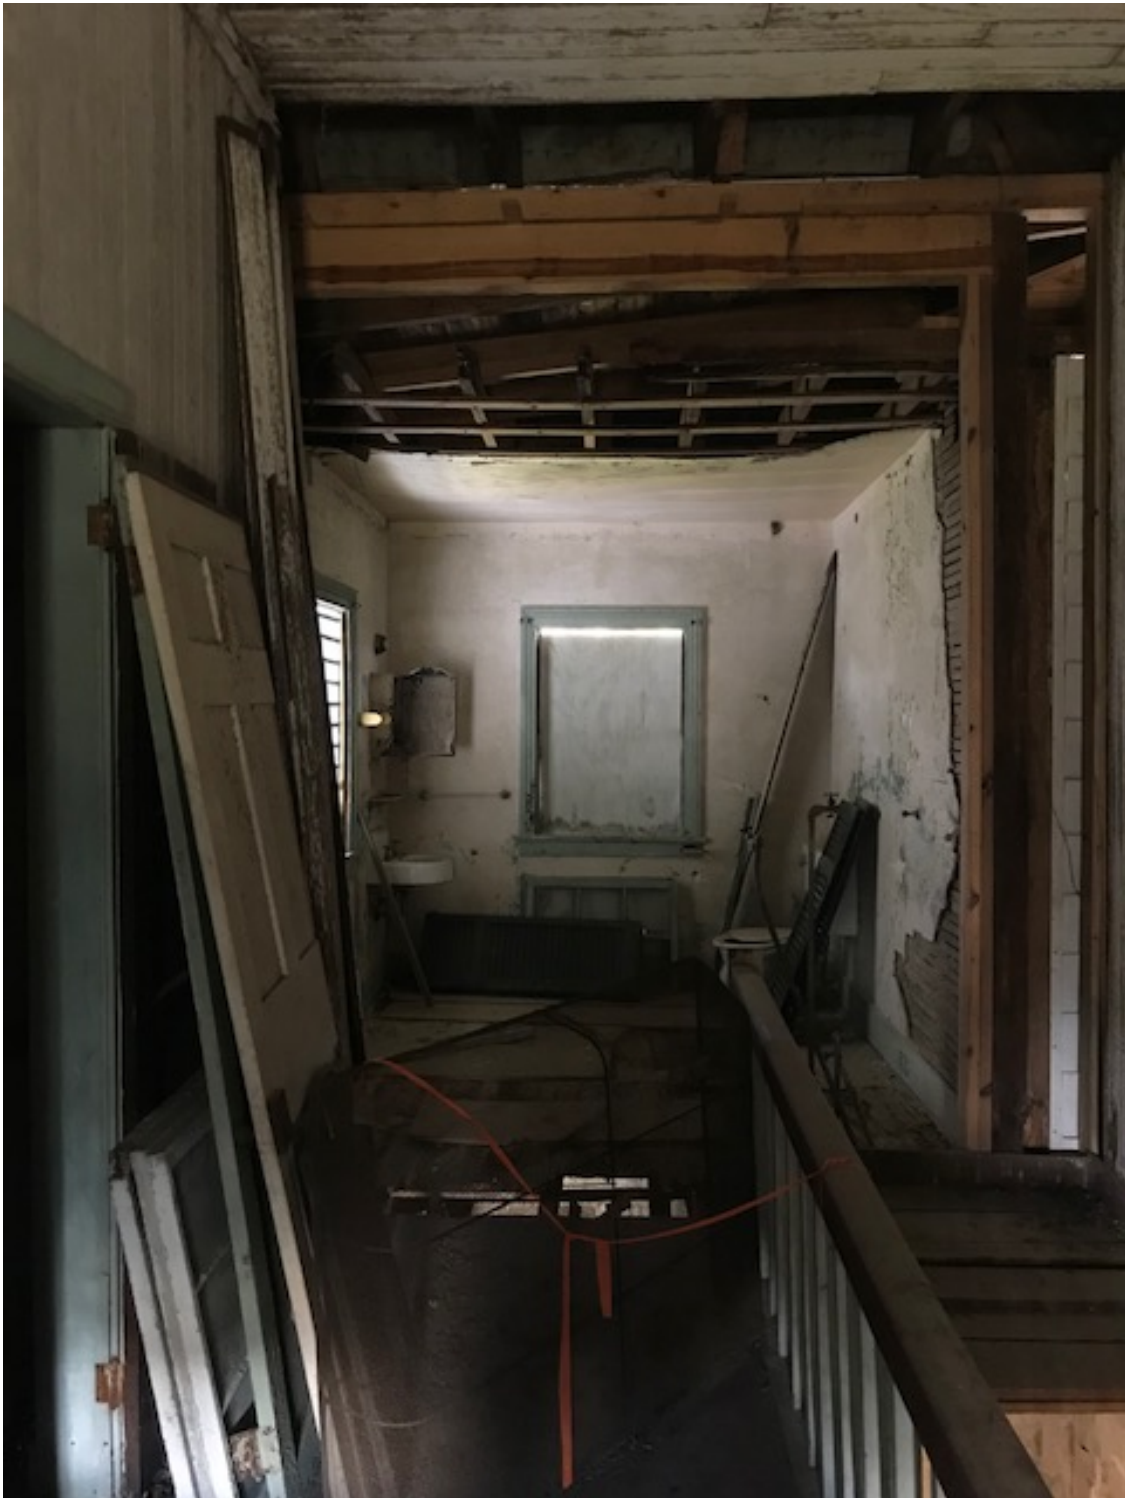
Figure A.19 – *Off limits area at Tibwin* A second floor bathroom addition is currently off-limits due to its structural failing (*Image from author*).

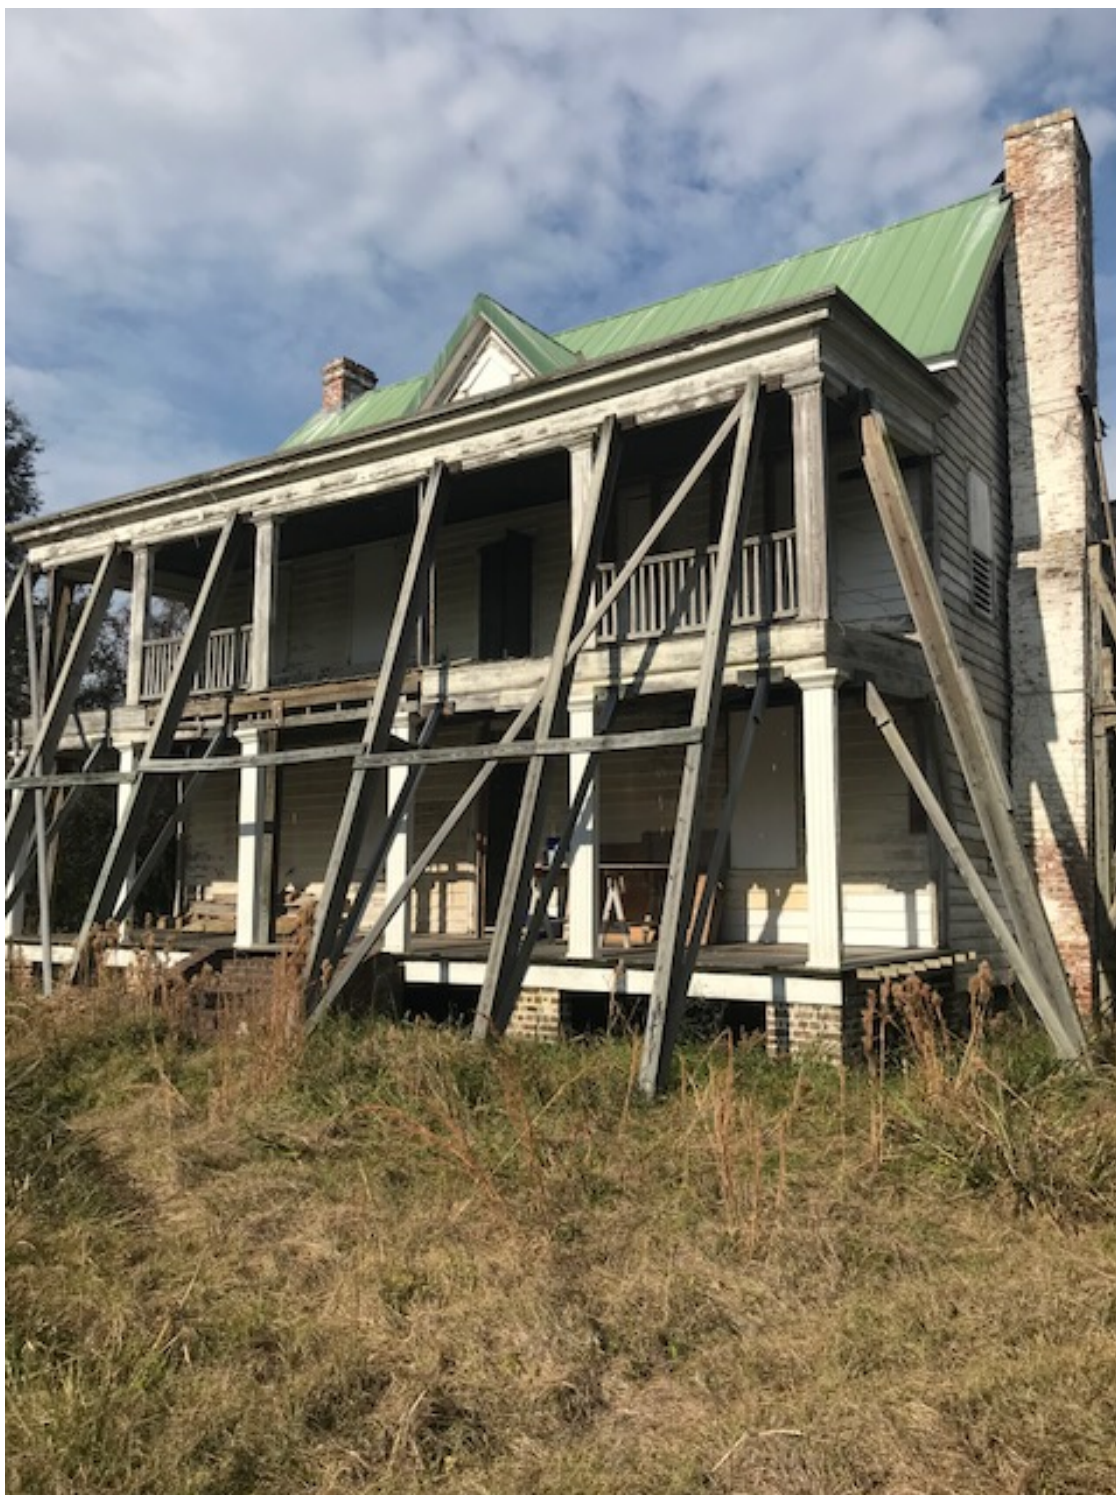
Figure A.20 – *Structural support at Tibwin* Tibwin's porches are currently shored up with the help of dimensional lumber and are in desperate need of repair (*Image from author*).

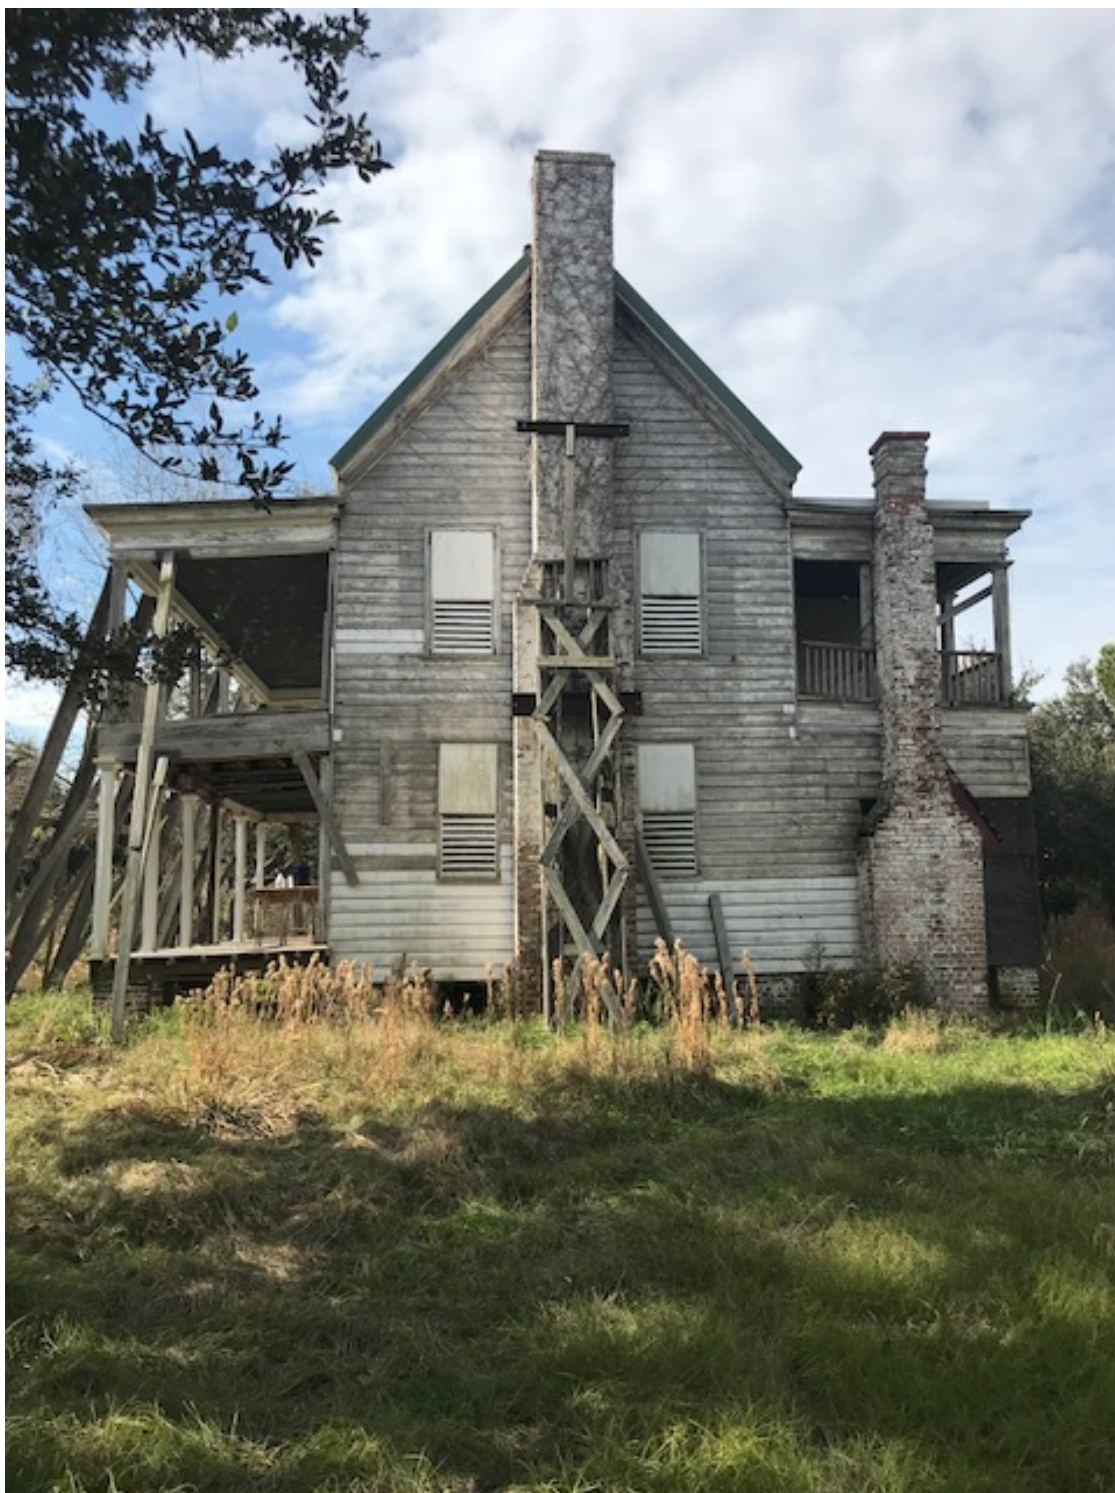
Figure A.21 – *Side façade of Tibwin* Tibwin's side façade provides an excellent glimpse of all the shoring in place, currently holding up porches and fireplaces (*Image from author*).

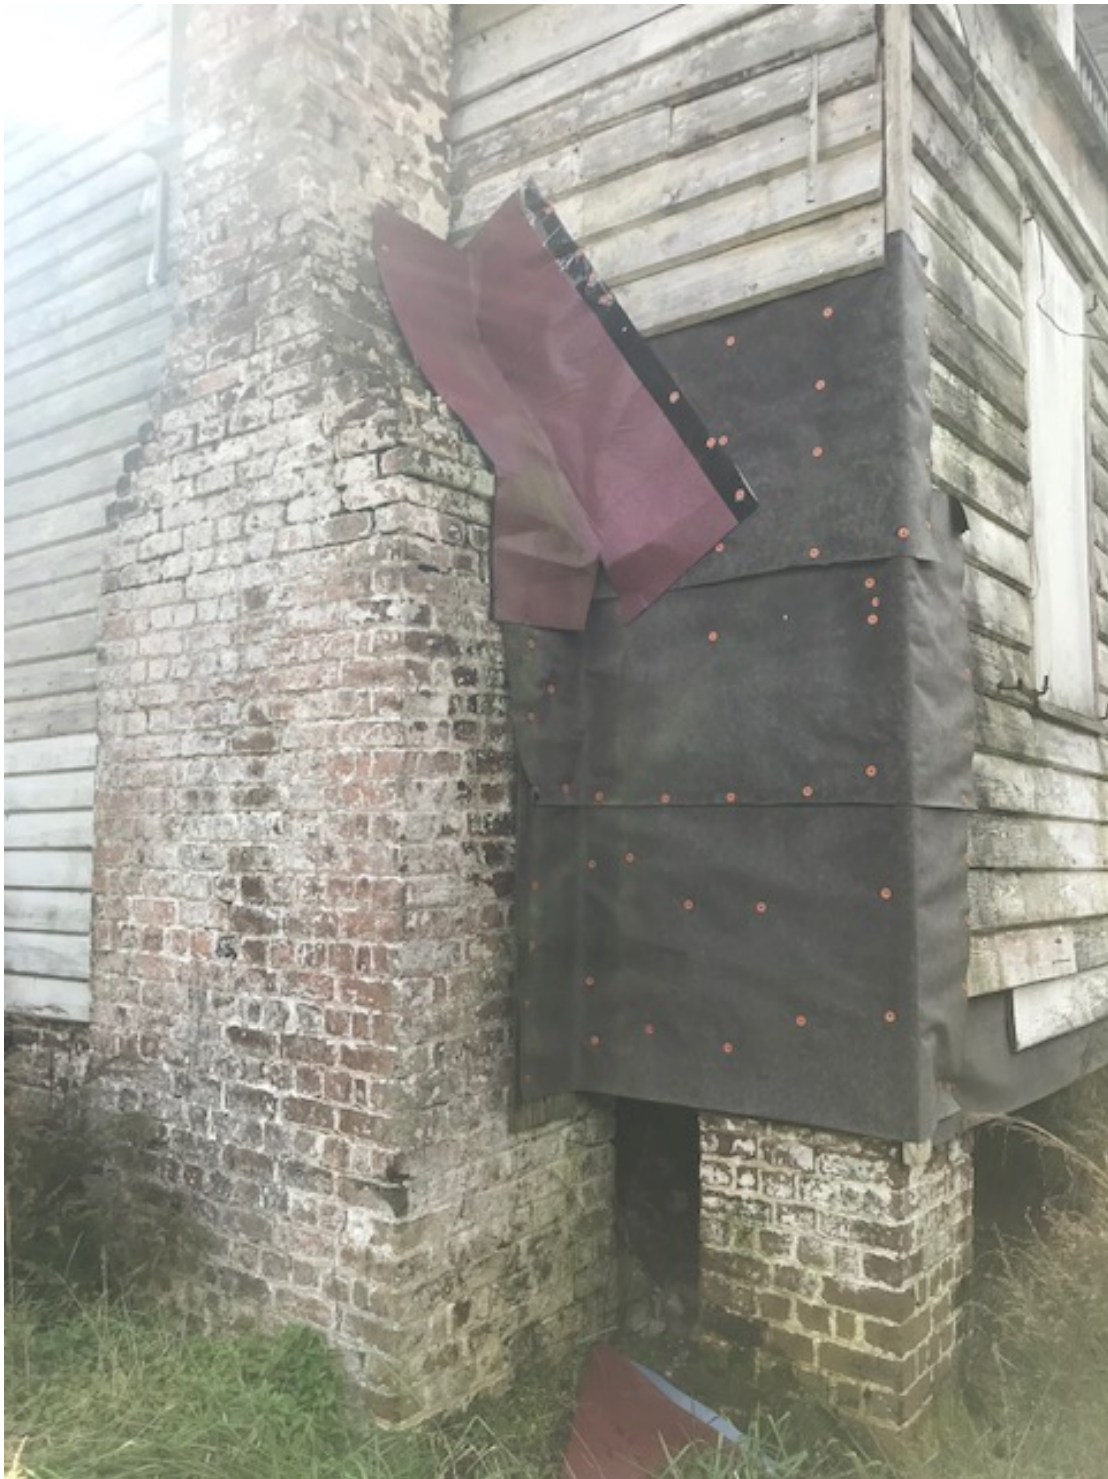
Figure A.22 – *Tibwin exterior chimney repair* A chimney at Tibwin is currently prevented from further separating from the building with sheet metal, a temporary fix (*Image from author*).

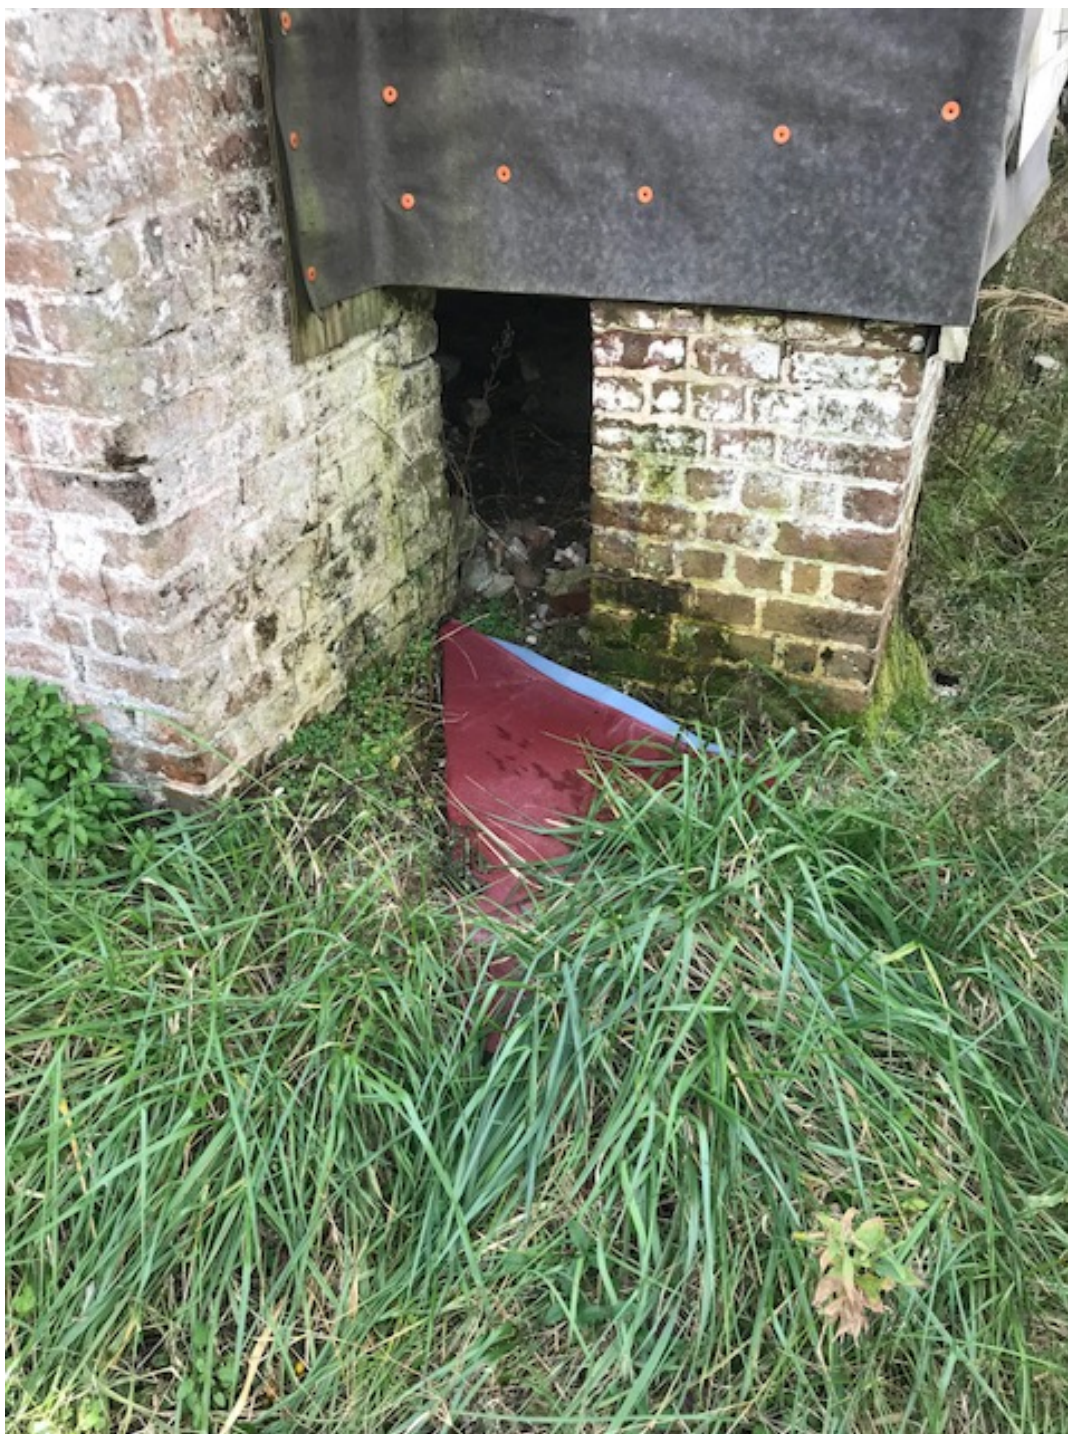
Figure A.23 – *Tibwin exterior chimney sheet metal* A chimney at Tibwin is currently prevented from further separating from the building with sheet metal, a temporary fix that is running out of time (*Image from author*).

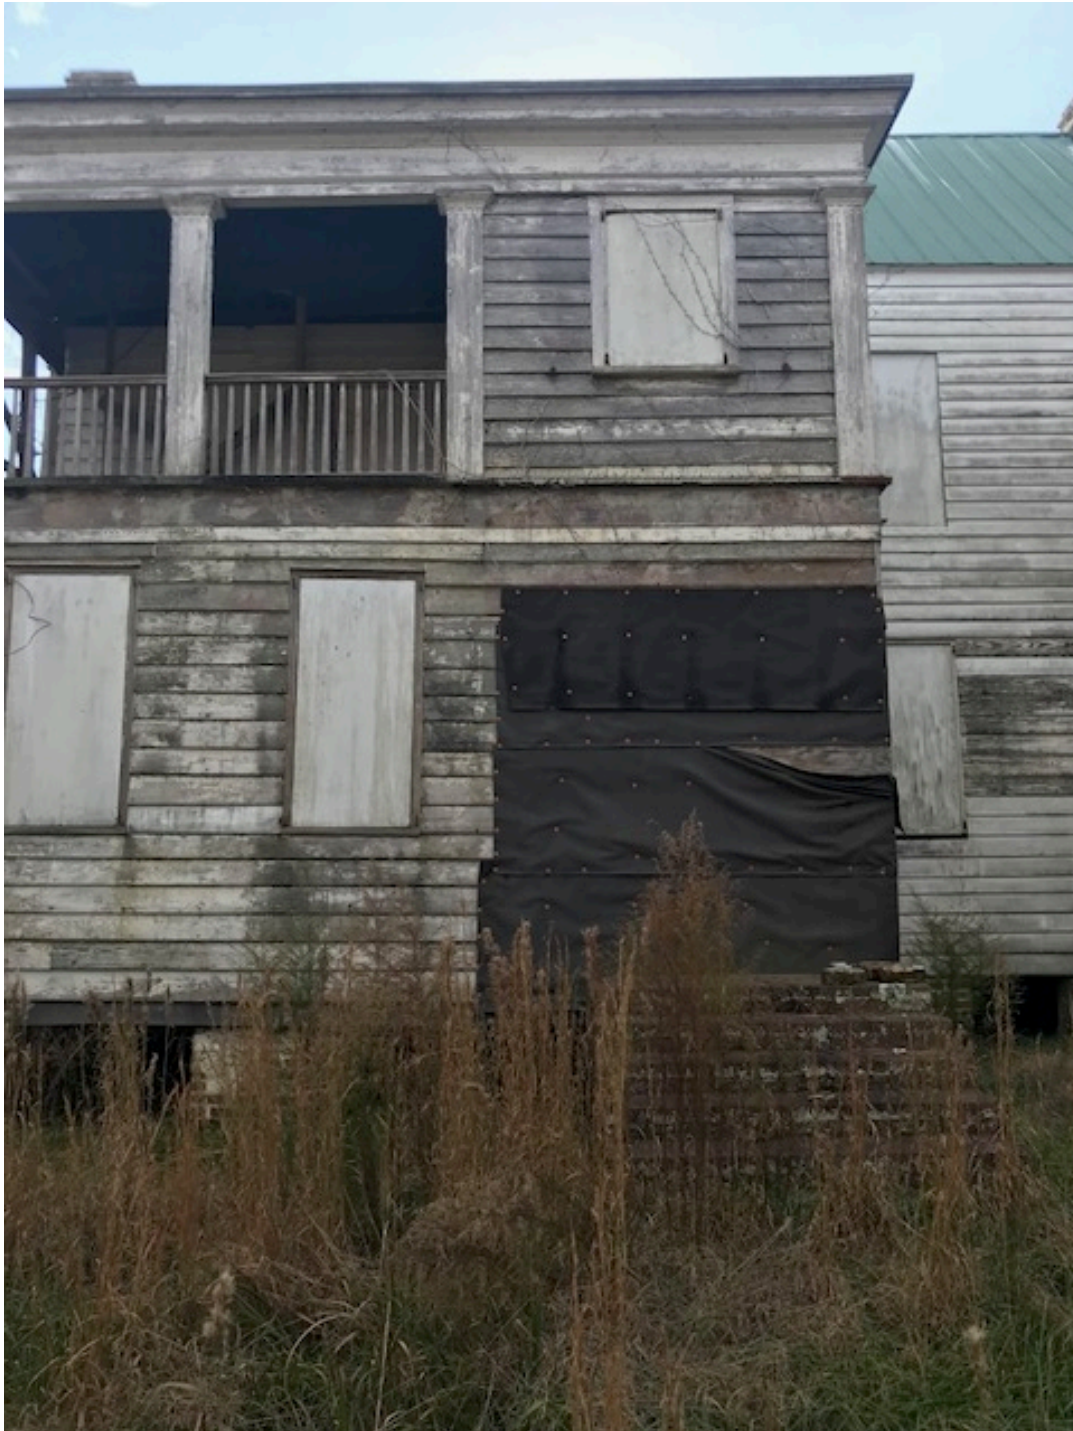
Figure A.24 – Tibwin rear elevation The rear elevation at Tibwin has been mothballed by the USFS (Image from author).

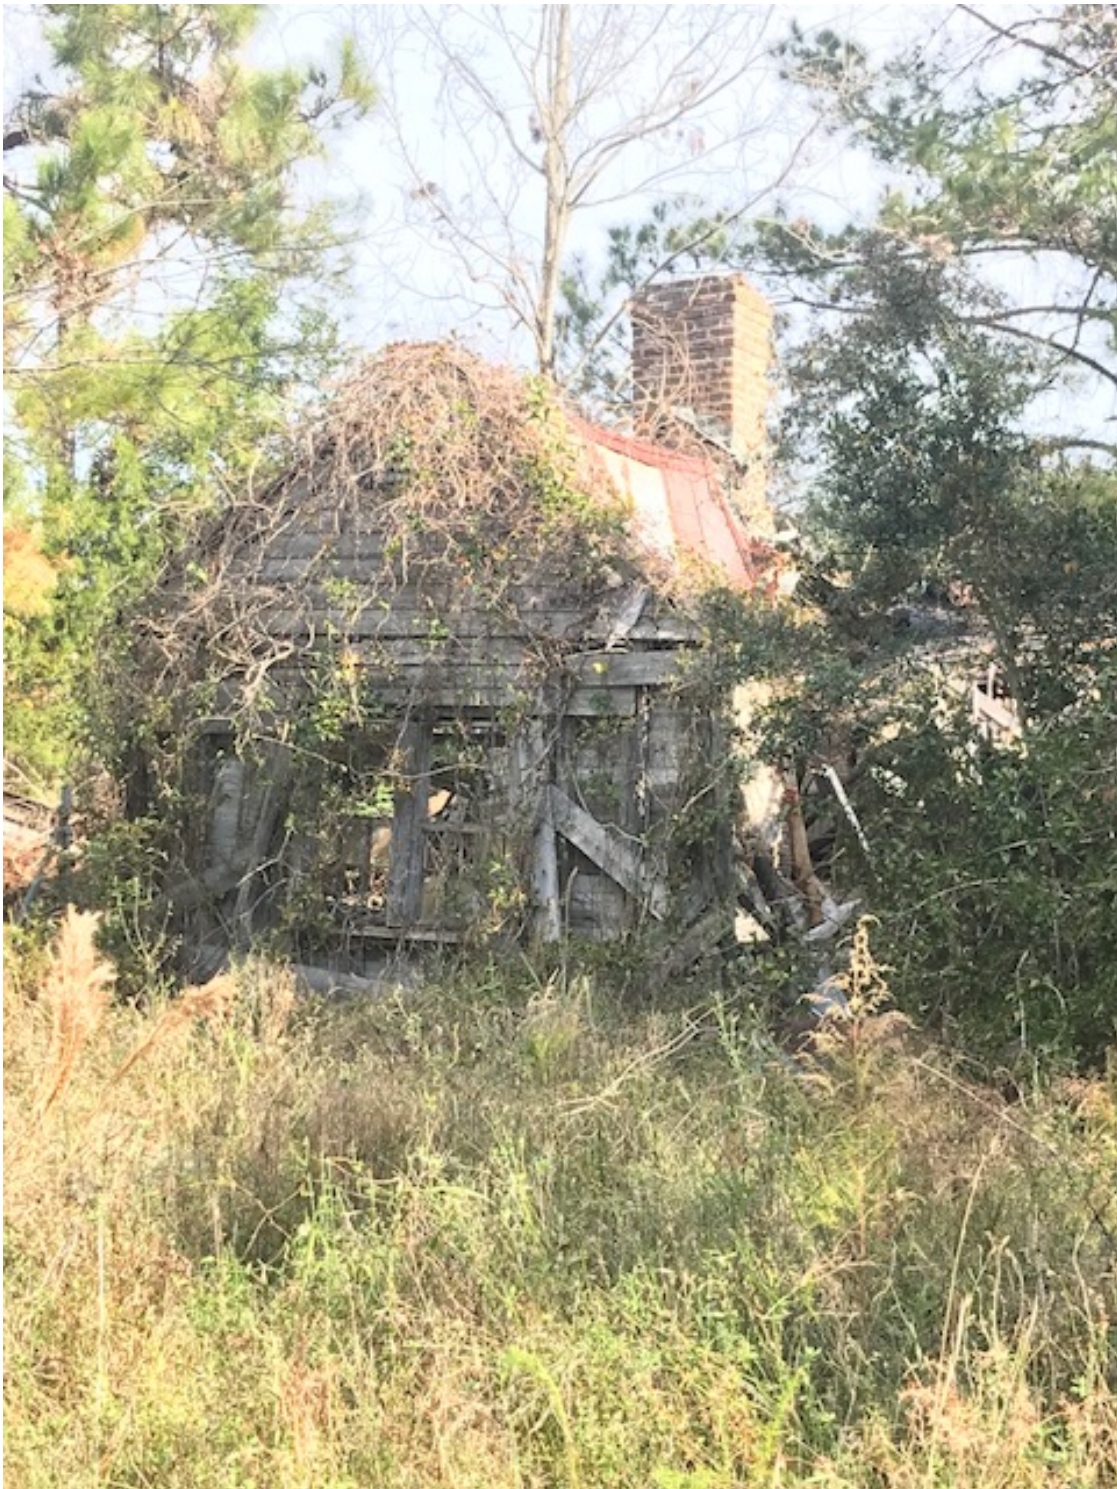
Figure A.25 – Tibwin horse barn The ruins of a former horse barn on property that fell down due to neglect under USFS care (*Image from author*).
