Out of the Woods: Facilitating Stewardship of Historic Resources in the National Forest Service

OUT OF THE WOODS: FACILITATING STEWARDSHIP OF HISTORIC
RESOURCES IN THE NATIONAL FOREST SERVICE

A Thesis
Presented to
the Graduate School of
Clemson University and the College of Charleston

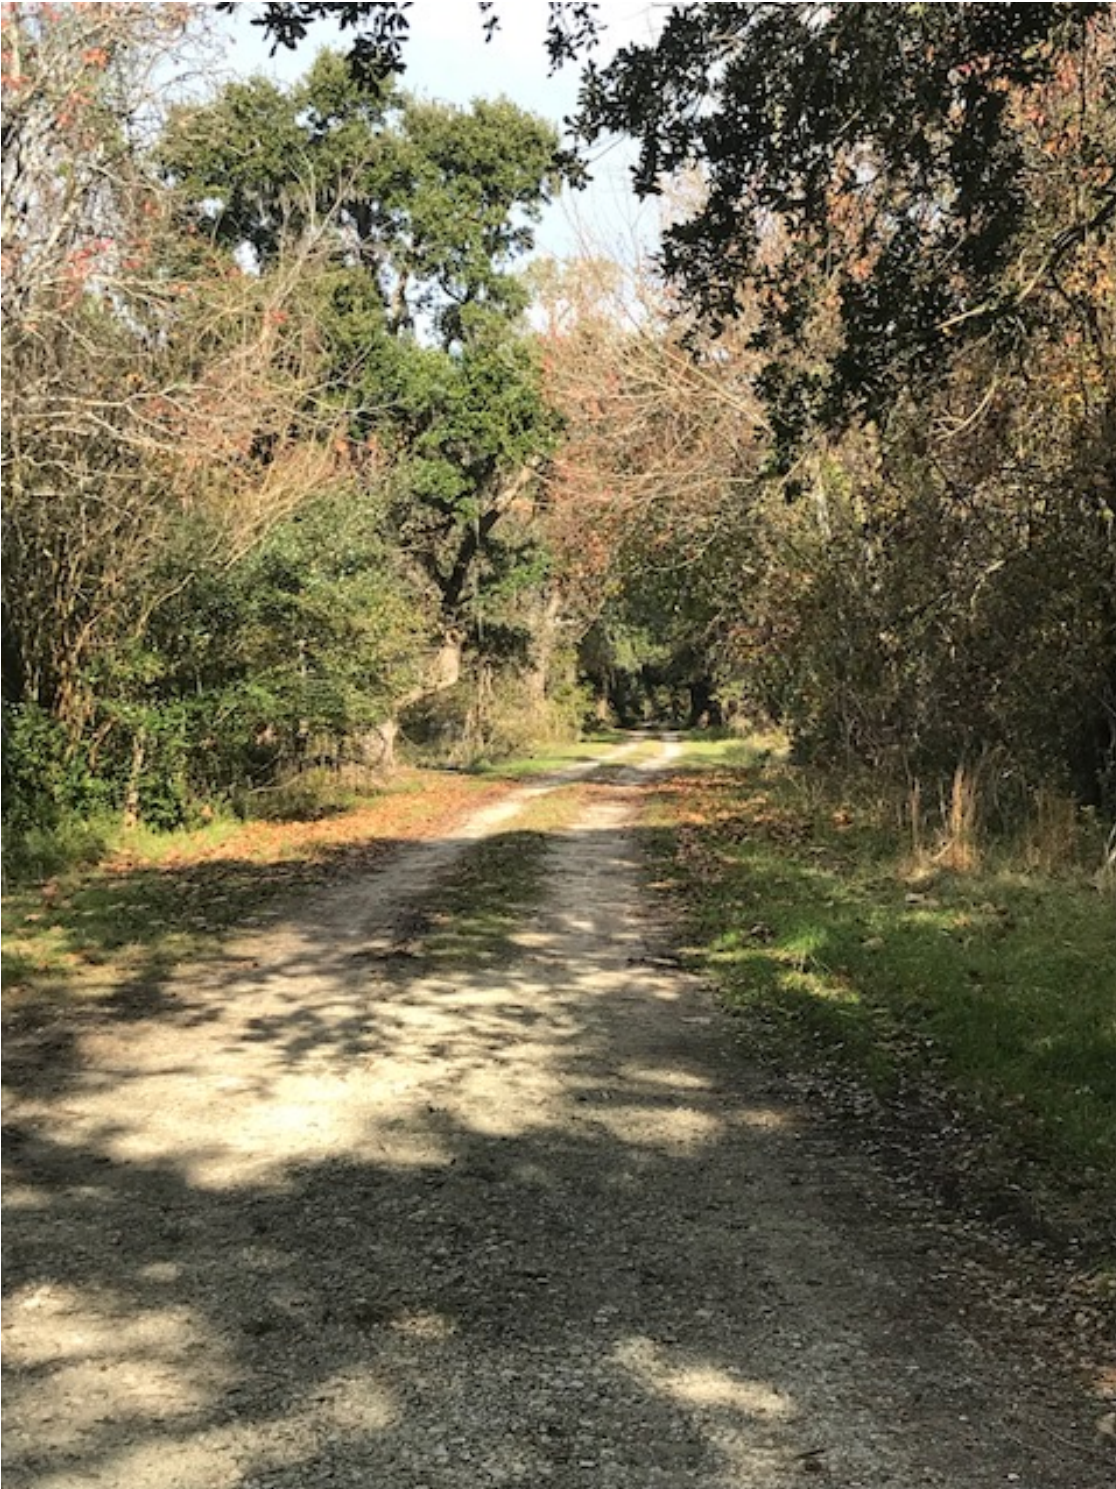
Figure A.26 – *Overgrowth at Tibwin* The drive into Tibwin is overgrown (*Image from author*).

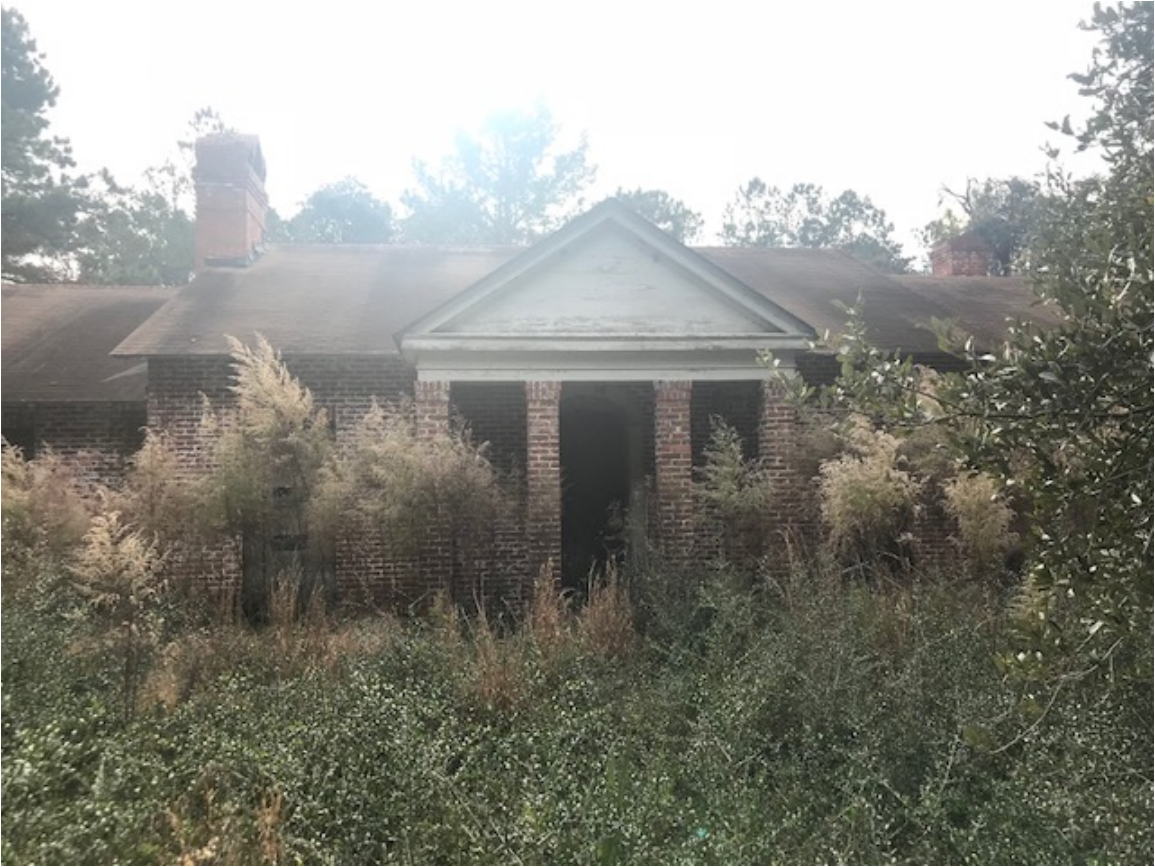
Figure A.27 – *Overgrowth at Walnut Grove* The front of Walnut Grove has severe biological overgrowth (Image from author).

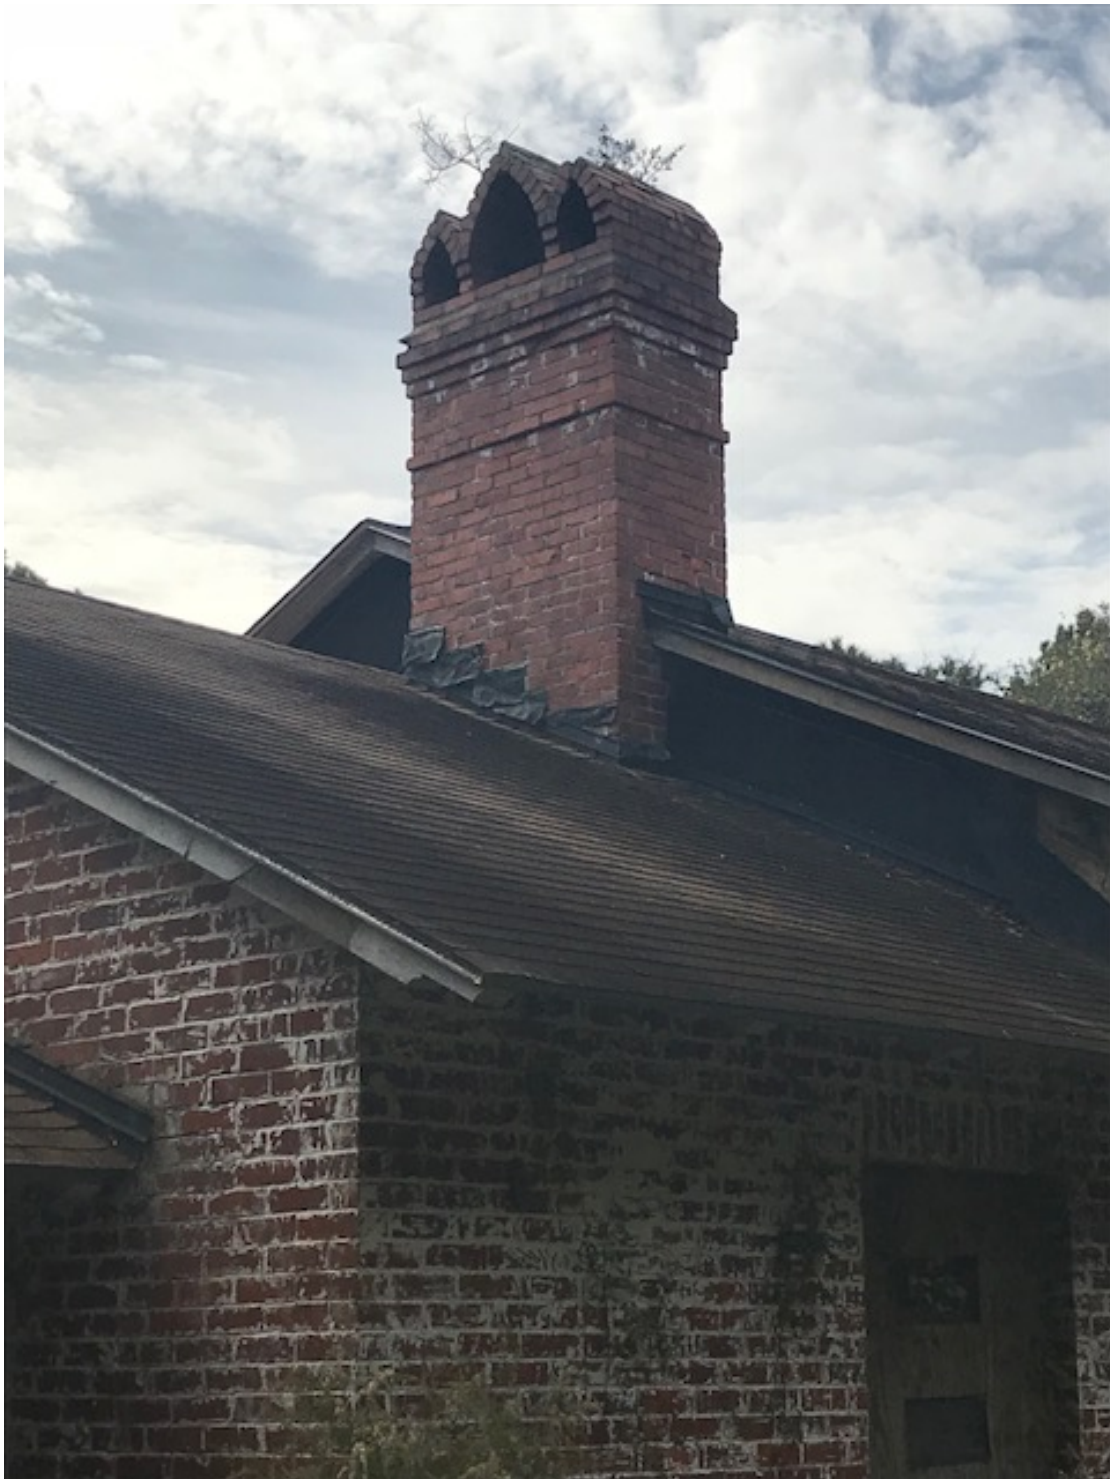
Figure A.28 – *Walnut Grove biological growth on chimney* A chimney at Walnut Grove has biological growth coming out of it (*Image from author*).

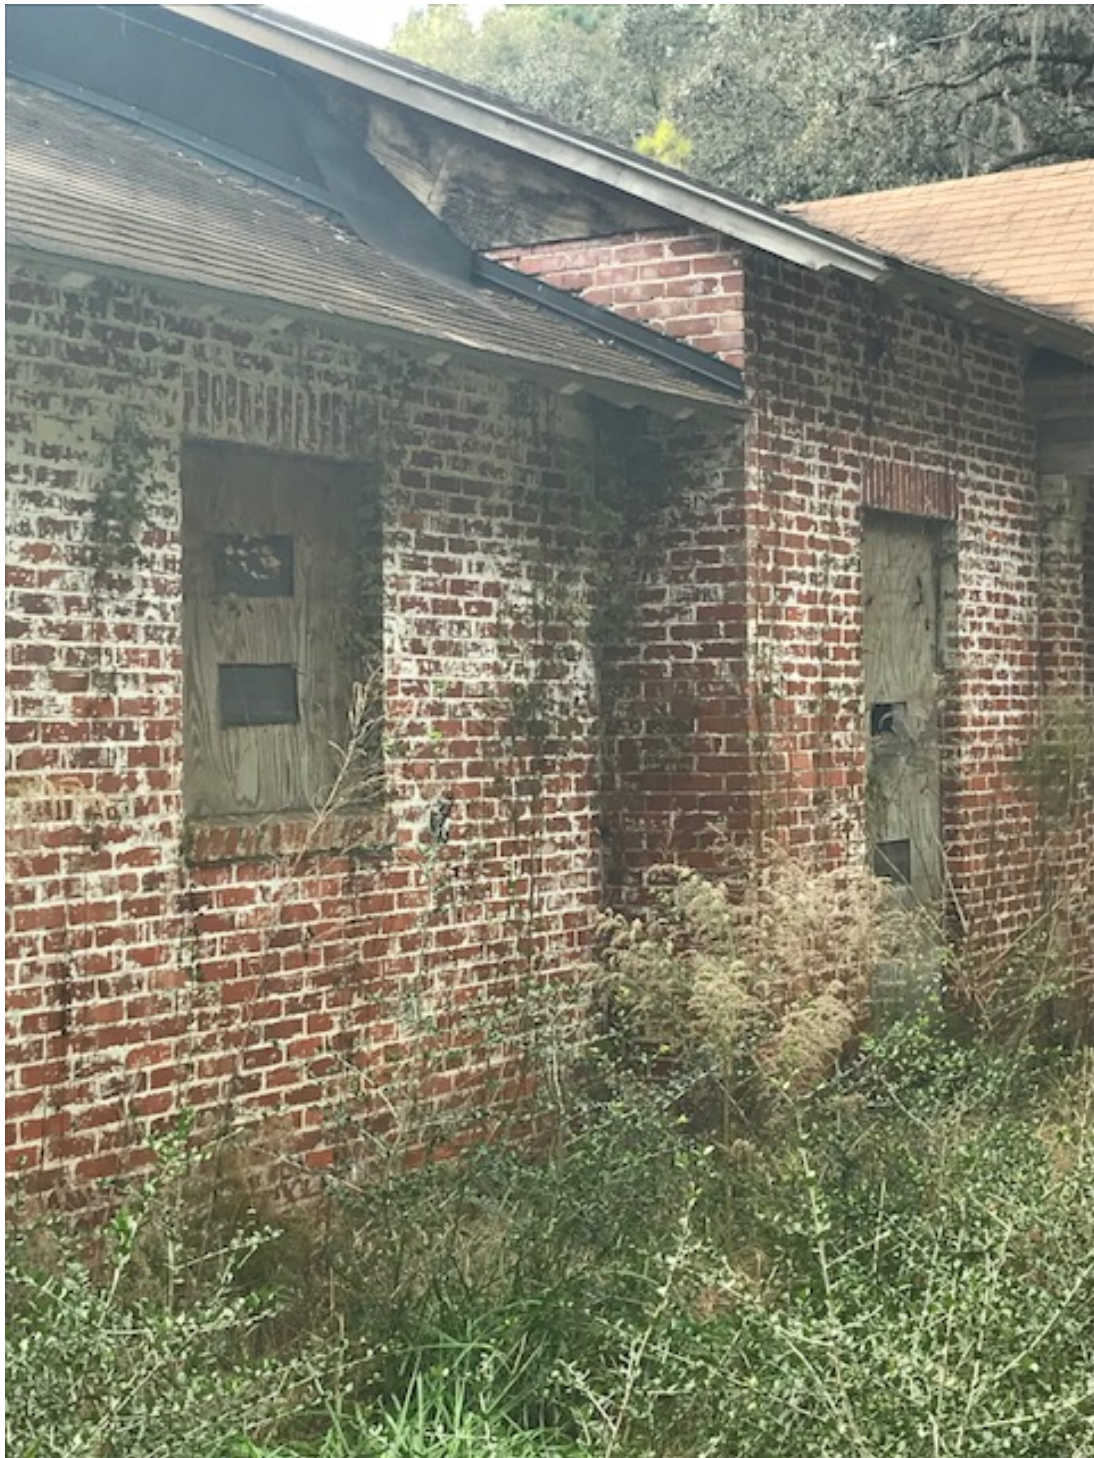
Figure A.29 – *Walnut Grove front façade mothballed* The front façade of Walnut Grove was mothballed by the USFS, with sealed windows shown here with vents, allowing the house to breathe (*Image from author*).

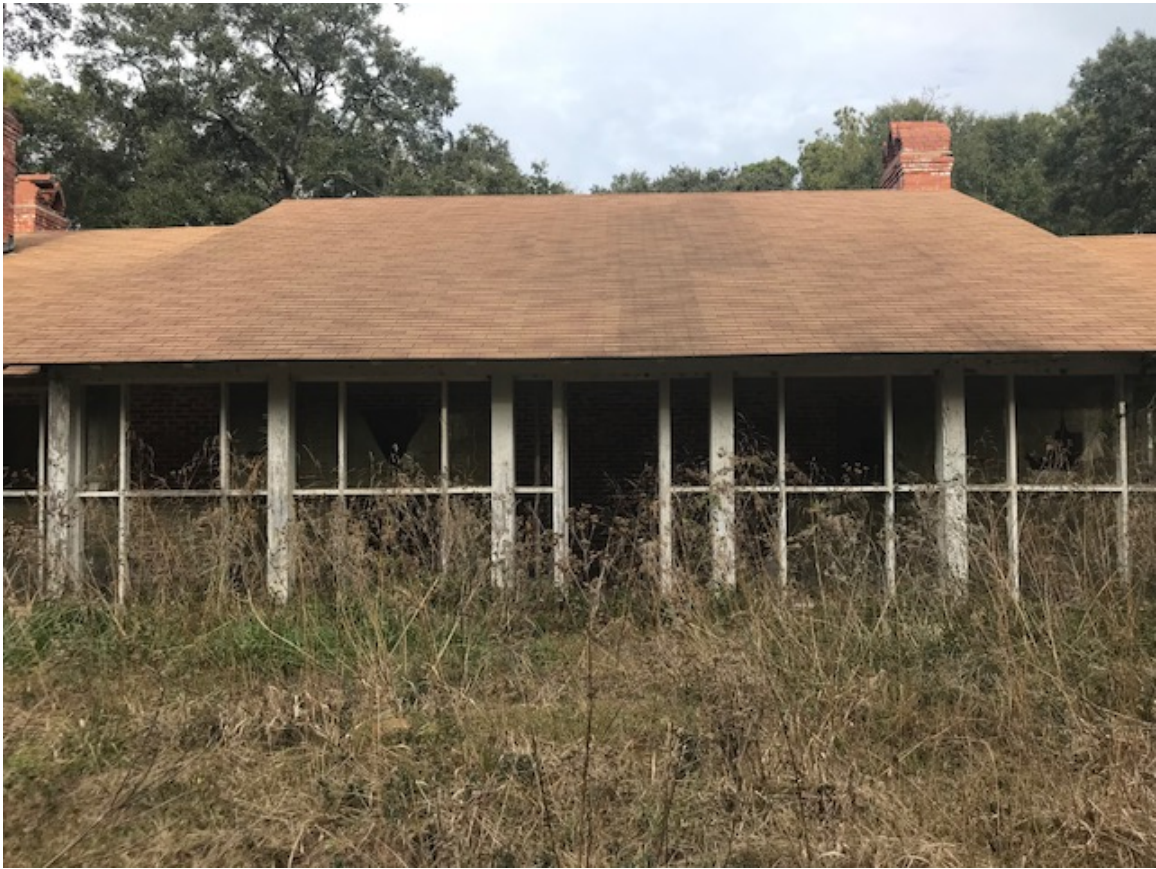
Figure A.30 – *Walnut Grove back porch* The back porch at Walnut Grove has had all of its screens ripped out (*Image from author*).

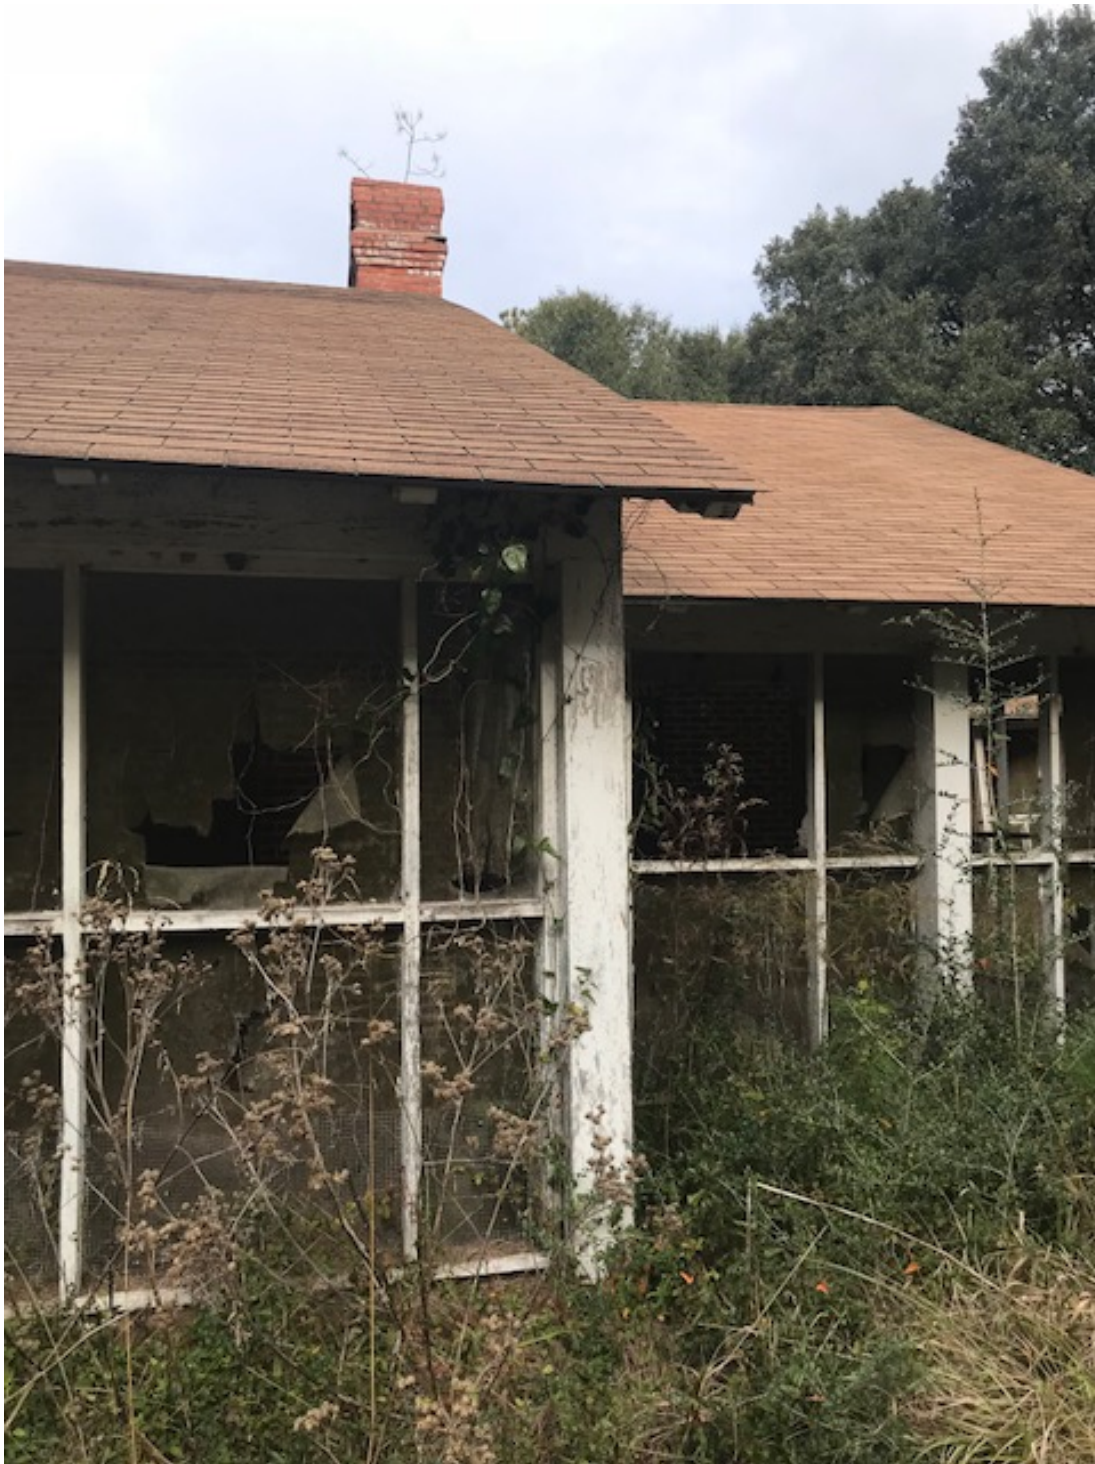
Figure A.31 – *Walnut Grove biological growth on back porch* The back porch at Walnut Grove is starting to be overtaken by biological growth (*Image from author*).

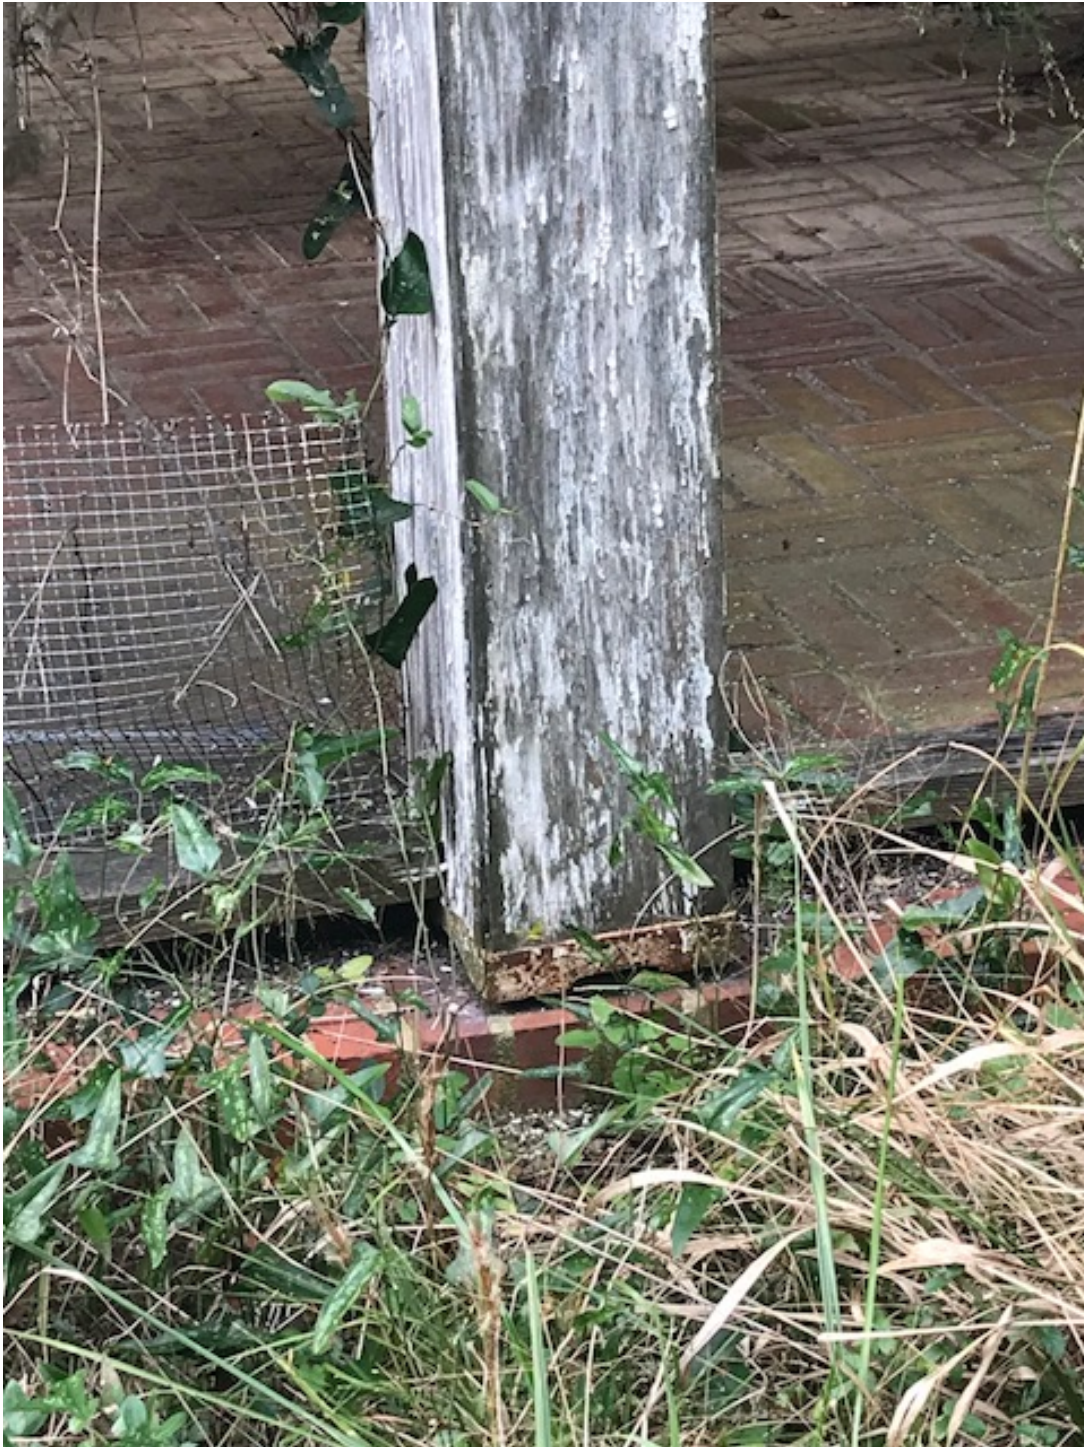
Figure A.32 – Walnut Grove wood rot Wood rot at Walnut Grove on a post on the back porch (*Image from author*).

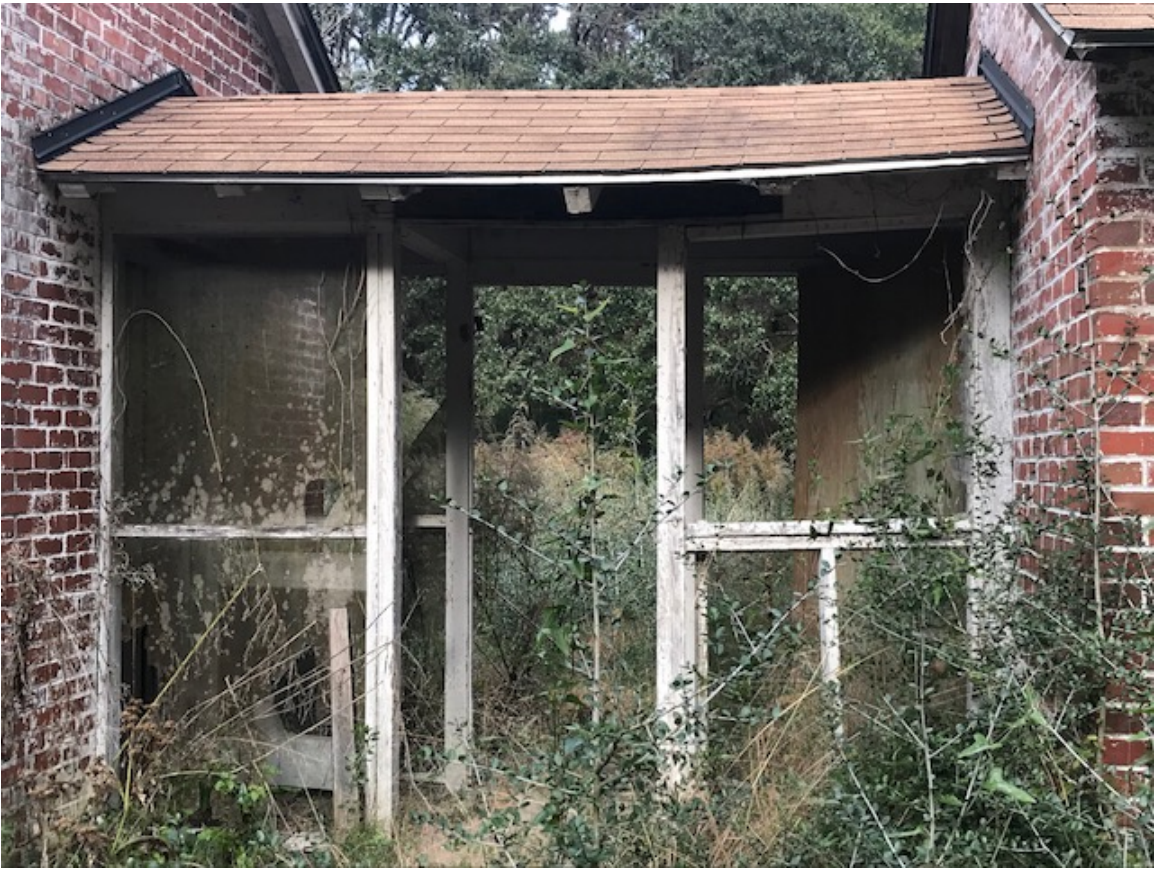
Figure A.33 – *Walnut Grove breezeway* The breezeway at Walnut Grove connecting the main house to the servants' quarters is beginning to sag and has lost its screens (*Image from author*).

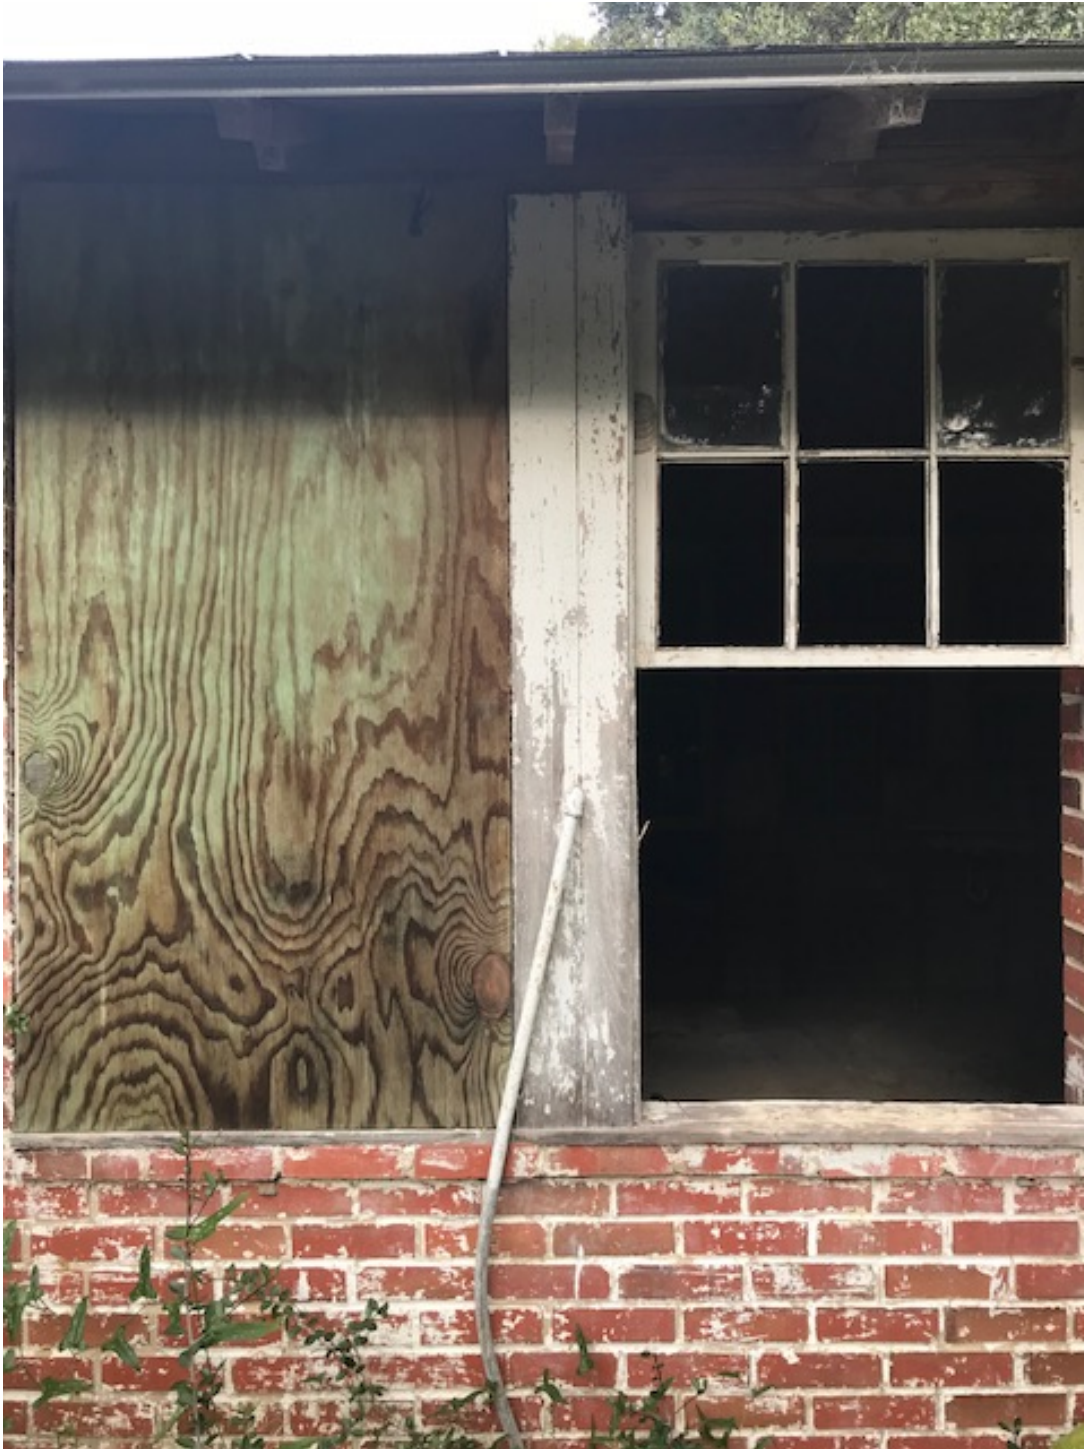
Figure A.34 – *Walnut Grove servants' quarters* A wooden panel has been removed from a window on the servants' quarters, meaning the structure is no longer closed off to the elements (*Image from author*).

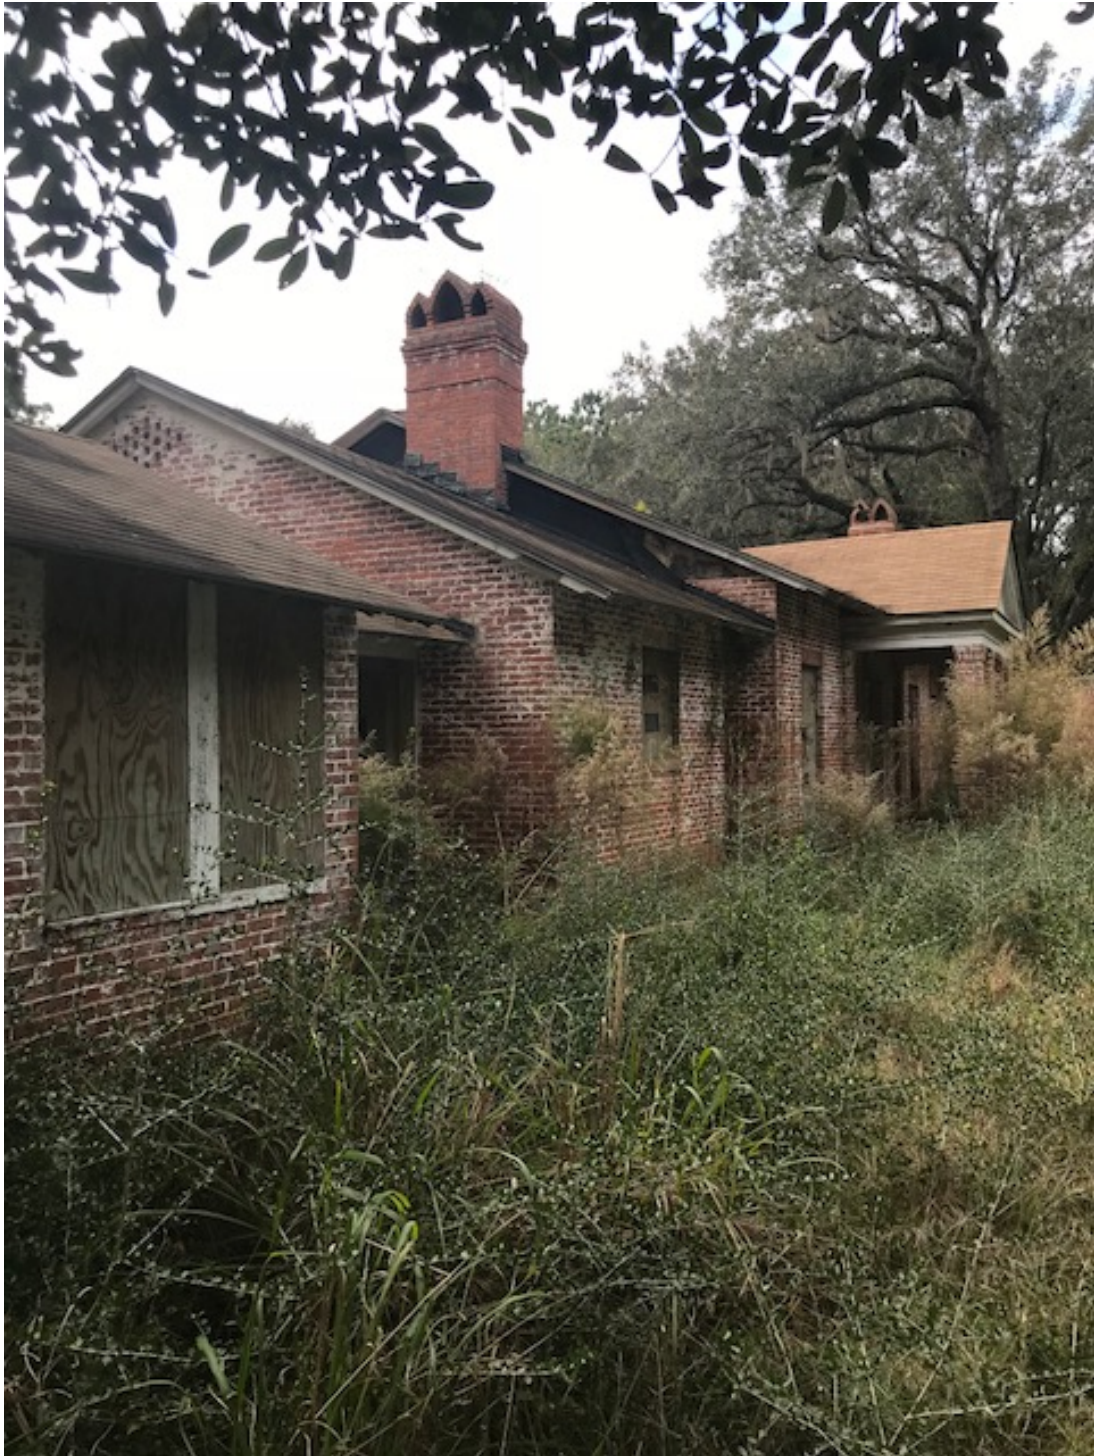
Figure A.35 – *Walnut Grove side elevation* A view of the front and side elevations at Walnut Grove shows the extent of the biological overgrowth surrounding the structure (*Image from author*).

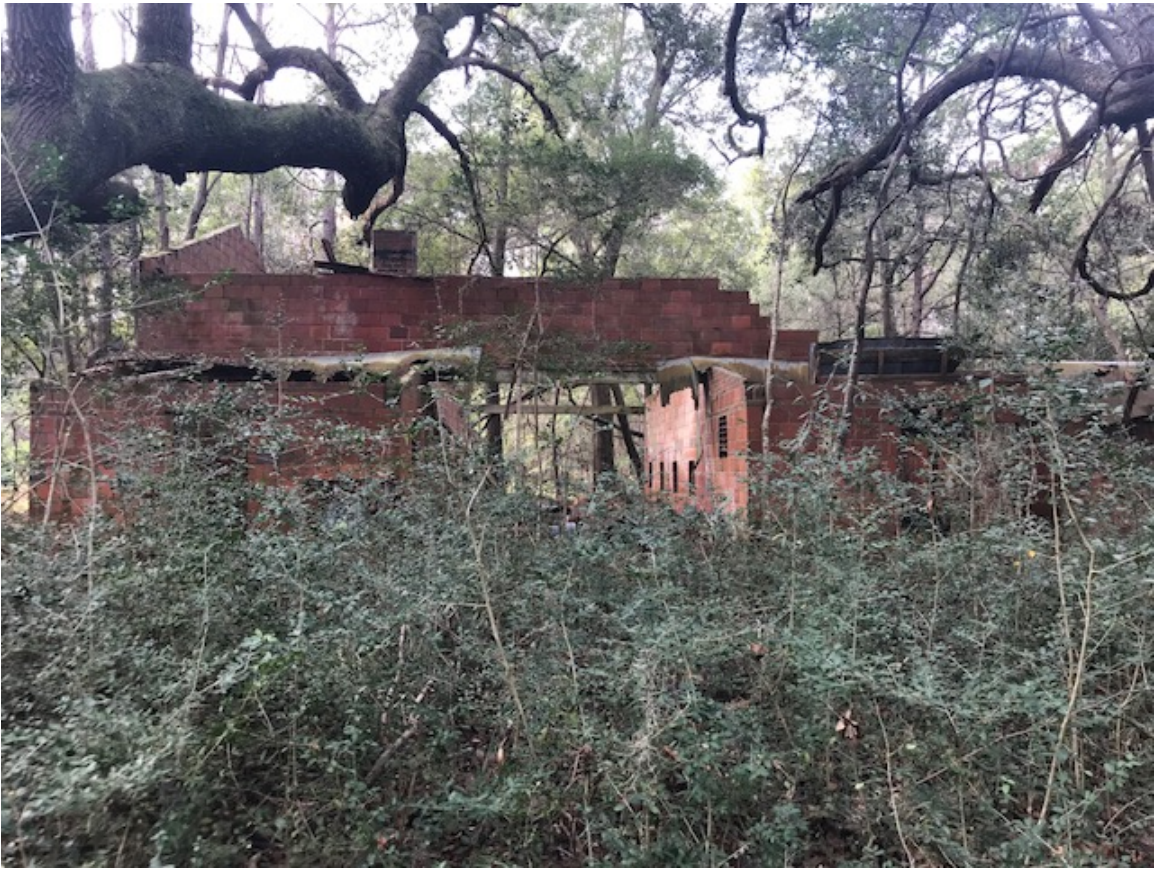
Figure A.36 – Walnut Grove barn The ruins of a former barn on property at Walnut Grove (*Image from author*).

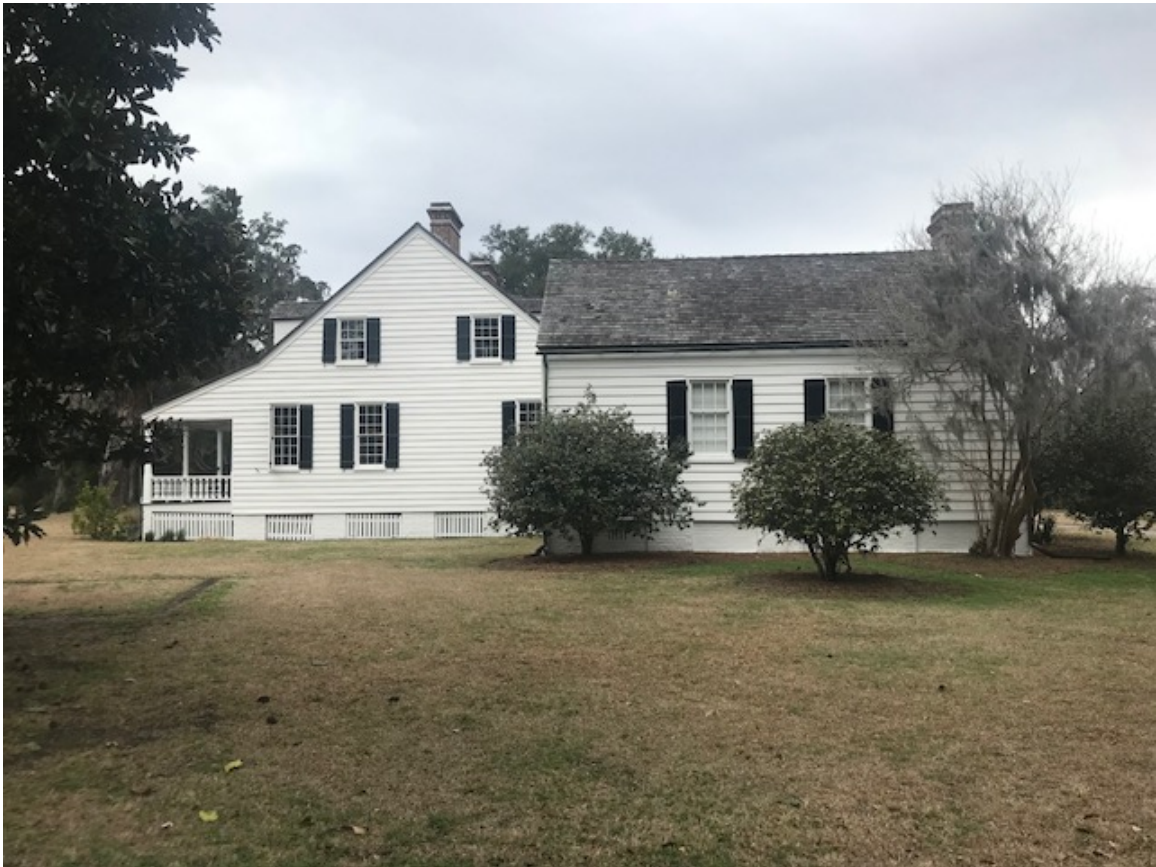
Figure A.37 – *Charles Pinckney side elevation* The side elevation of Charles Pinckney House, fully restored (*Image from author*).

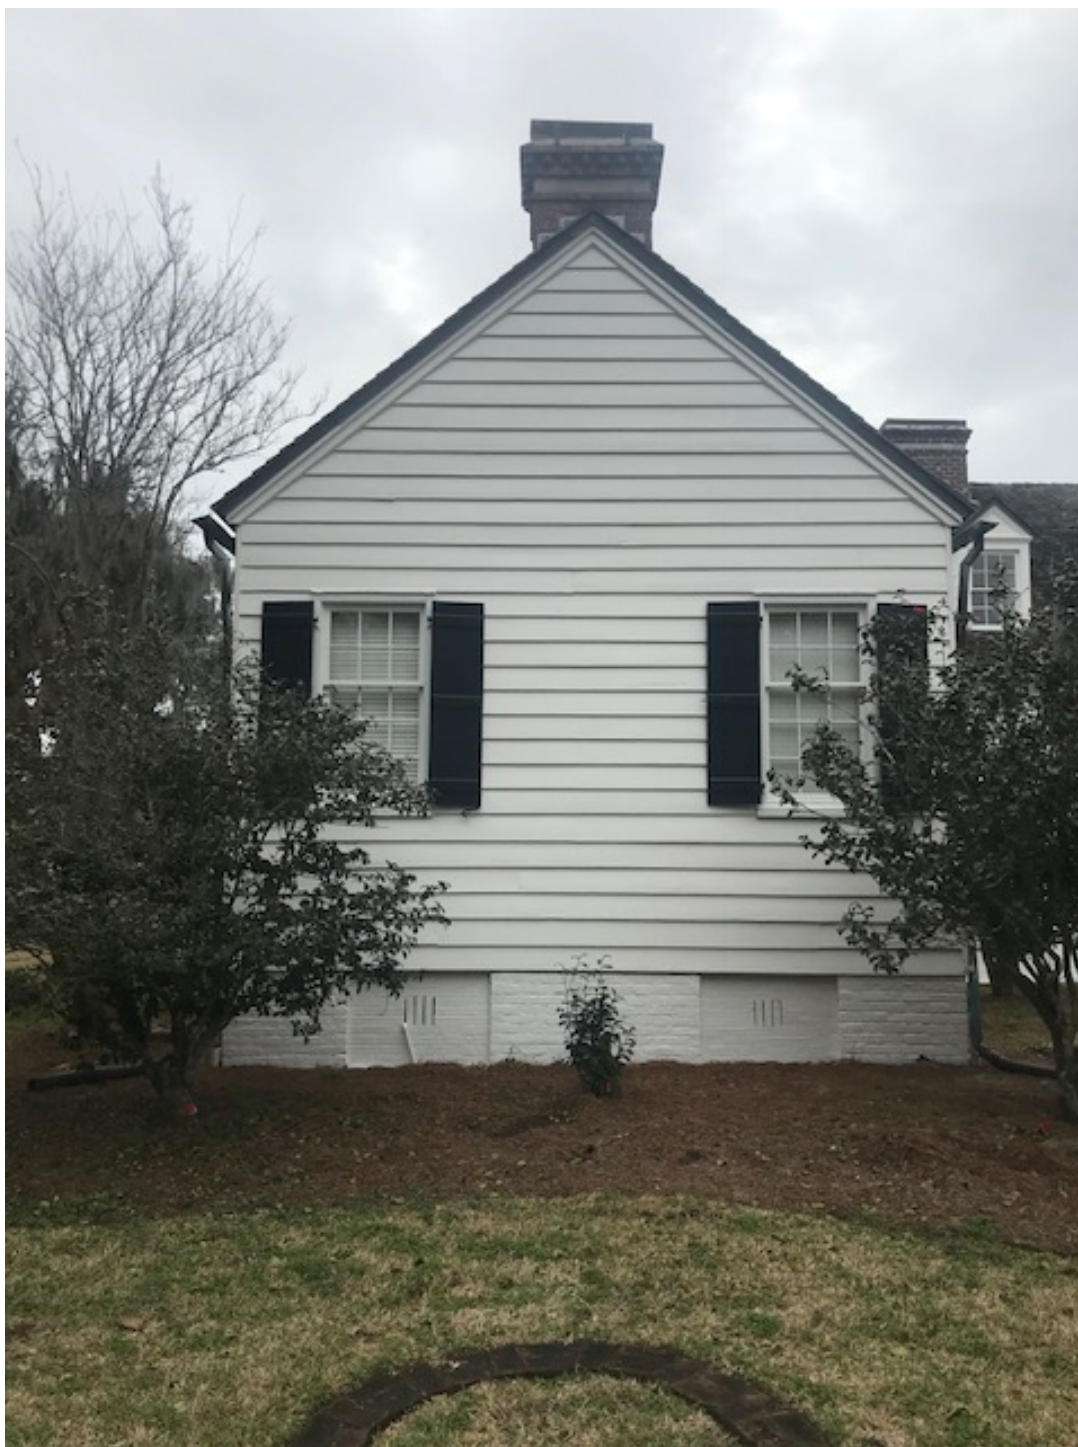
Figure A.38 – *Charles Pinckney wing addition* An addition to the original footprint of the Charles Pinckney House (Image from author).

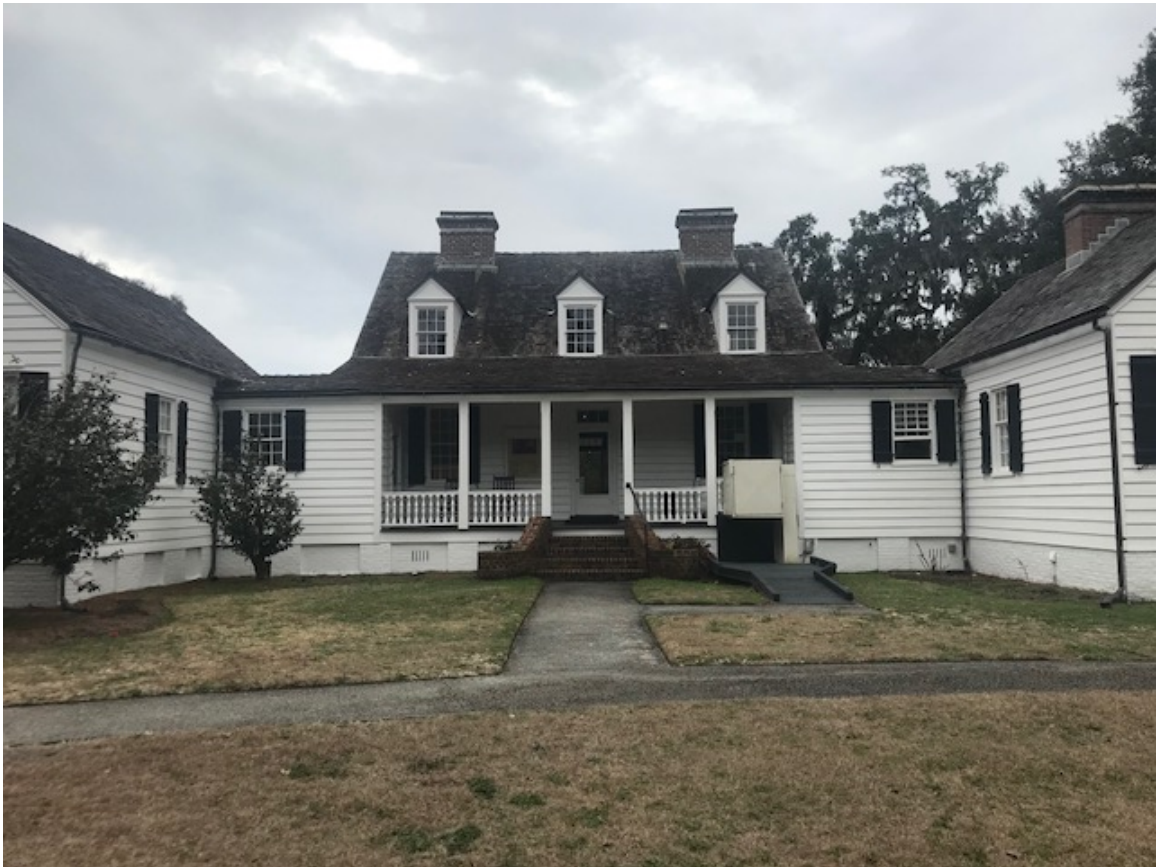
Figure A.39 – *Charles Pinckney front elevation* The front elevation of Charles Pinckney House, fully restored (*Image from author*).

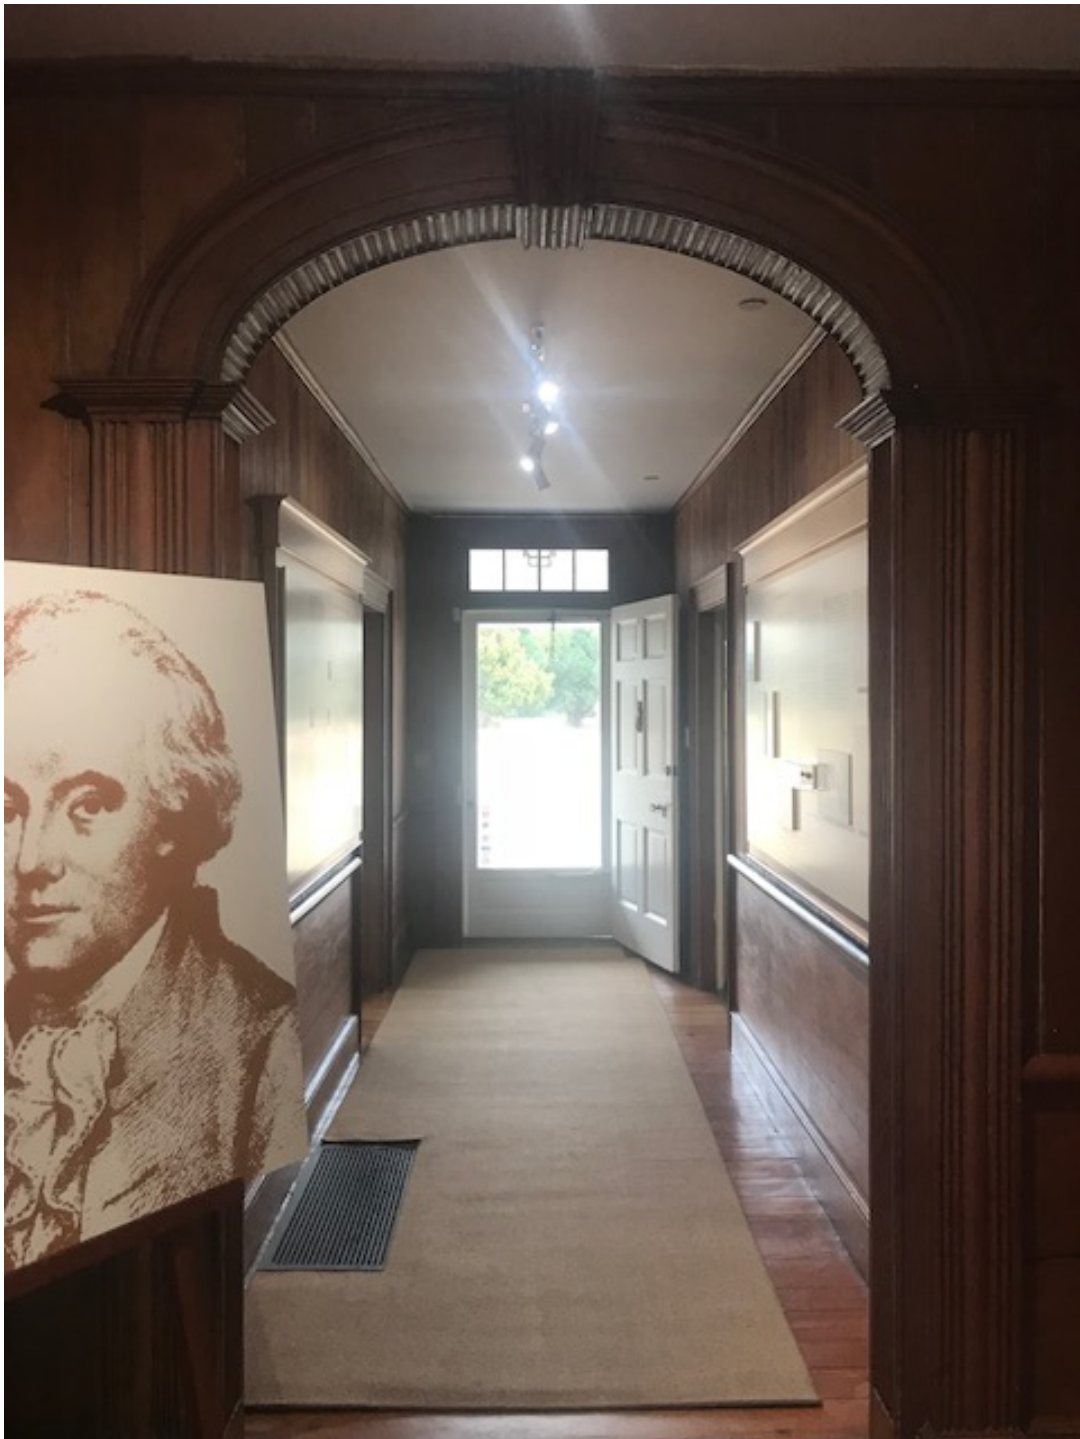
Figure A.40 – *Charles Pinckney main hallway* The restored main hallway at the Charles Pinckney House; note the addition of the glass door on the front entrance (*Image from author*).

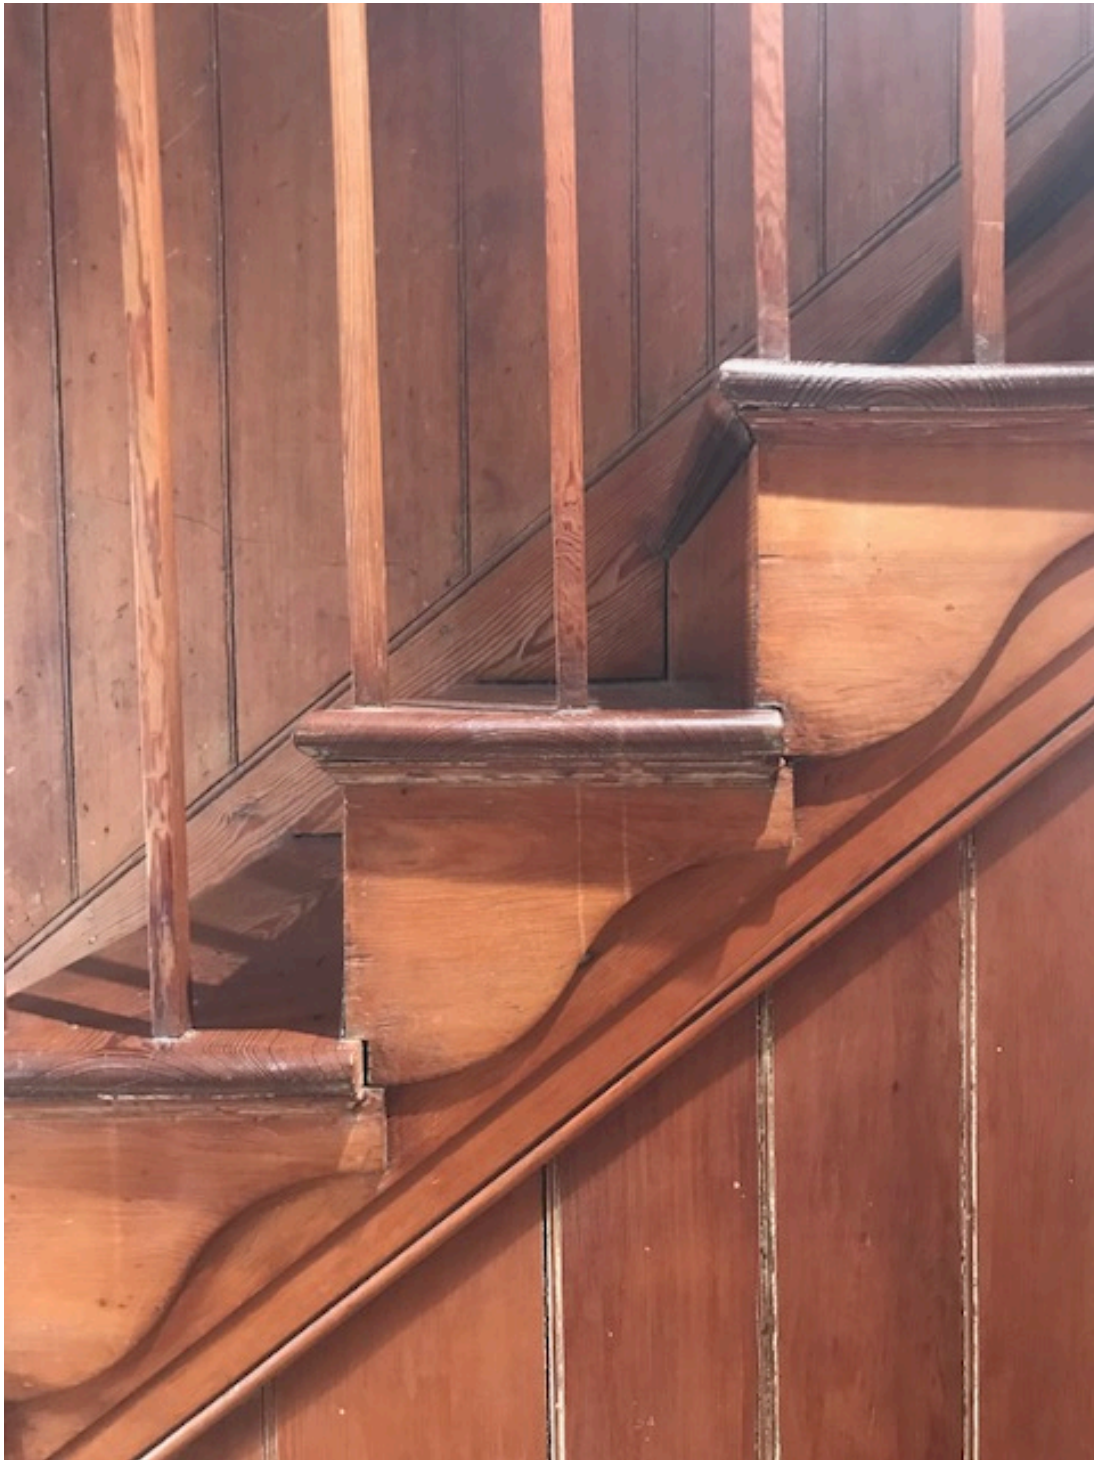
Figure A.41 – *Charles Pinckney stair detail* The woodwork at the Charles Pinckney House has been restored to its original finish, as seen in this image of the staircase (*Image from author*).
