Out of the Woods: Facilitating Stewardship of Historic Resources in the National Forest Service

OUT OF THE WOODS: FACILITATING STEWARDSHIP OF HISTORIC
RESOURCES IN THE NATIONAL FOREST SERVICE

A Thesis
Presented to
the Graduate School of
Clemson University and the College of Charleston

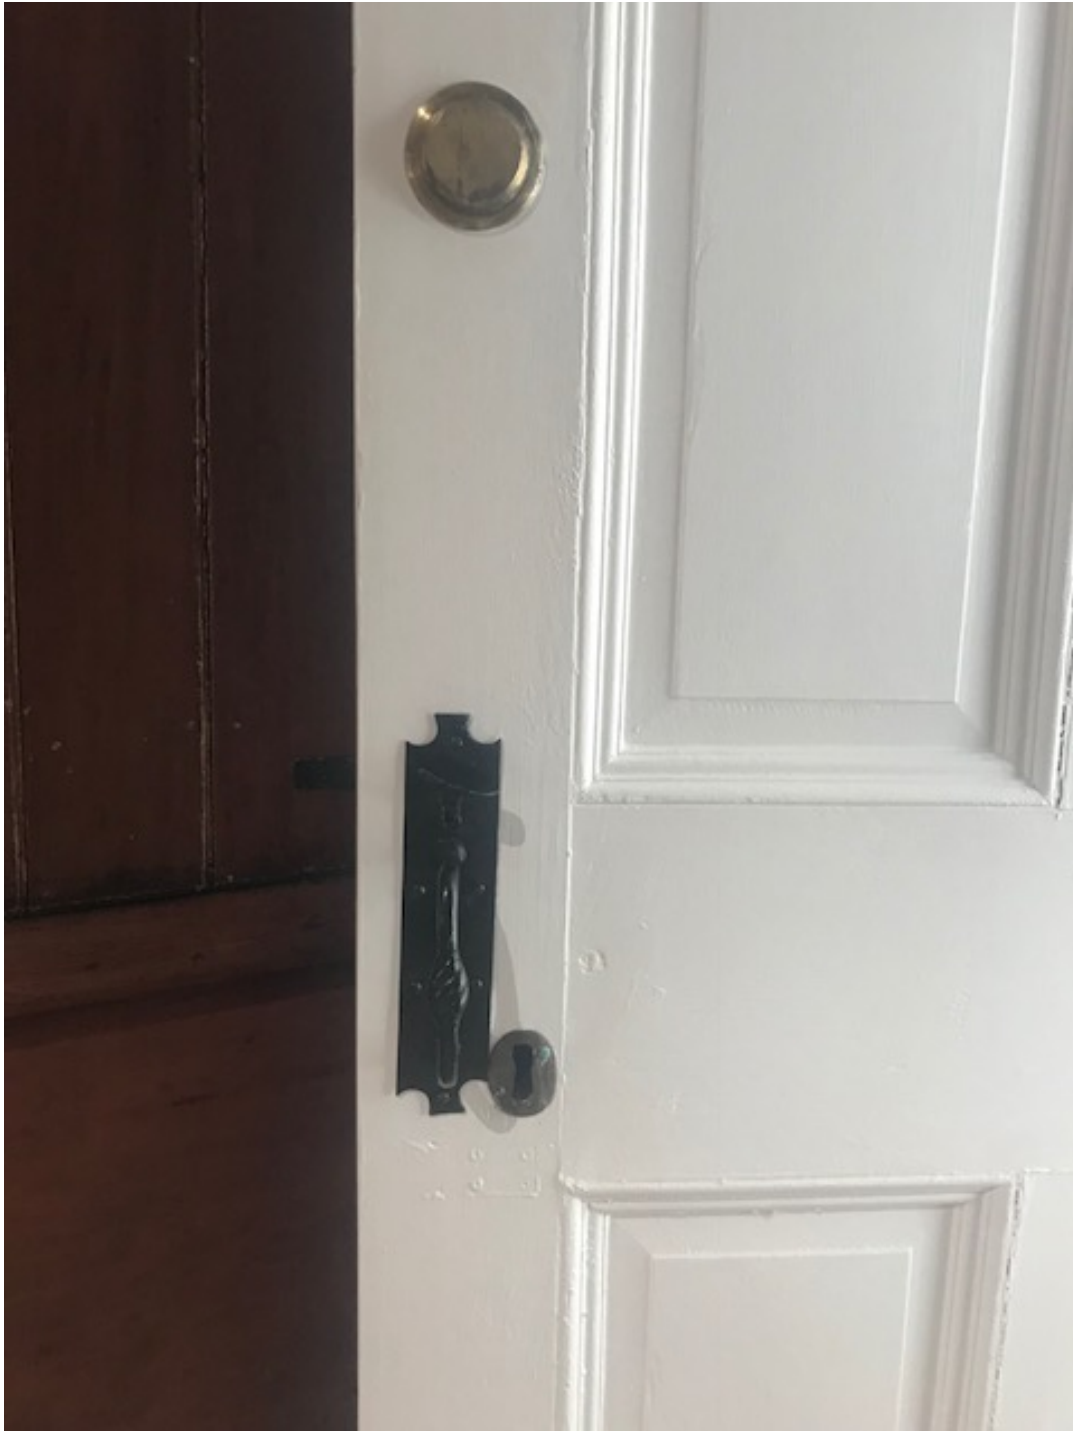
Figure A.42 – *Charles Pinckney door hardware* When the Charles Pinckney House was restored, the NPS took care to maintain as many original details as possible, like the door hardware seen here (*Image from author*).

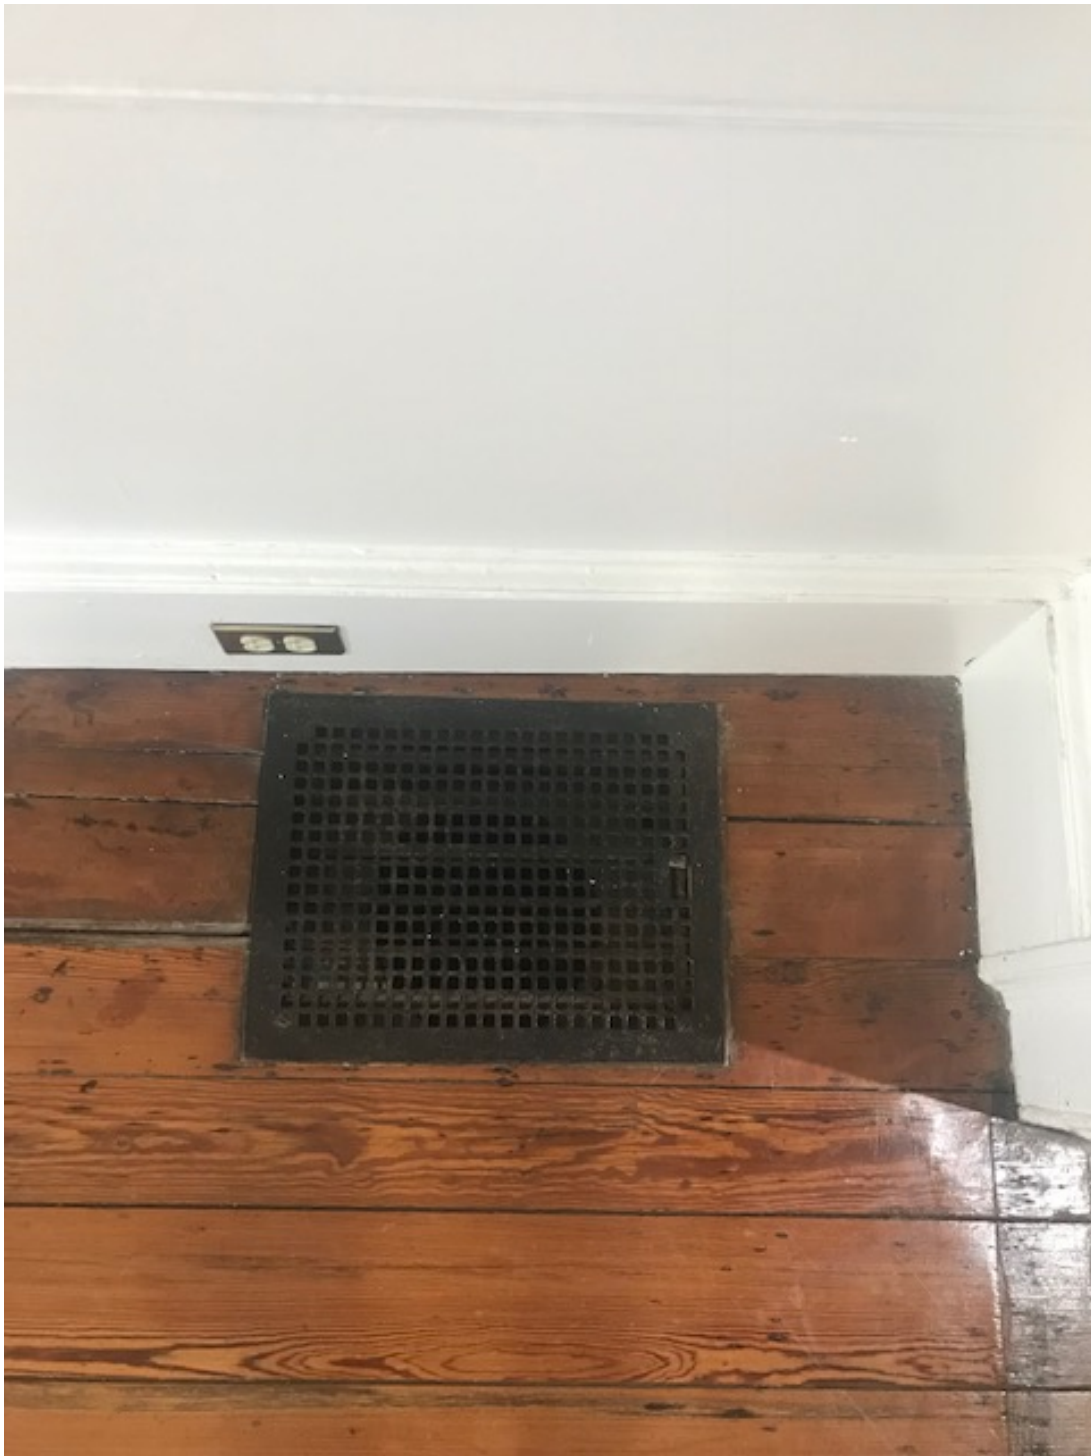
Figure A.43 – *Charles Pinckney A/C vent* The restoration of the Pinckney House also modernized it for visitors, including upgrading HVAC units (*Image from author*).

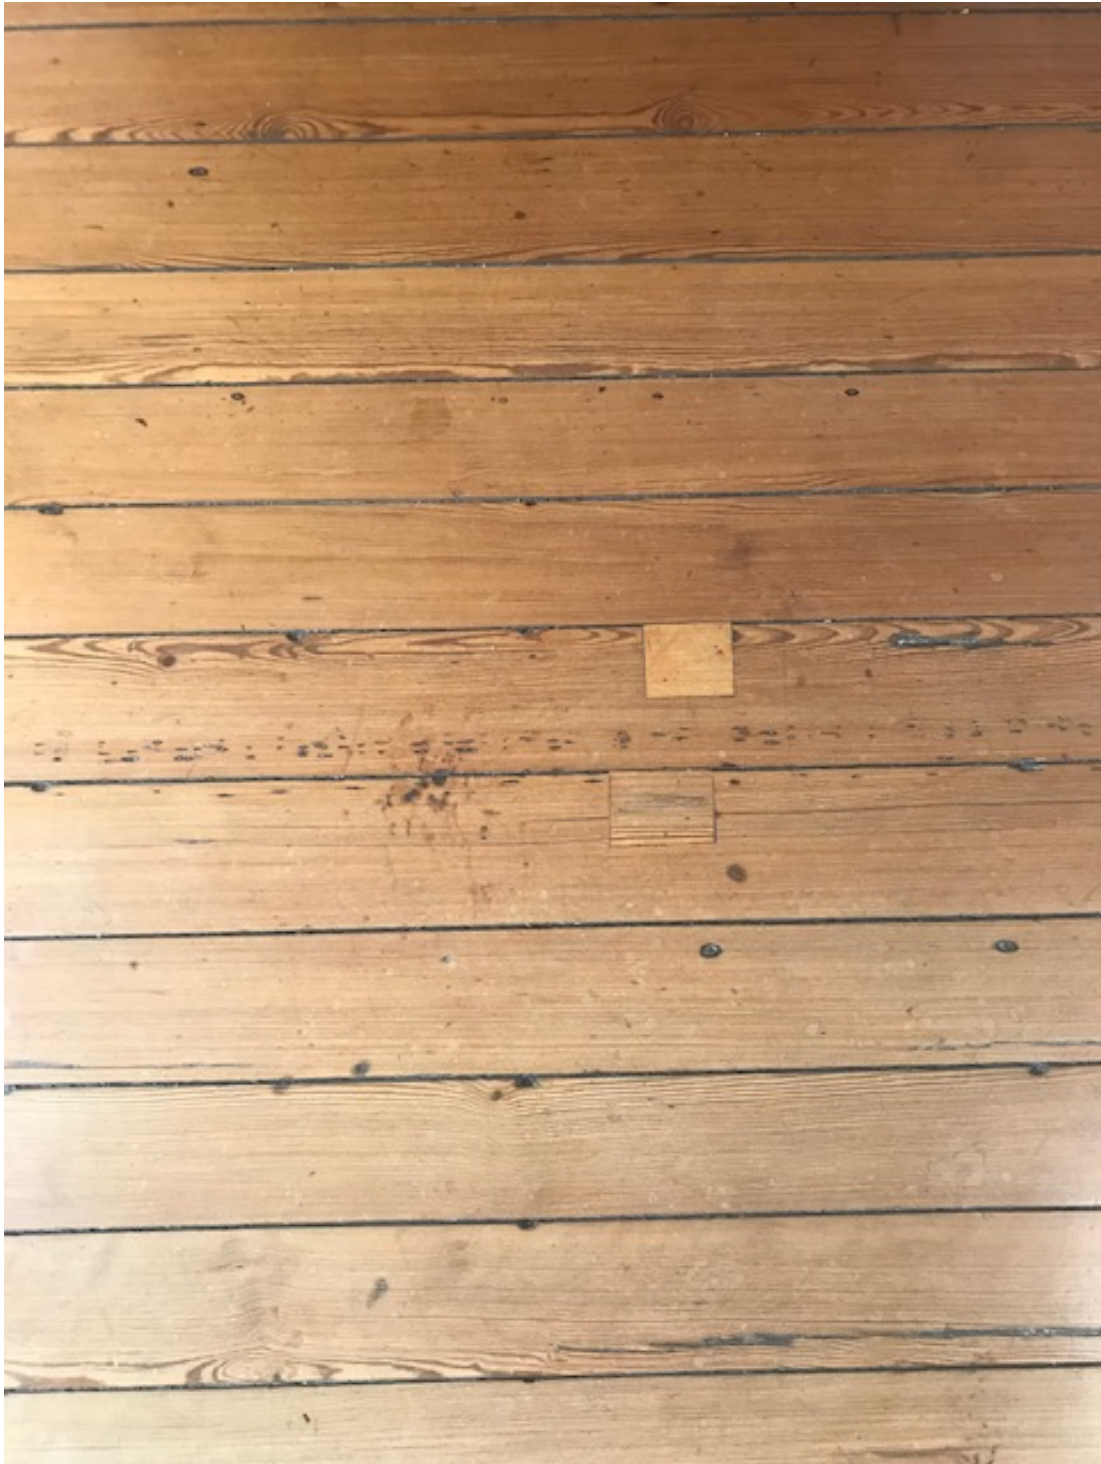
Figure A.44 – *Charles Pinckney repaired wood floor* The wooden floors have been patched in spots from damage sustained over the years, as seen in this image (*Image from author*).

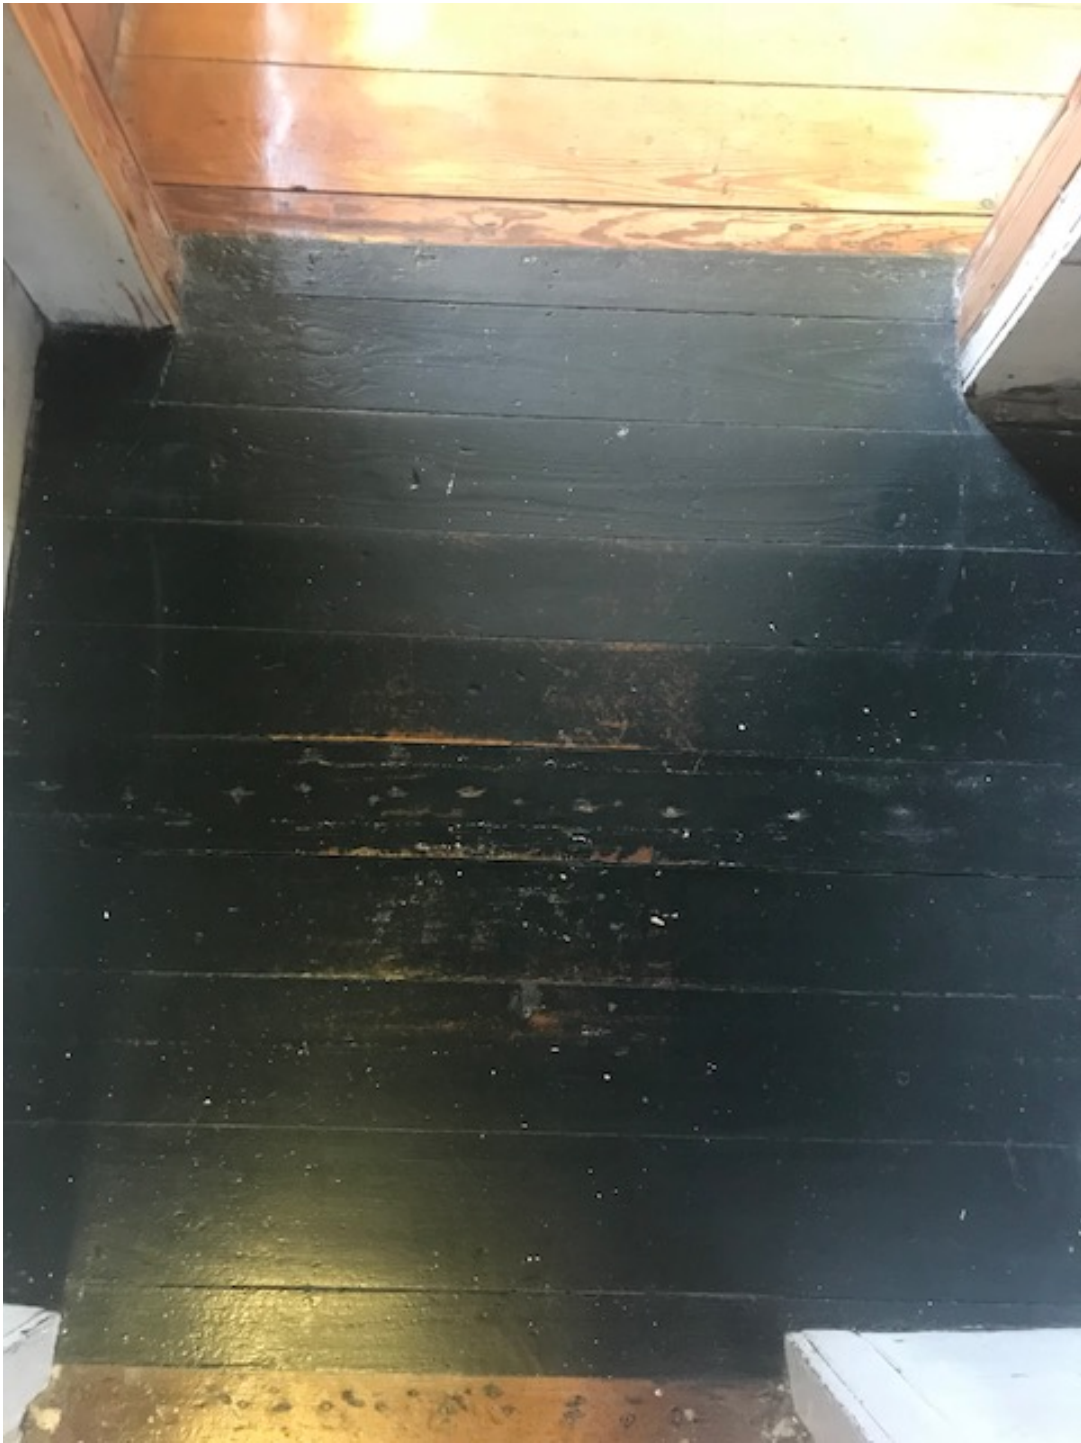
Figure A.45 – *Charles Pinckney painted floor* Portions of the wood floor at the Pinckney House were left painted (*Image from author*).

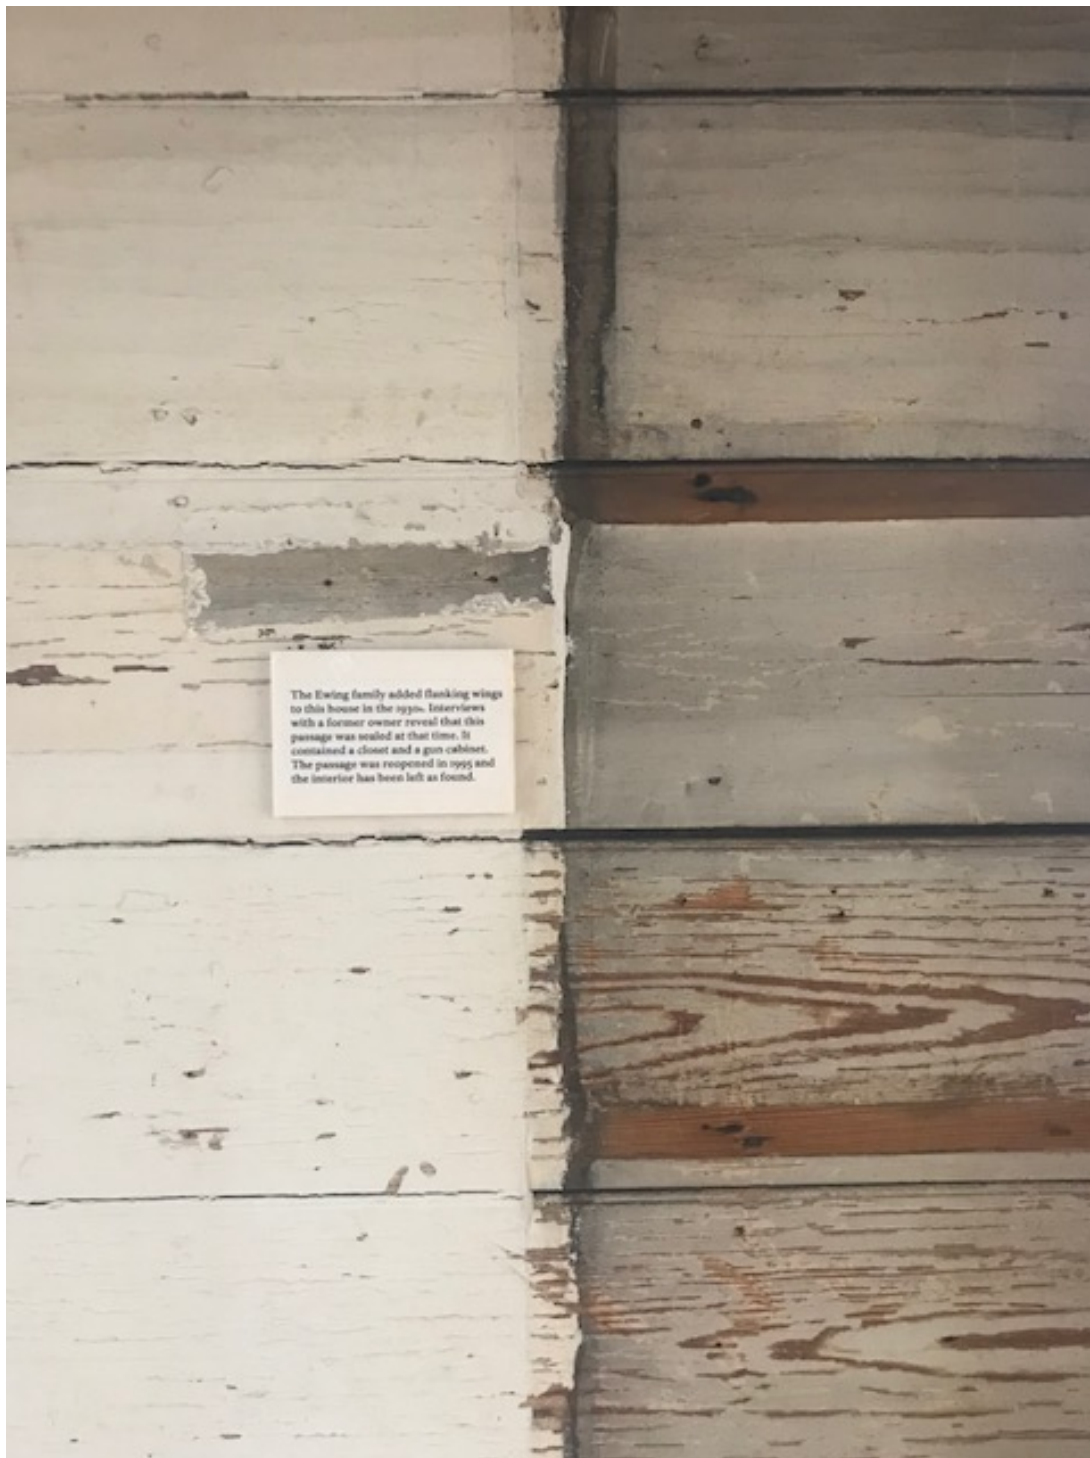
Figure A.46 – *Charles Pinckney flanking wing joint* This image shows where the original interior paneling meets the newer, twentieth century paneling of the wings that were added to the house (*Image from author*).

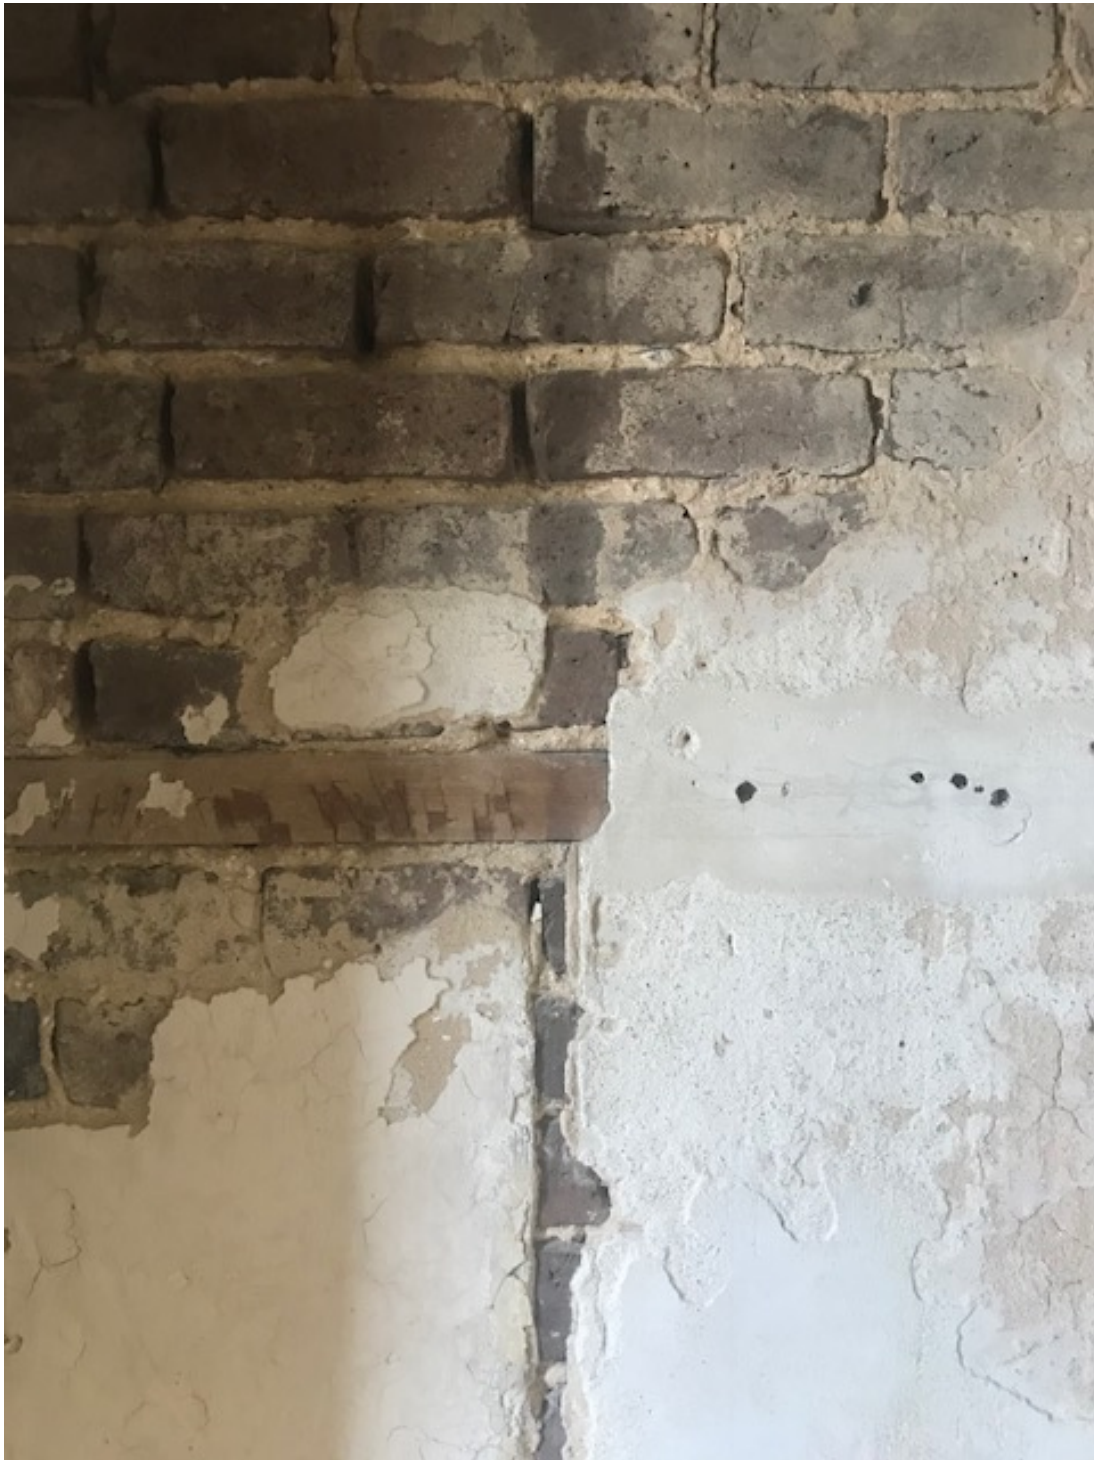
Figure A.47 – *Charles Pinckney exposed brick* Exposed brick wall at the Charles Pinckney House (*Image from author*).

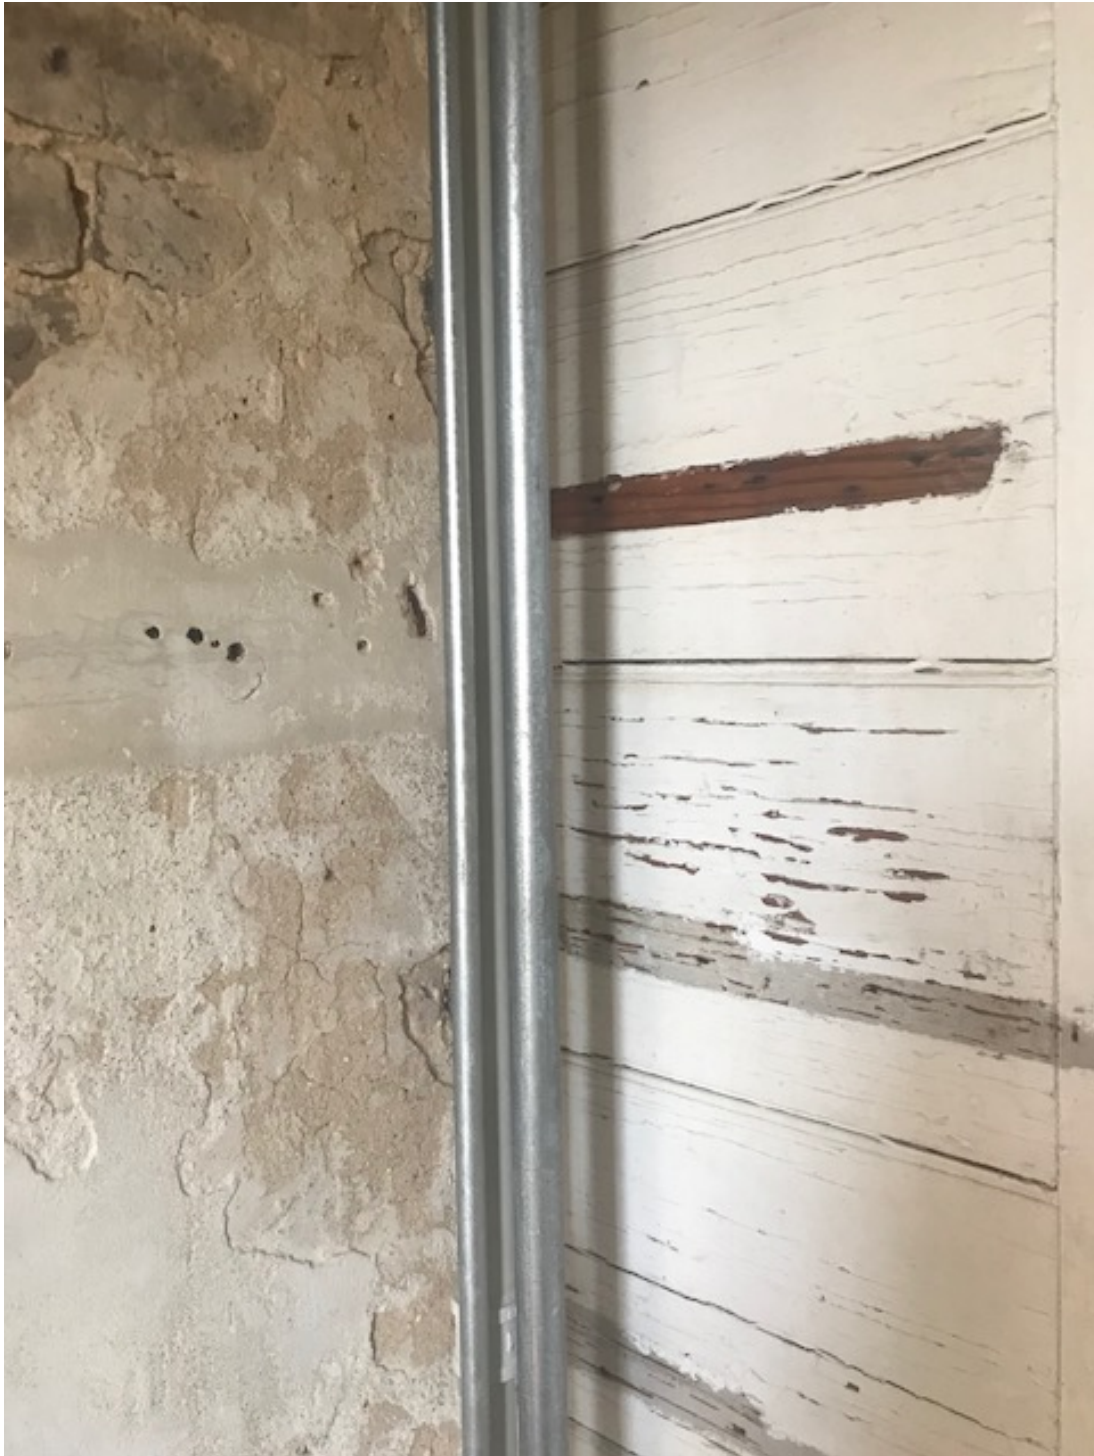
Figure A.48 – *Charles Pinckney modern plumbing* Modern pipes for plumbing have been run in plain sight in the restored Pinckney House (*Image from author*).

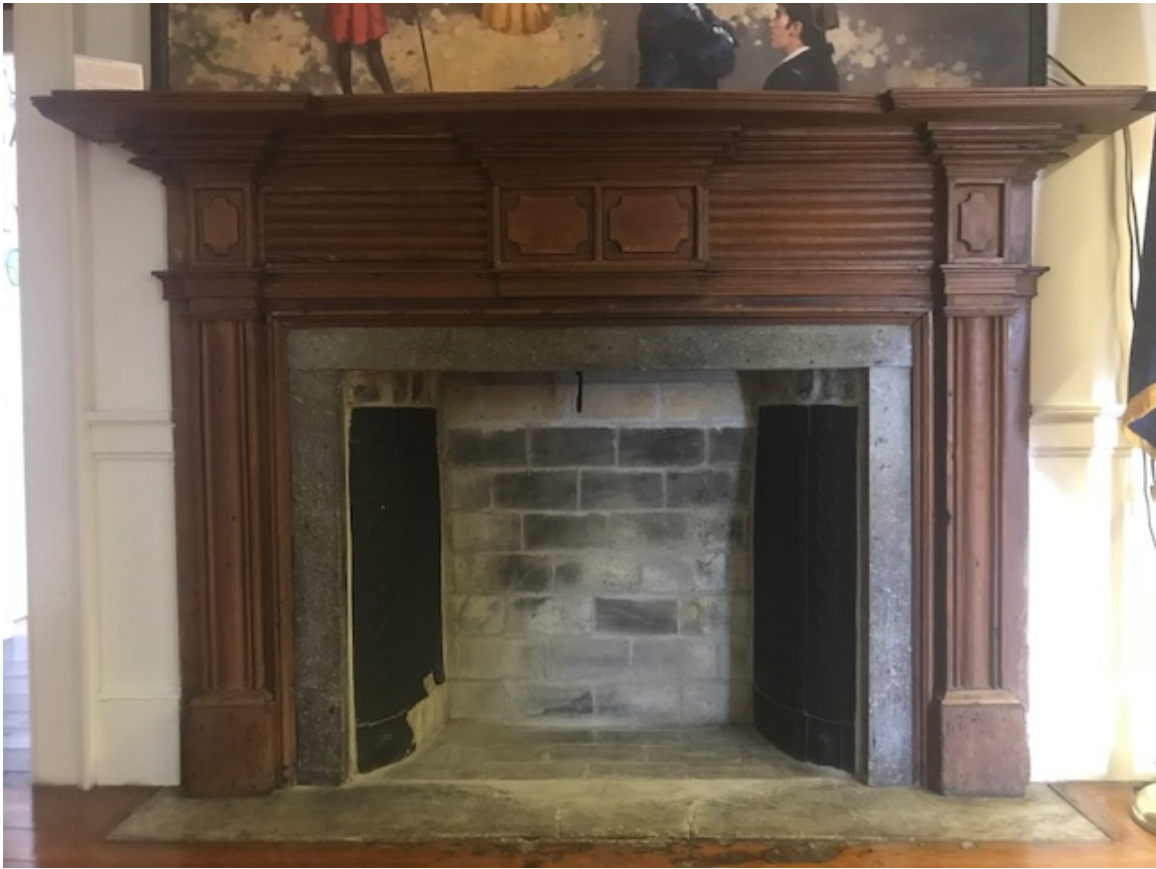
Figure A.49 – *Charles Pinckney fireplace* A restored fireplace at the Pinckney House (*Image from author*).

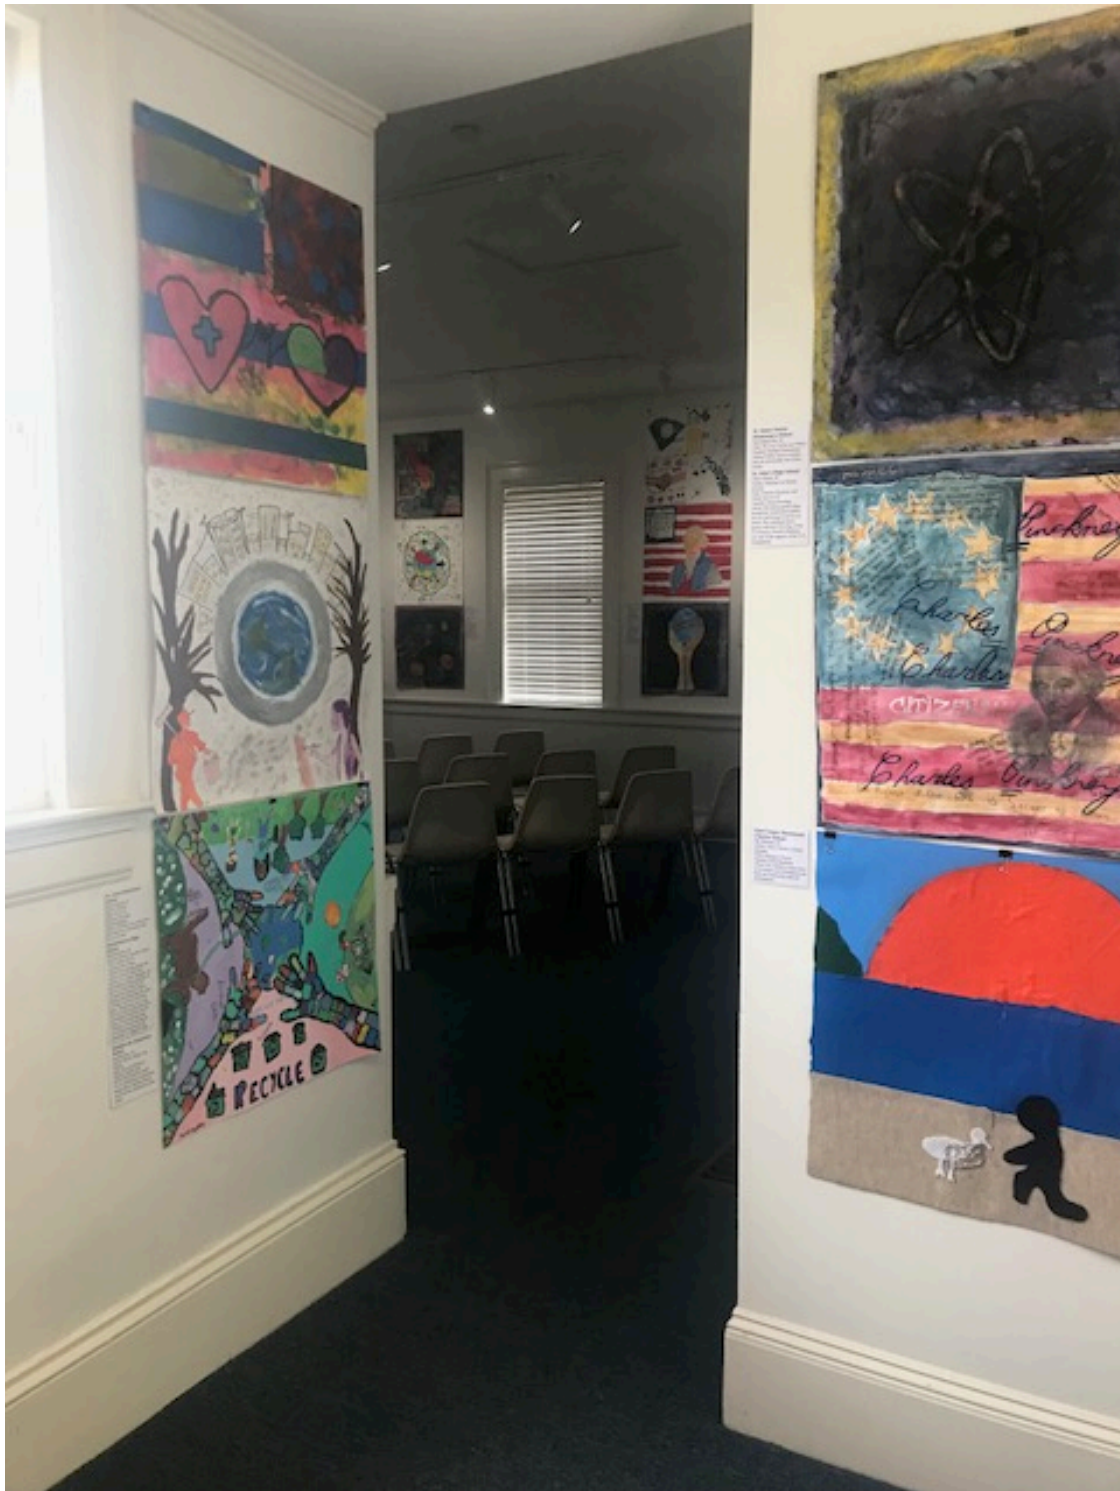
Figure A.50 – *Charles Pinckney classroom* One of the wing additions has been turned into a modern classroom, complete with track lighting (*Image from author*).

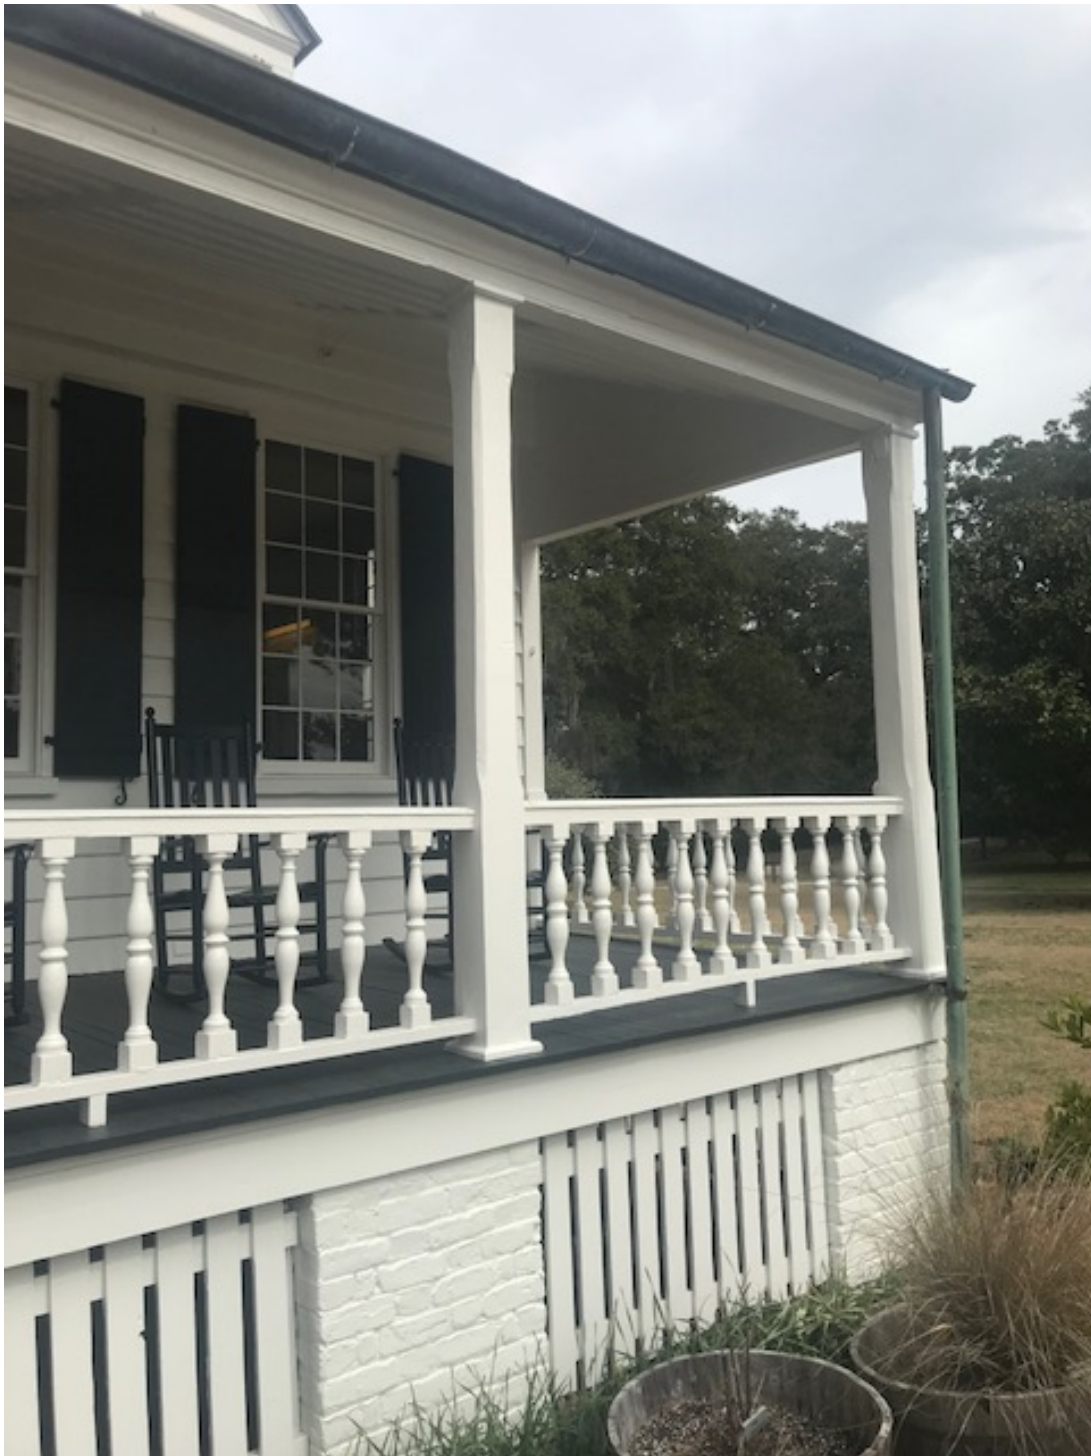
Figure A.51 – *Charles Pinckney back porch* The back porch at the Pinckney House has been fully restored, allowing for use and enjoyment by visitors (*Image from author*).

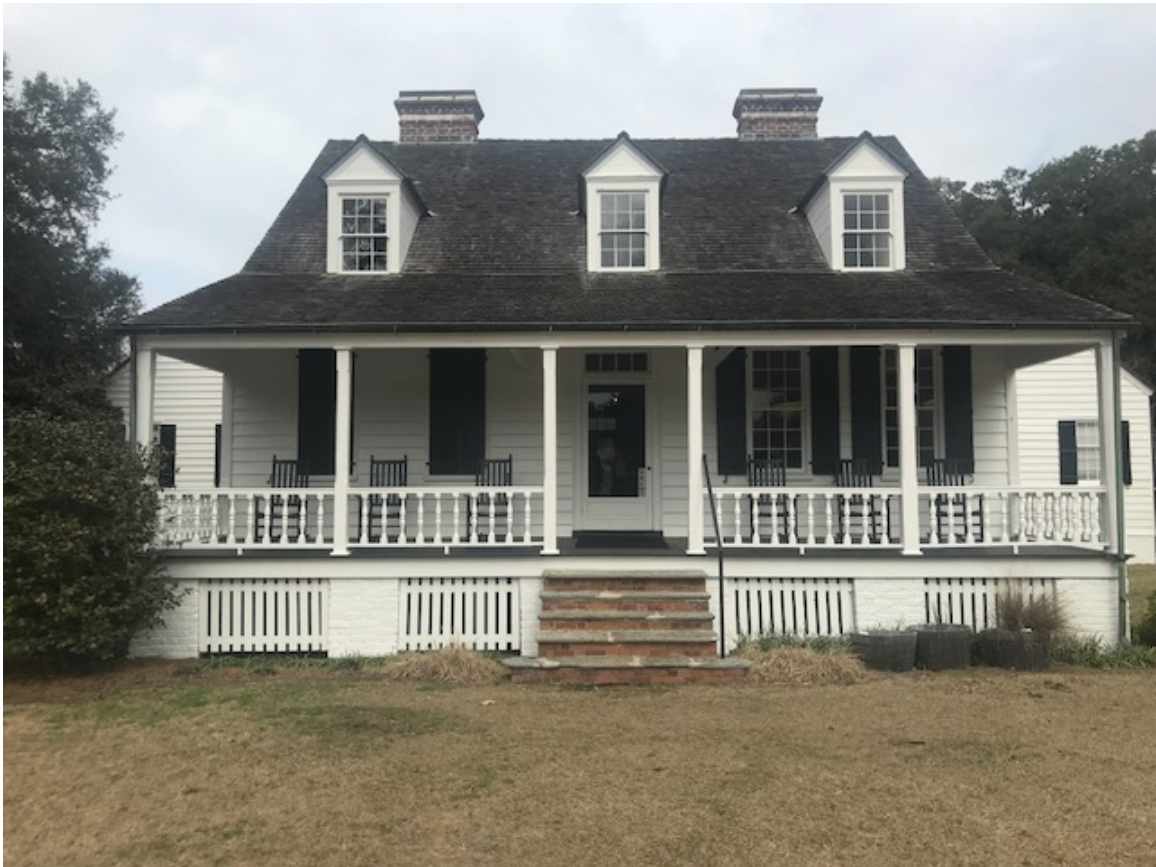
Figure A.52 – *Charles Pinckney rear elevation* The rear elevation of Charles Pinckney House, fully restored (*Image from author*).

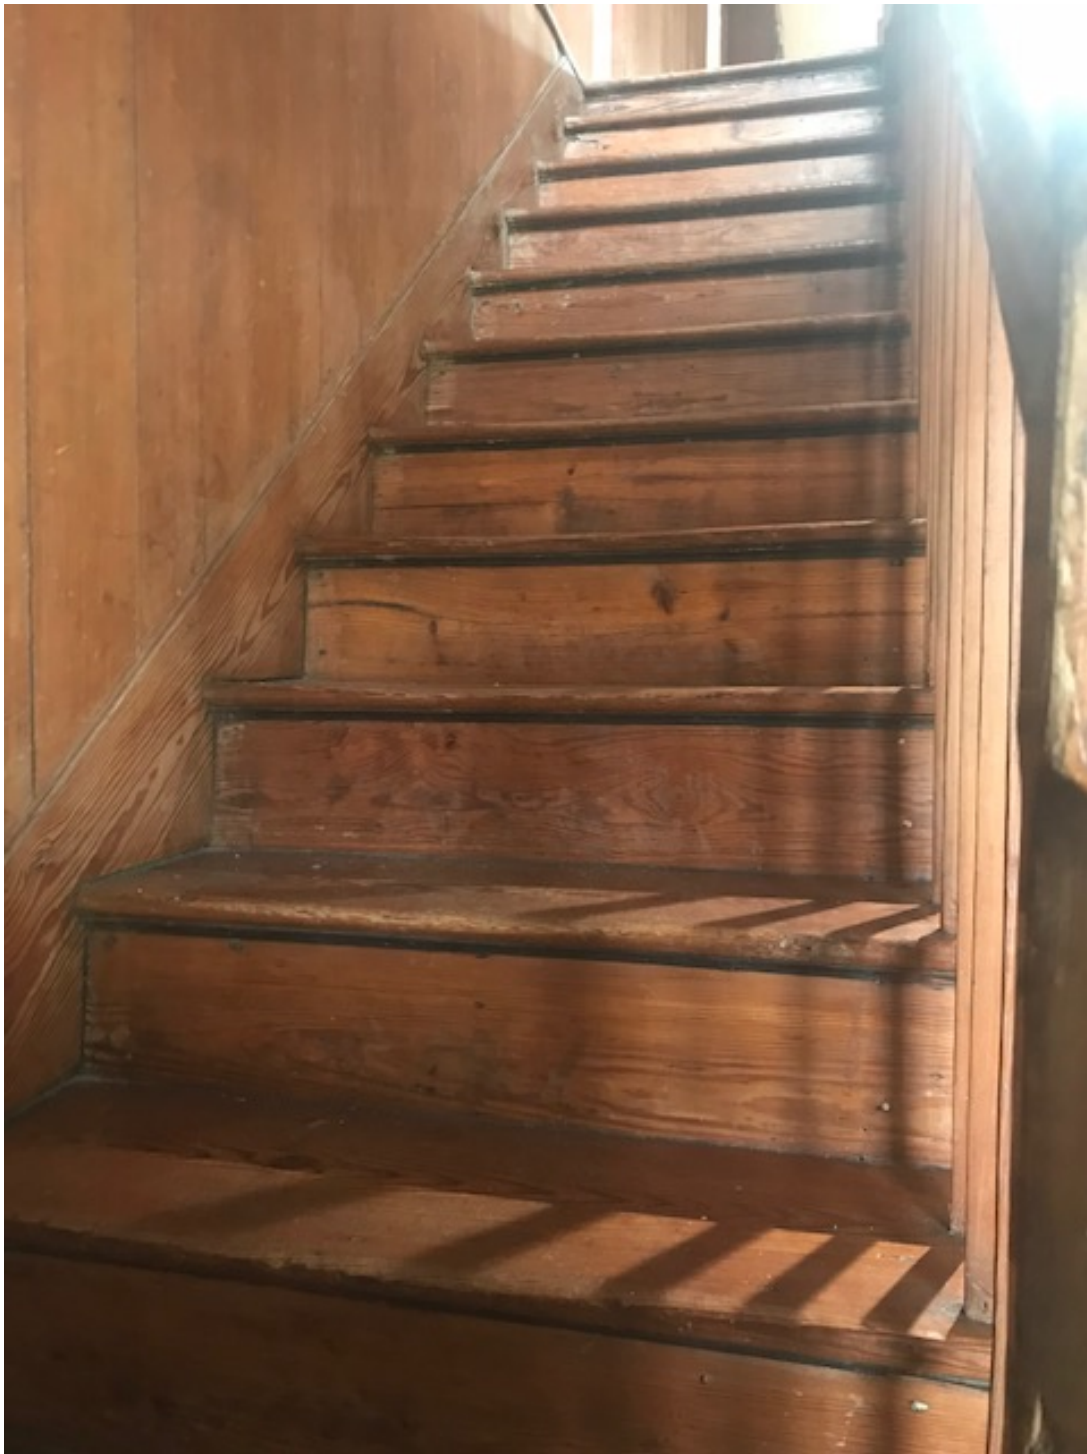
Figure A.53 – *Charles Pinckney staircase* The upstairs of the Pinckney House is off-limits to the public but is deemed safe for use by NPS employees (*Image from author*).

- 8. Staircase(s) (5)** in excellent condition; upstairs off-limits to visitors but safe for staff
- 9. Foundation (5)** like everything else in and outside of the house, the foundation was fully rebuilt and restored; in excellent condition

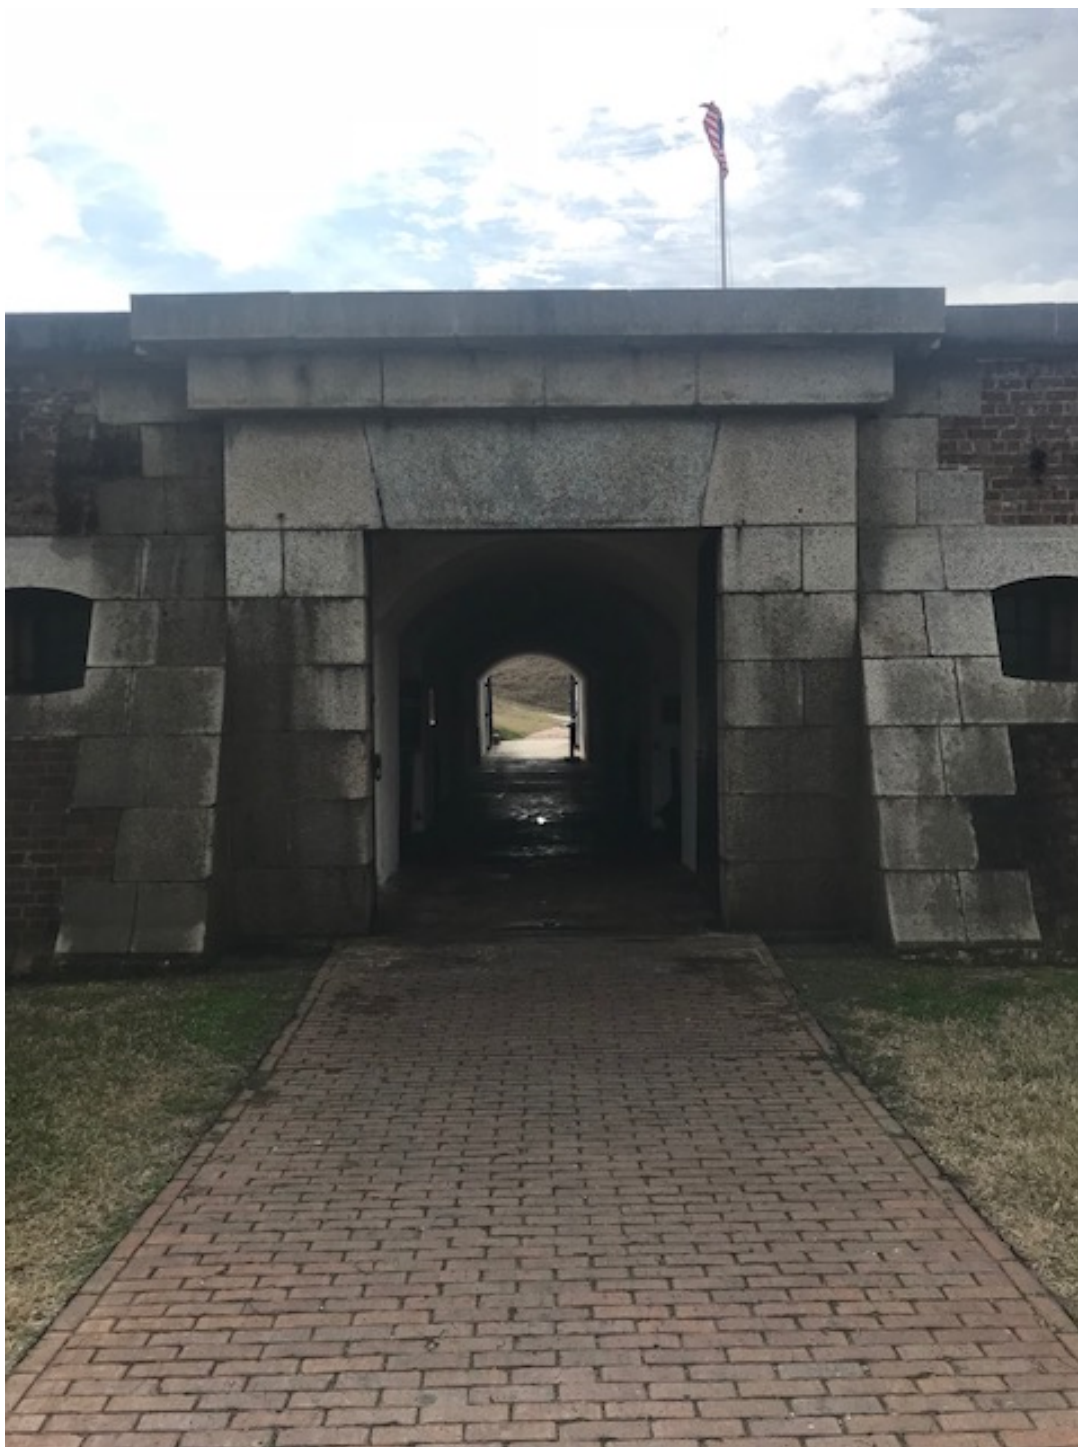
Figure A.54 – *Entrance to Fort Moultrie* The entrance to Fort Moultrie, fully restored by the NPS (*Image from author*).

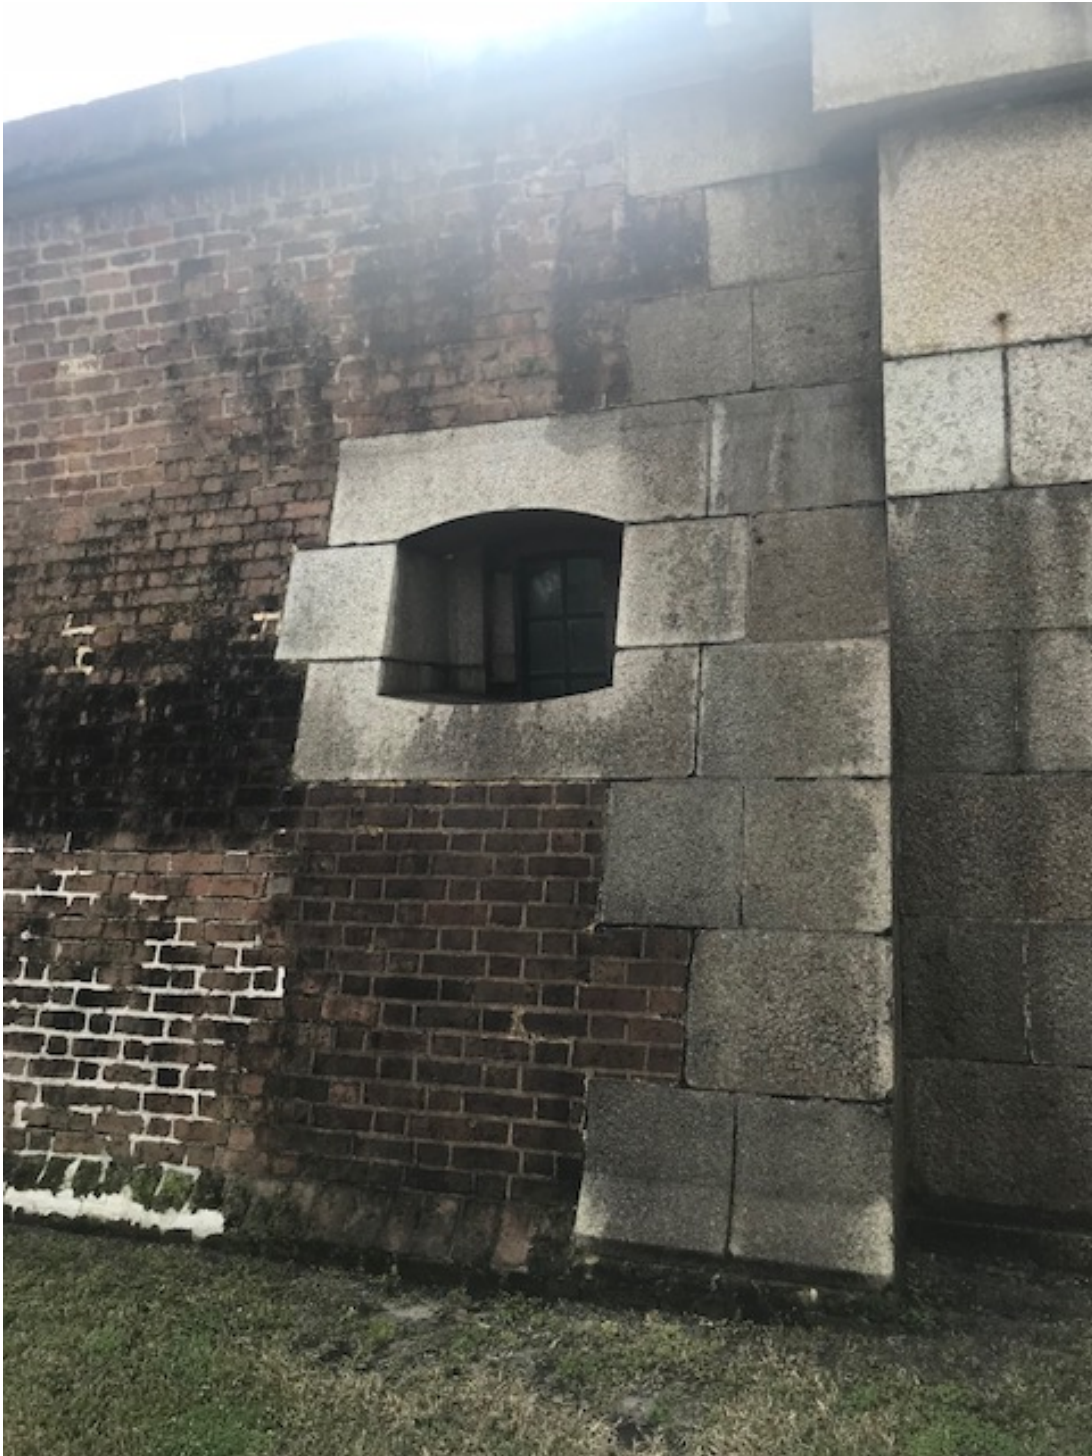
Figure A.55 – *Fort Moultrie entrance stonework* Repointed brick and restored stonework at Fort Moultrie (Image from author).
