Out of the Woods: Facilitating Stewardship of Historic Resources in the National Forest Service

OUT OF THE WOODS: FACILITATING STEWARDSHIP OF HISTORIC
RESOURCES IN THE NATIONAL FOREST SERVICE

A Thesis
Presented to
the Graduate School of
Clemson University and the College of Charleston

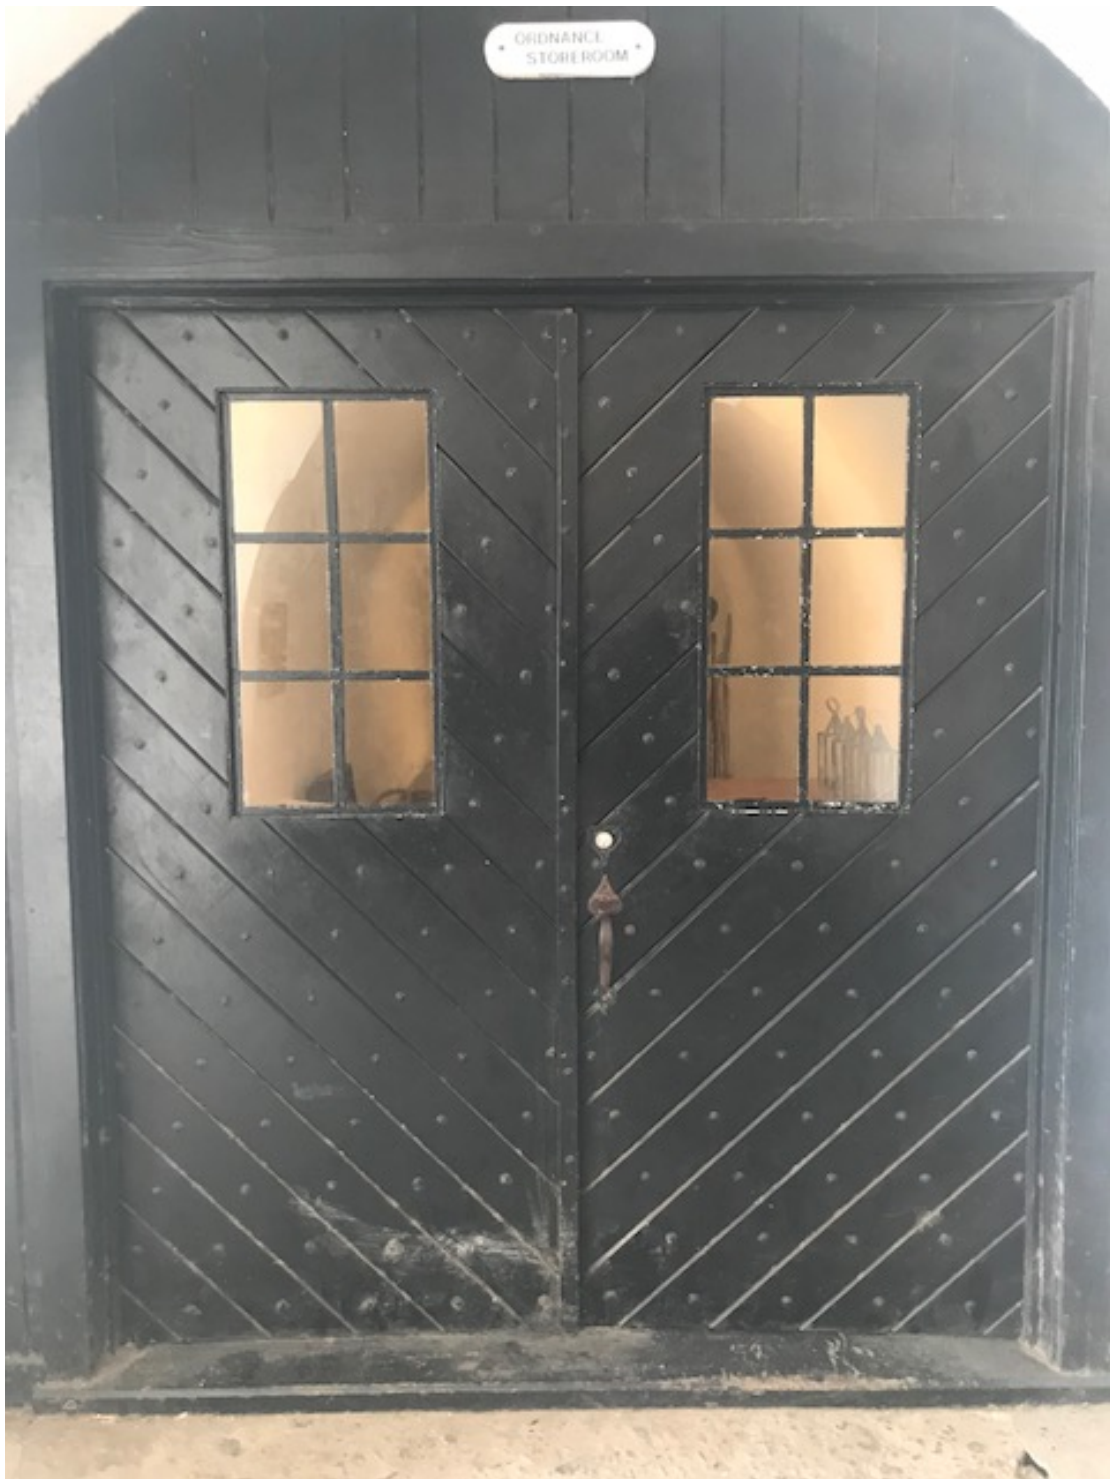
Figure A.56 – *Fort Moultrie wooden door* Restored wooden door to interior room at Fort Moultrie (Image from author).

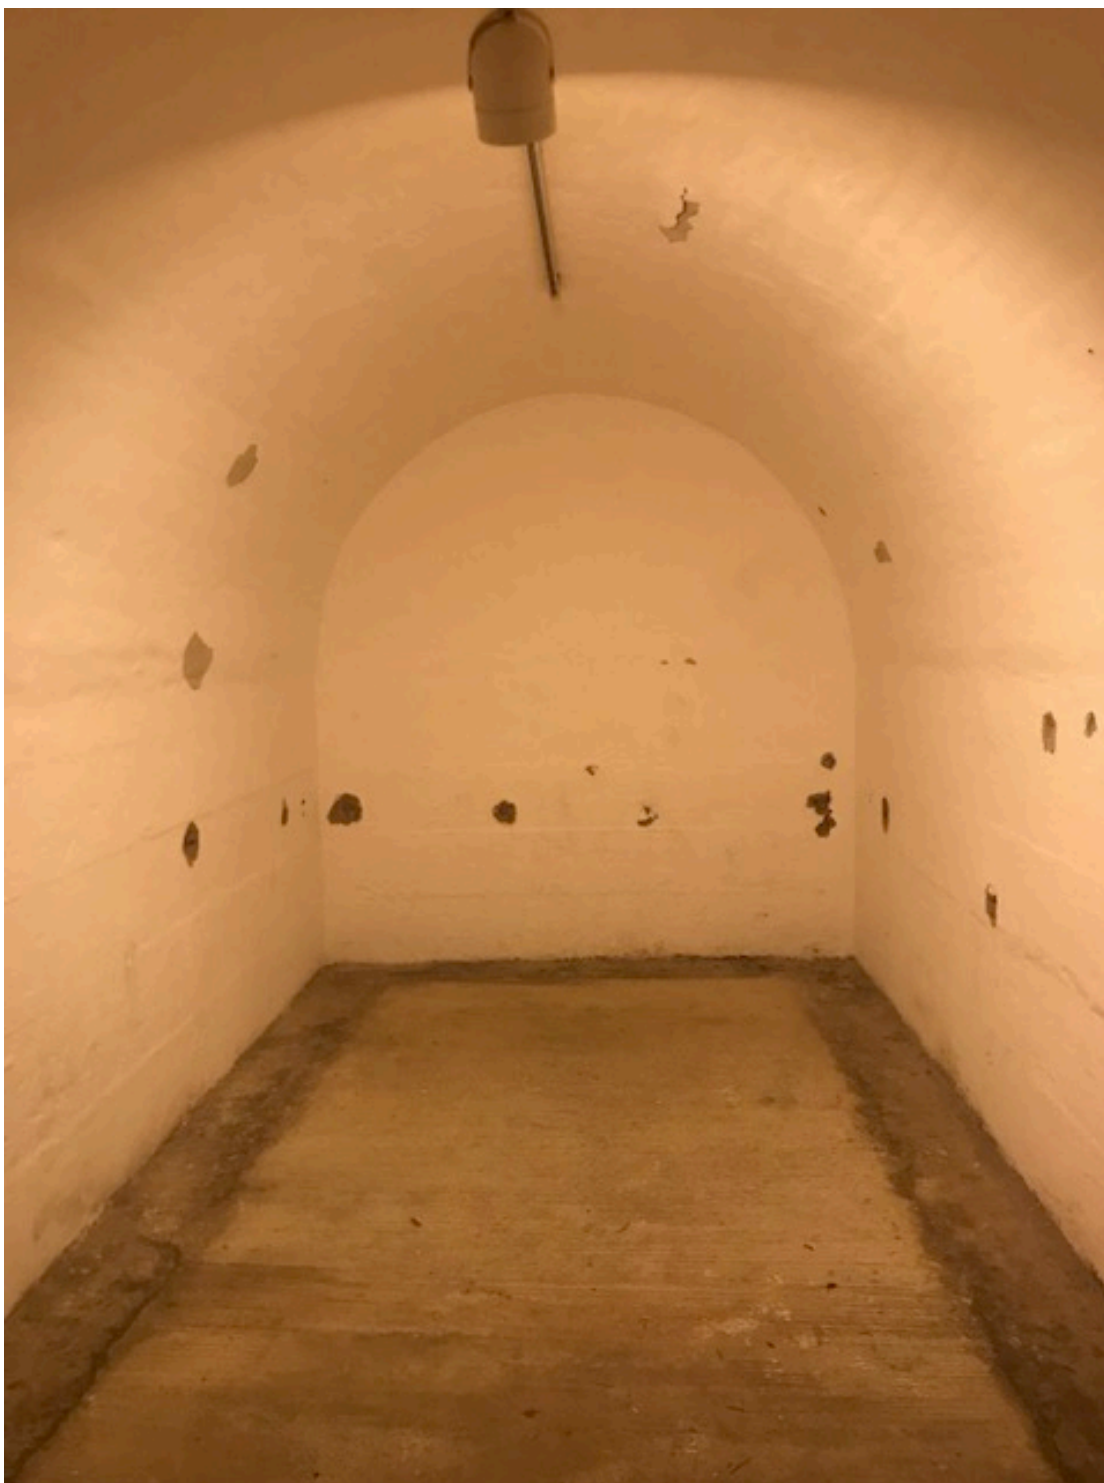
Figure A.57 – *Fort Moultrie interior room A* restored interior room at Fort Moultrie (*Image from author*).

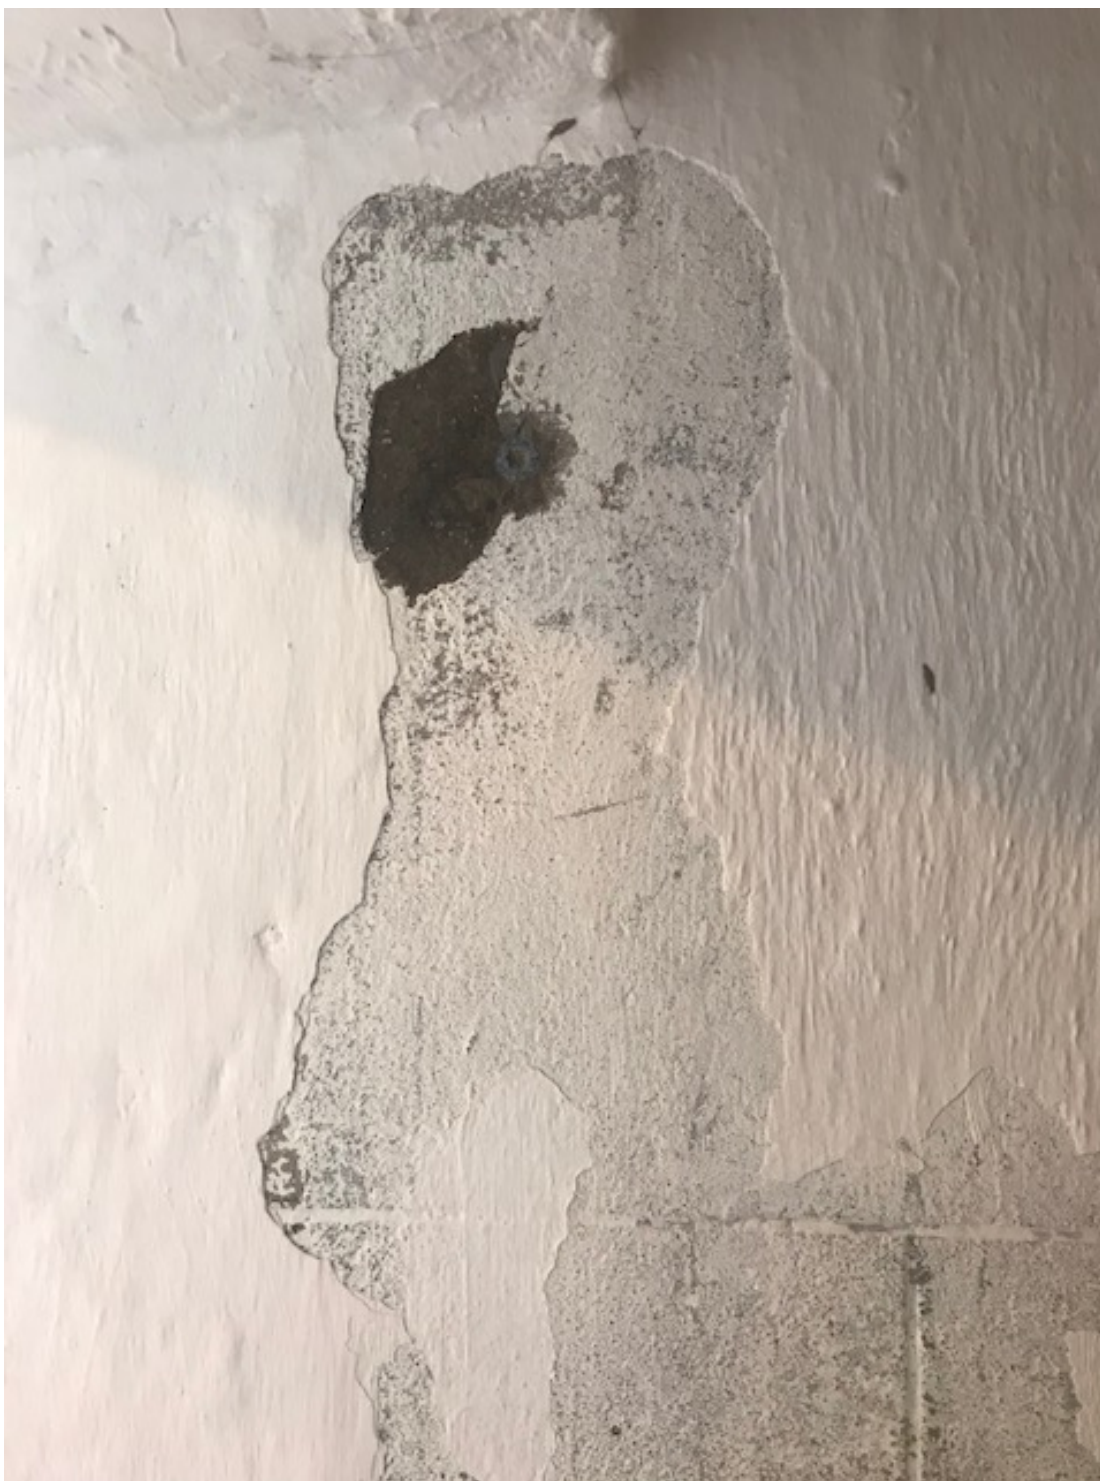
Figure A.58 – *Fort Moultrie peeling paint* Peeling paint on the interior of Fort Moultrie shows the stonework (*Image from author*).

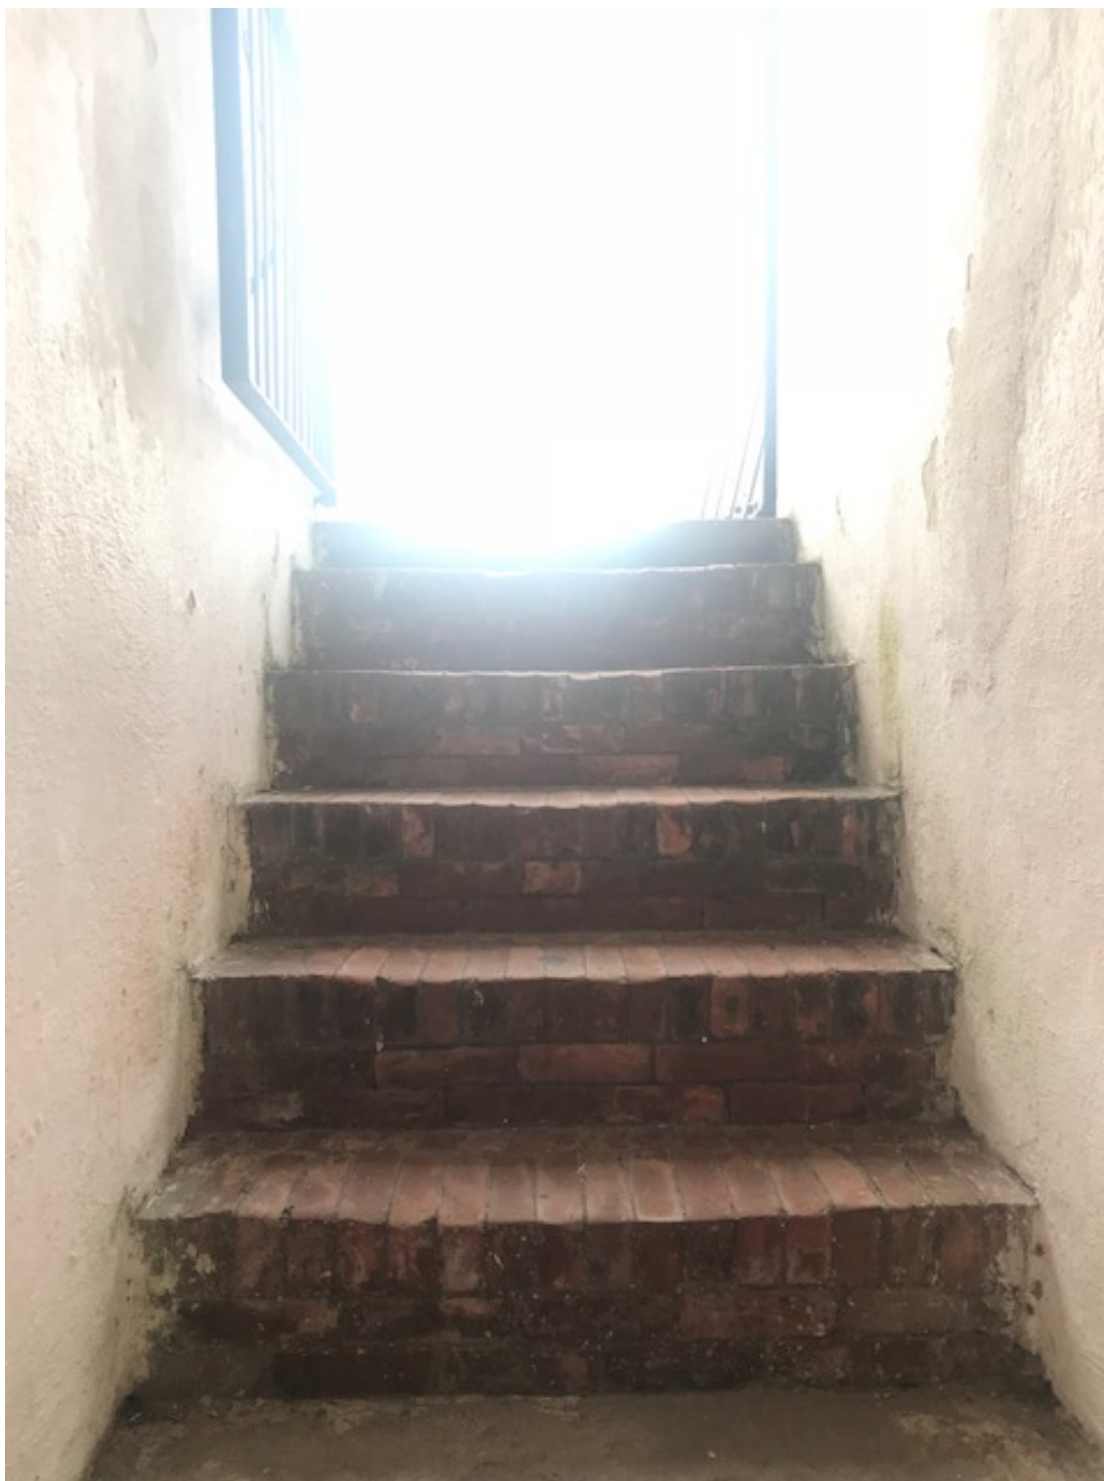
Figure A.59 – *Fort Moultrie brick staircase to exterior* A restored brick staircase leads from the interior to the exterior courtyard at Fort Moultrie (*Image from author*).

8. Staircase(s) (5) historical staircases (brick) are in excellent condition, as are new, wooden ones built to make access easier for visitors

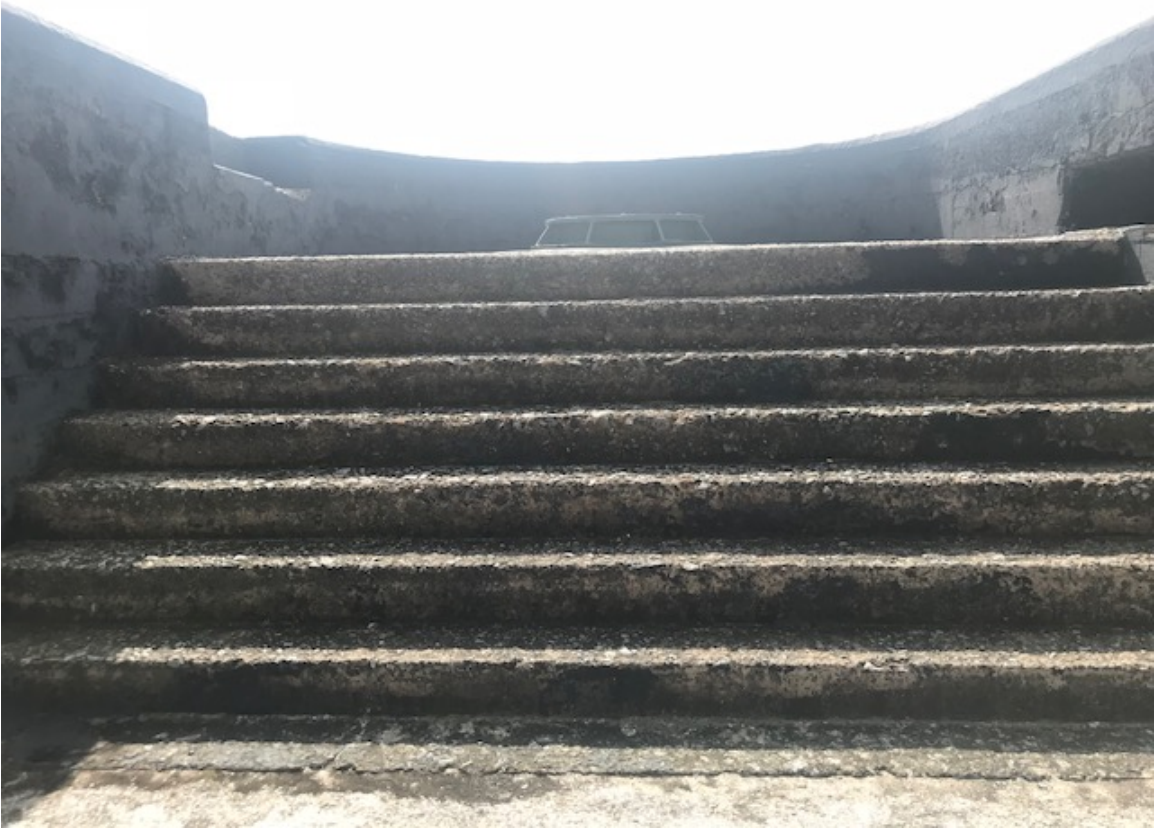
Figure A.60 – *Fort Moultrie exterior stone stairs* Exterior, restored stairs at Fort Moultrie (*Image from author*).

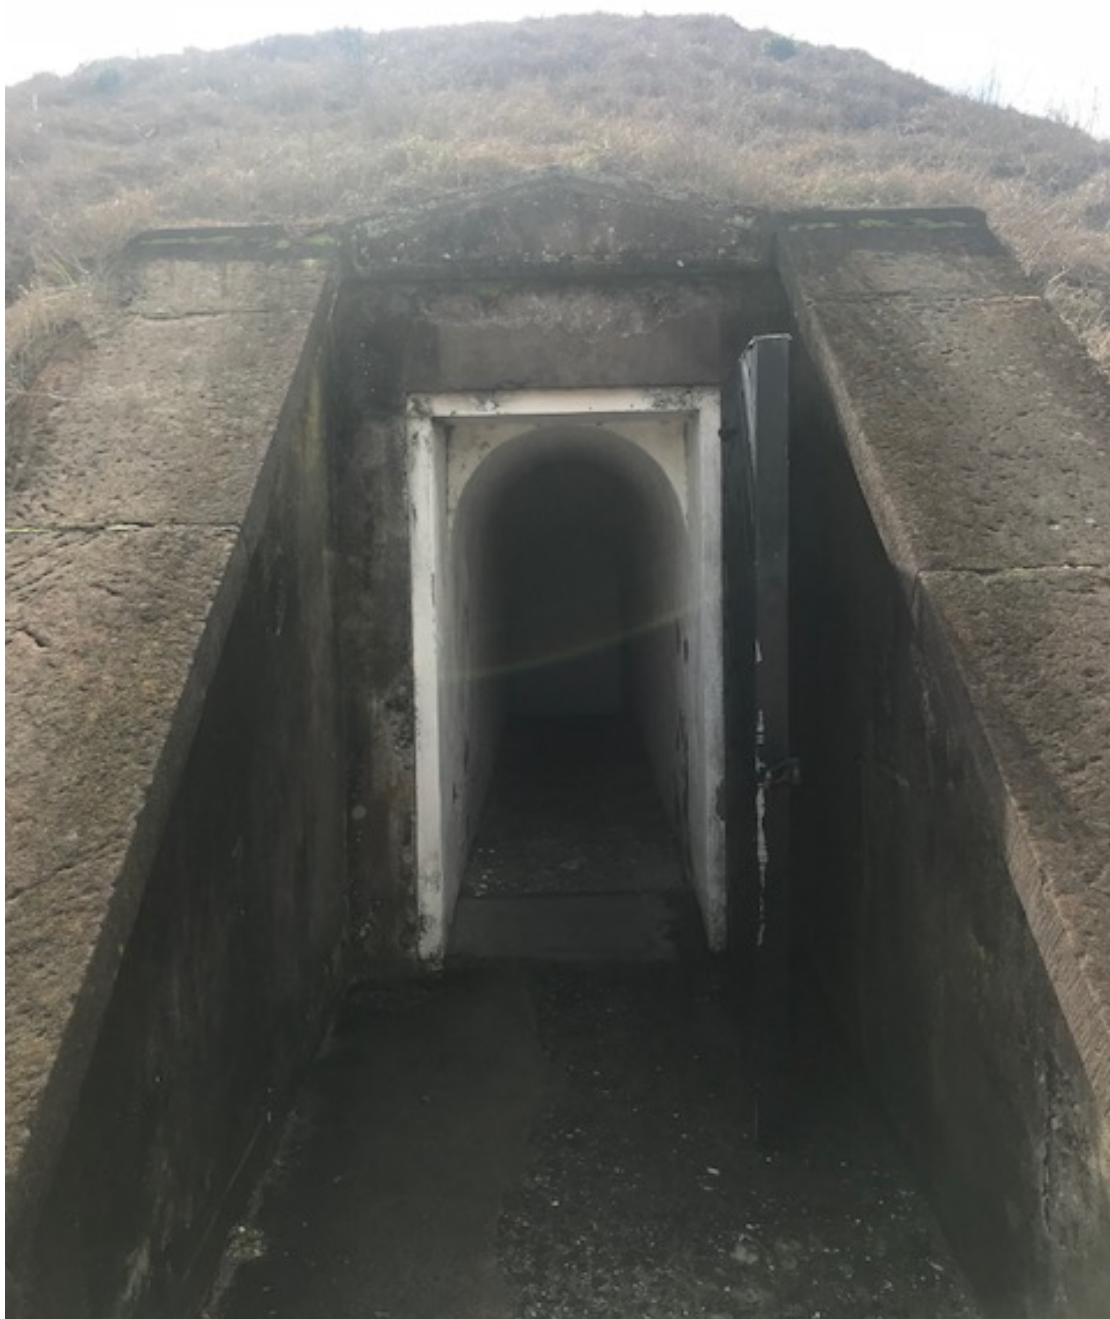
Figure A.61 – *Fort Moultrie arched entrance* An arched entrance in the side of a hill at Fort Moultrie (Image from author).

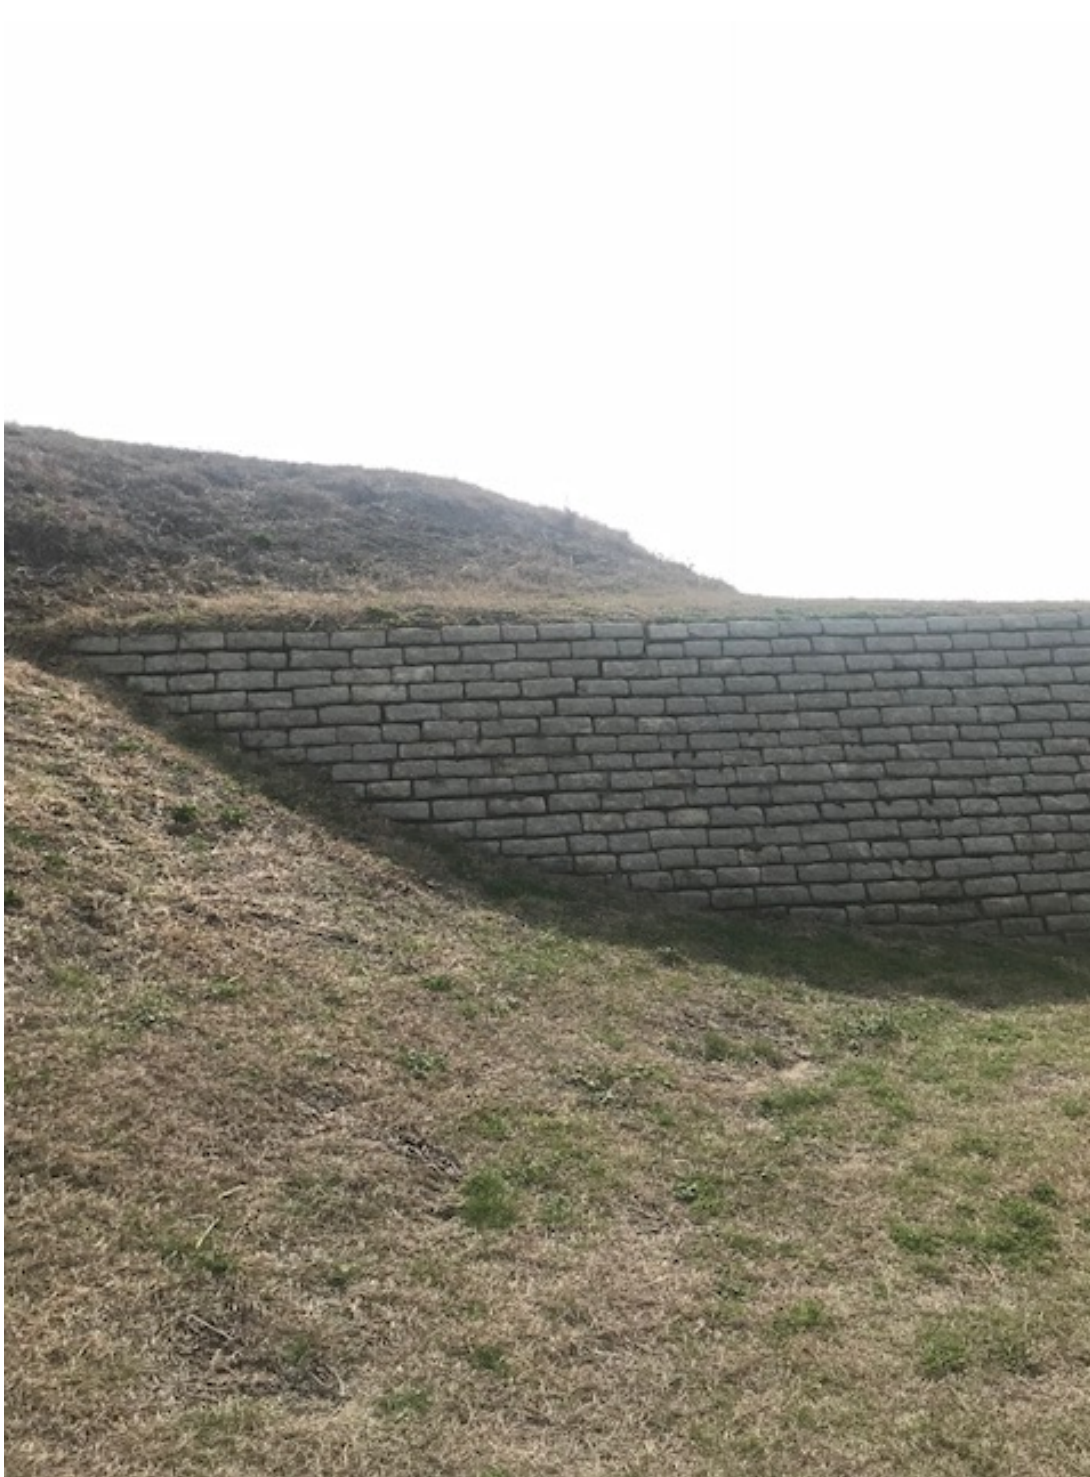
Figure A.62 – *Fort Moultrie stone wall* A stone support wall at Fort Moultrie (*Image from author*).

7. Walls (5) in excellent condition; again, extremely overbuilt due to its intended use

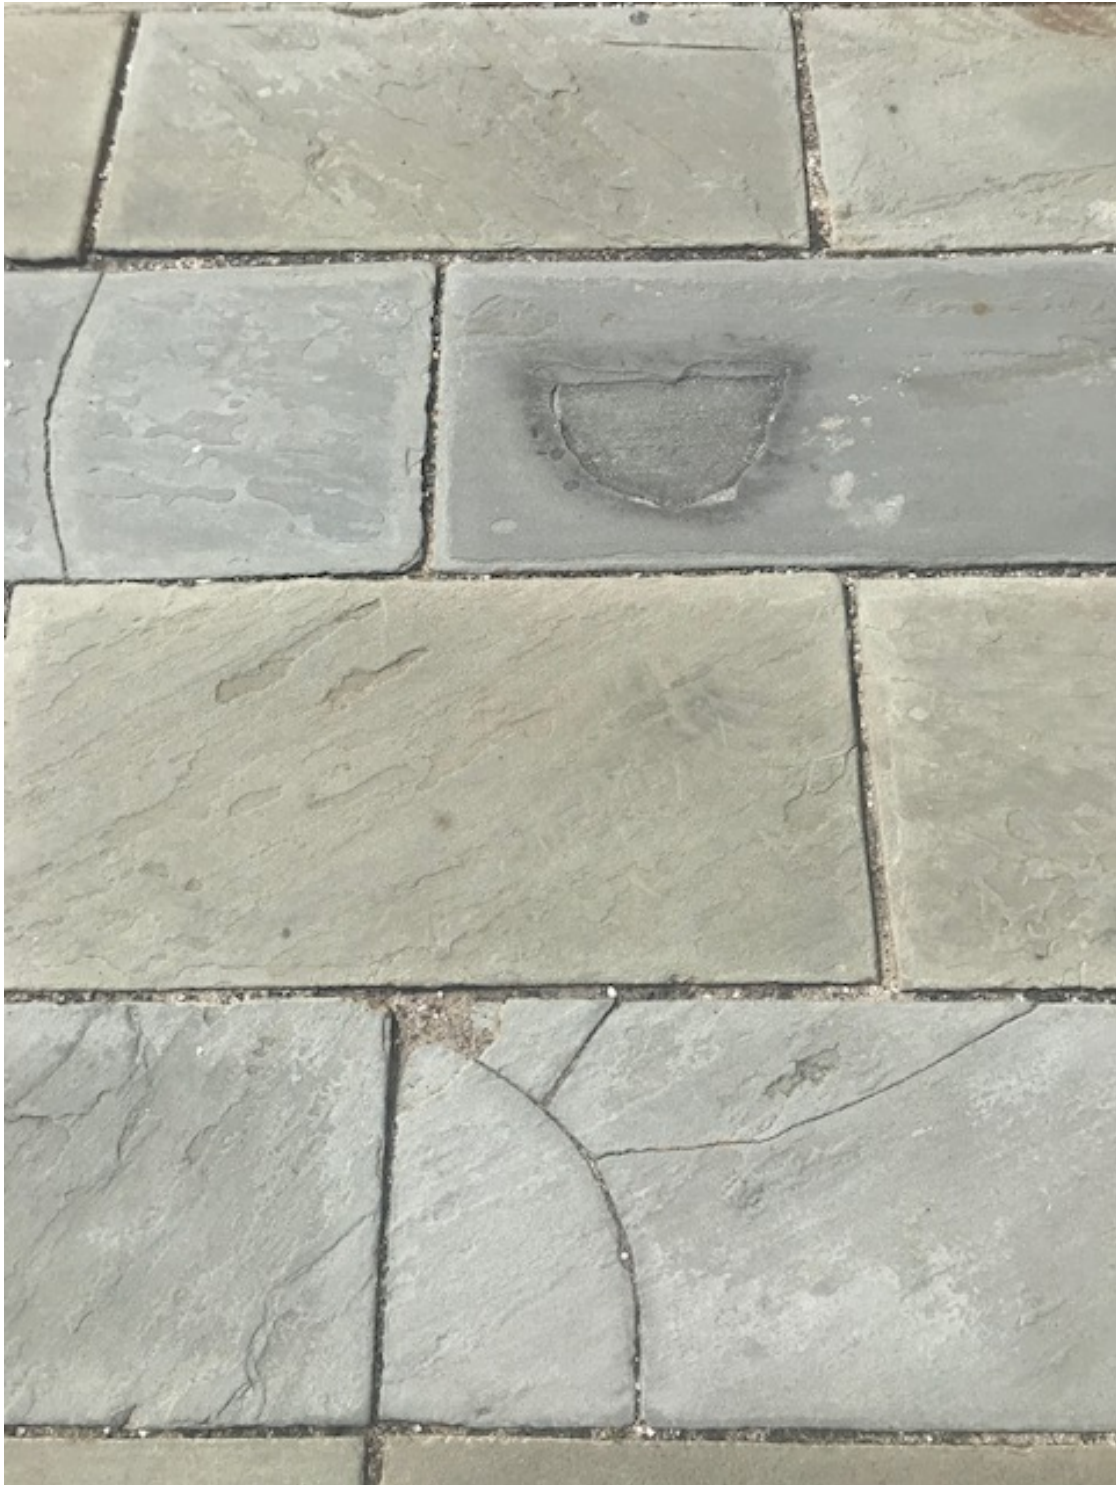
Figure A.63 – *Fort Moultrie bluestone walkway* Bluestone walkway at Fort Moultrie (*Image from author*).

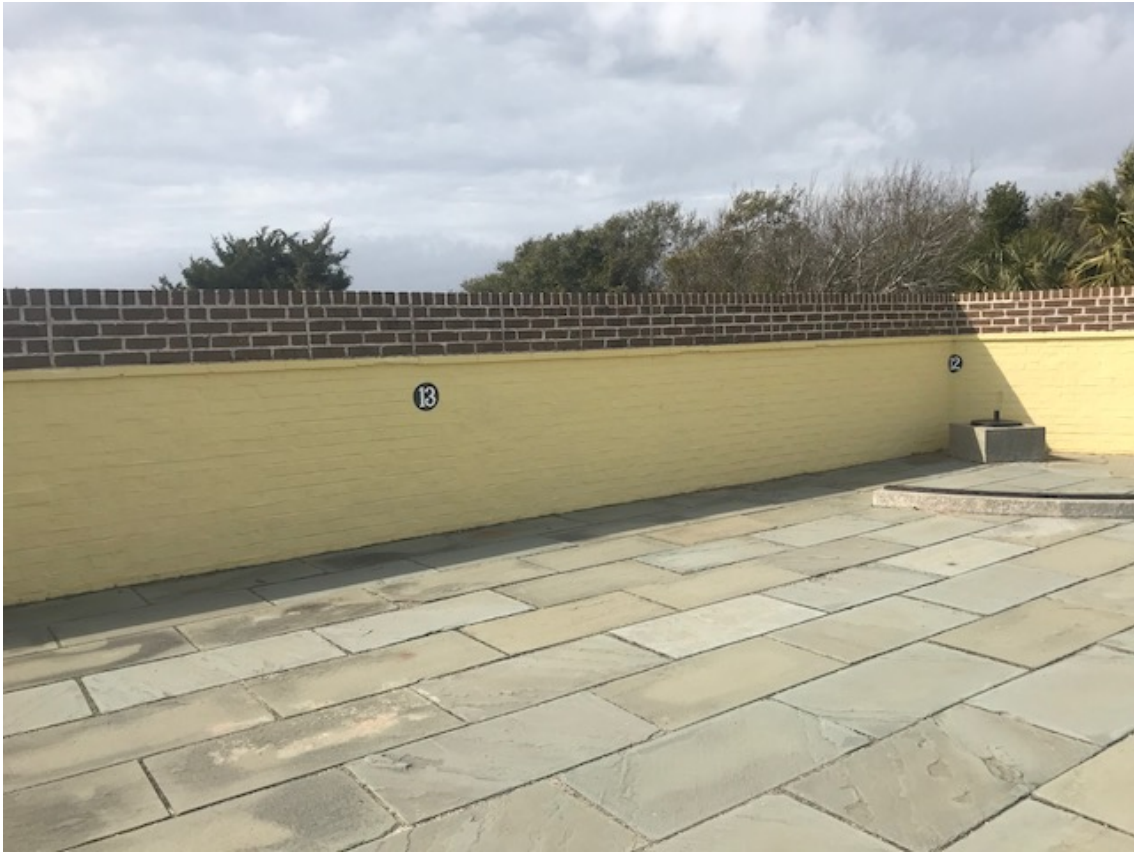
Figure A.64 – *Fort Moultrie perimeter wall* A repointed brick perimeter wall at Fort Moultrie (*Image from author*).

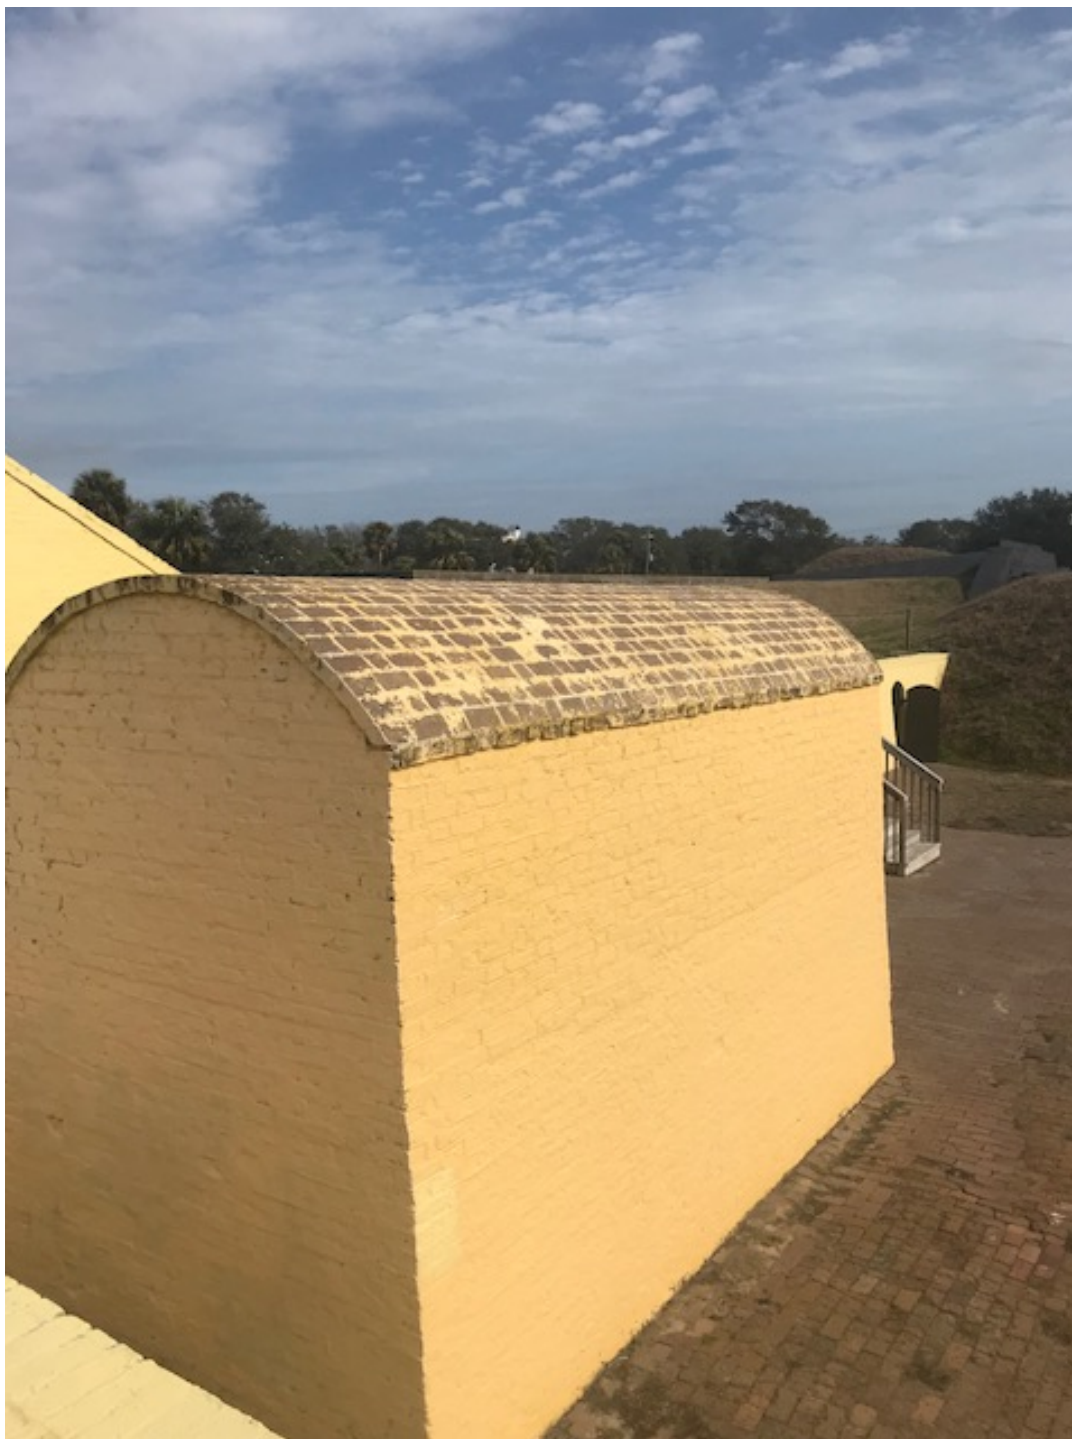
Figure A.65 – *Fort Moultrie vaulted roof* A restored vaulted roof at Fort Moultrie (*Image from author*).

1. Roof (5) mixture of grass, replacement clay tile; in excellent condition

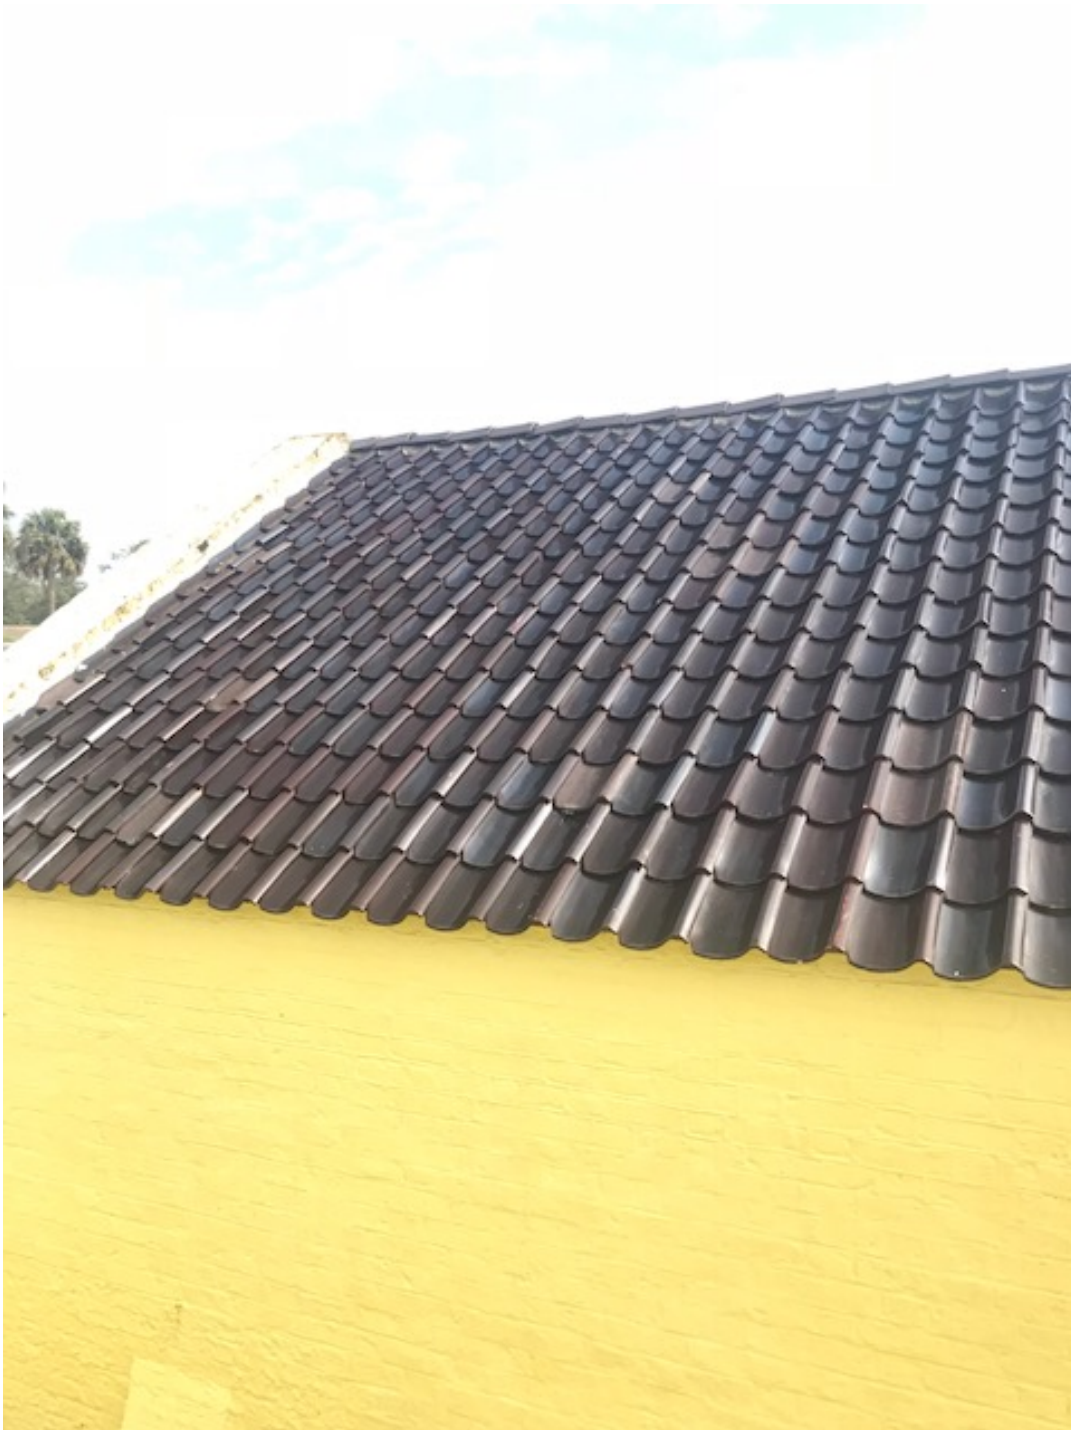
Figure A.66 – *Fort Moultrie roof tile* Replaced roof tile at Fort Moultrie (*Image from author*).

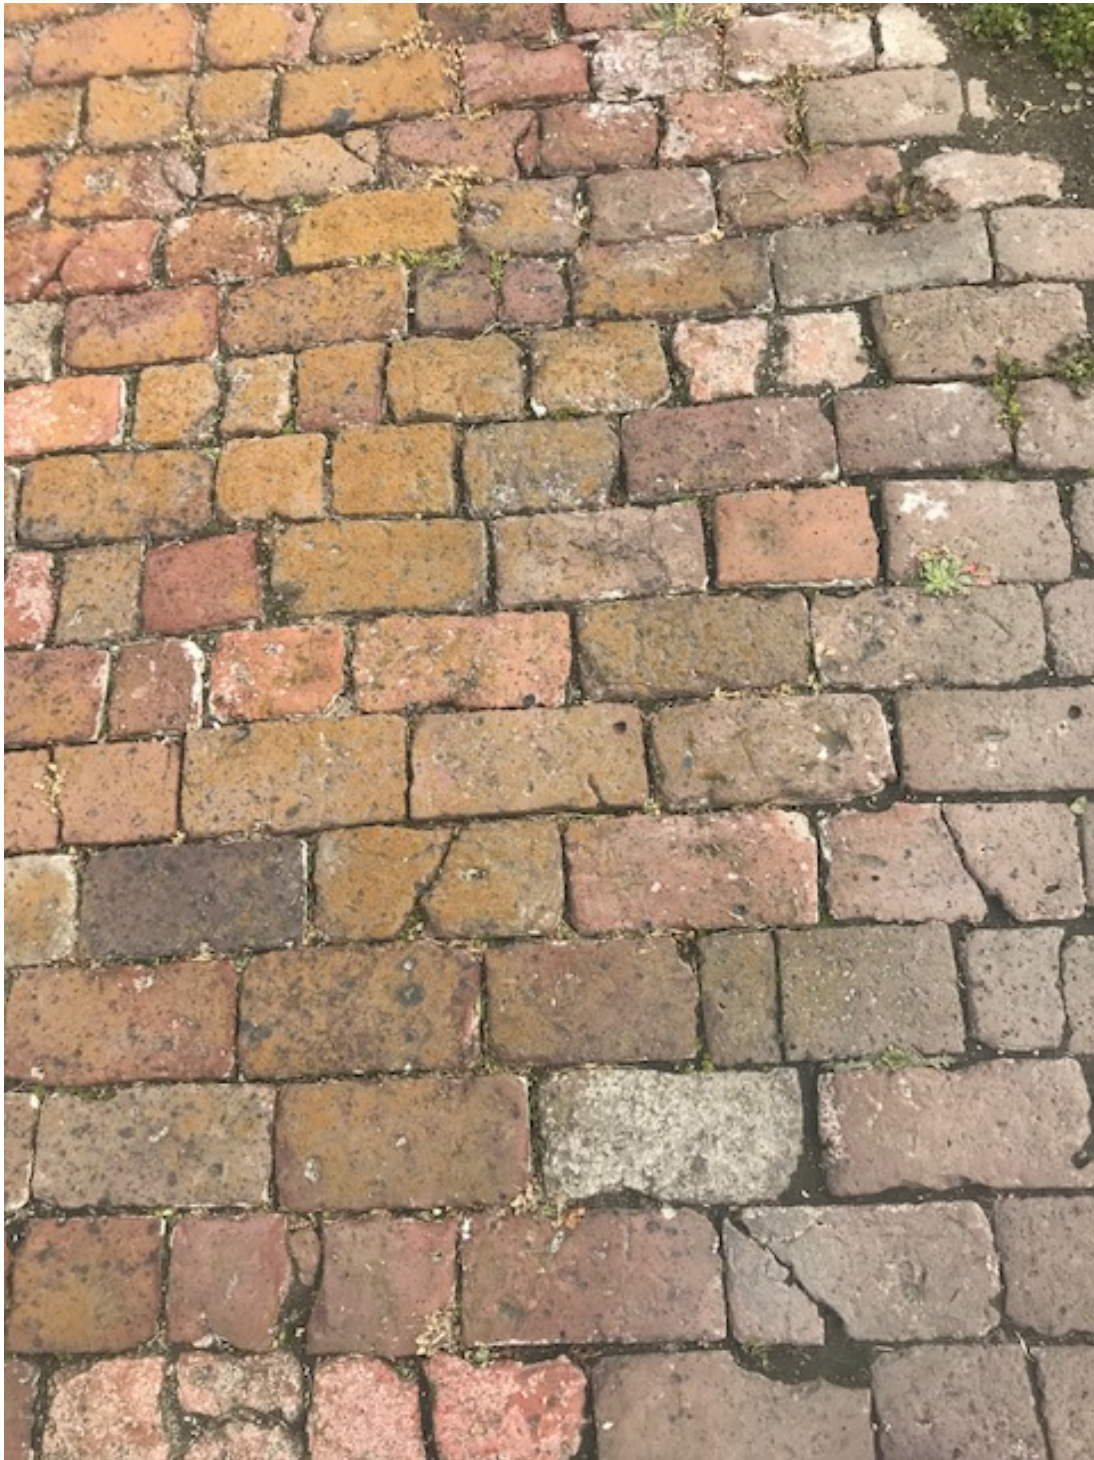
Figure A.67 – *Fort Moultrie brick walkway* Brick walkway entrance at Fort Moultrie (*Image from author*).

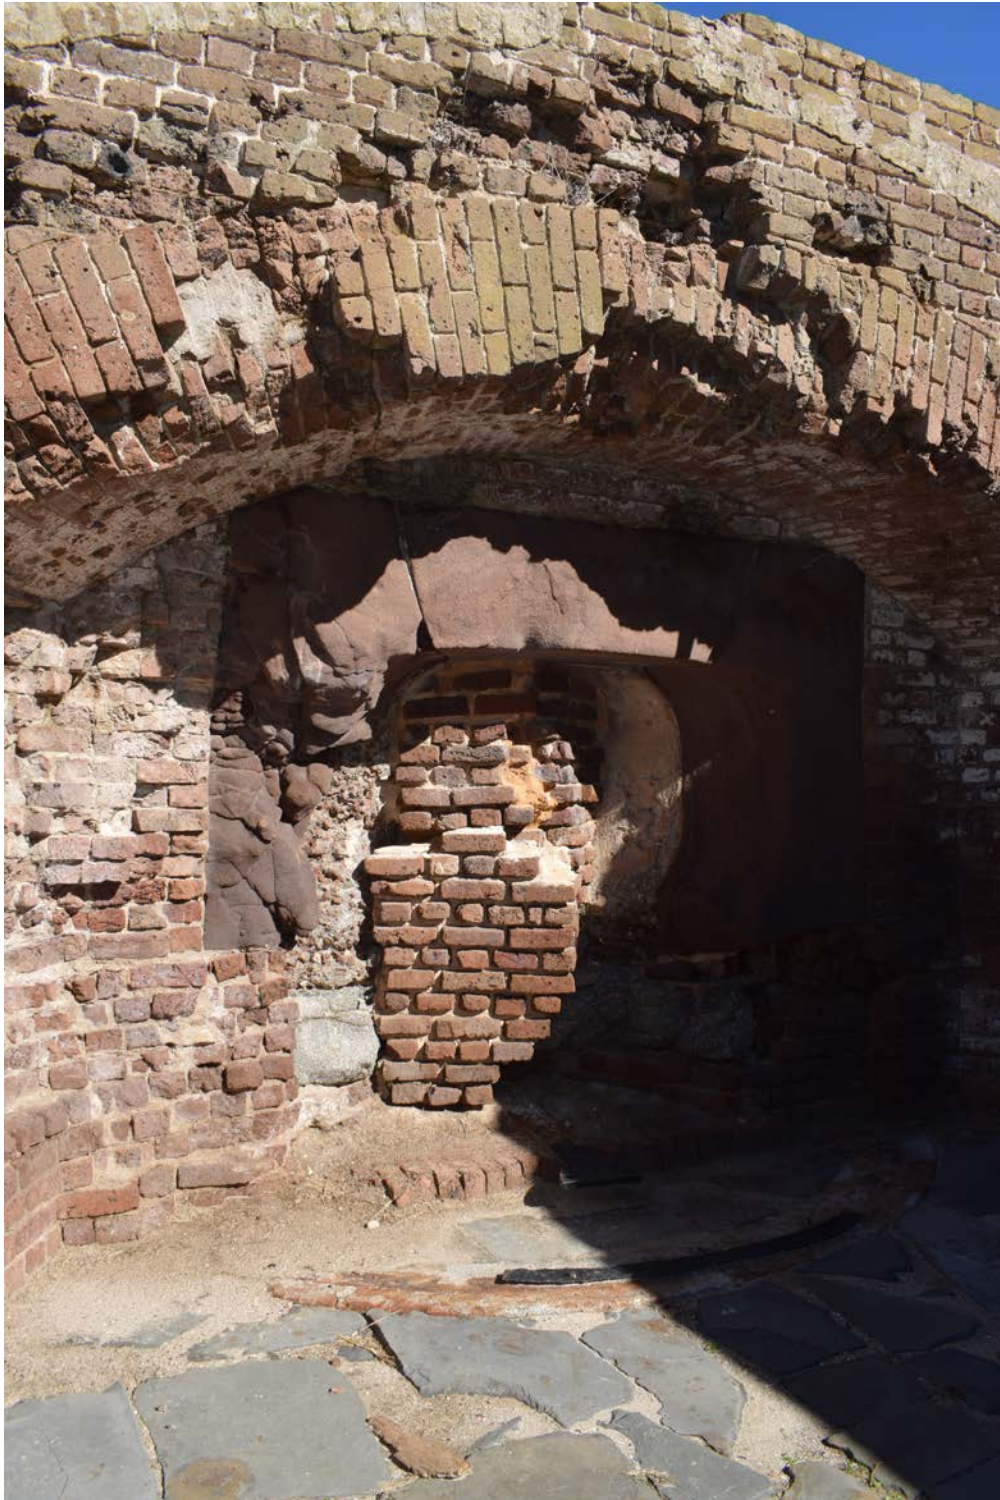
Figure A.68 – *Fort Sumter interior brick wall* A damaged but partially restored brick wall at Fort Sumter (Image from Meghan Olson).

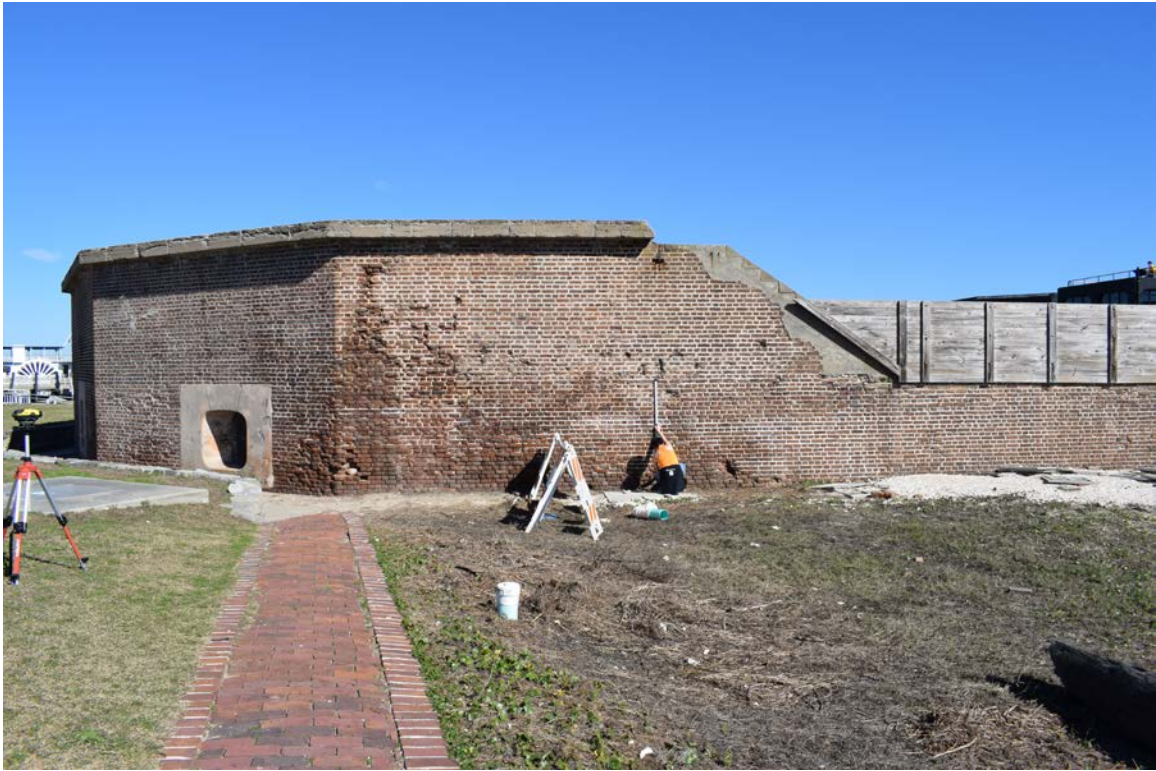
Figure A.69 – *Fort Sumter exterior brick wall* A damaged but partially restored brick wall at Fort Sumter (Image from Meghan Olson).

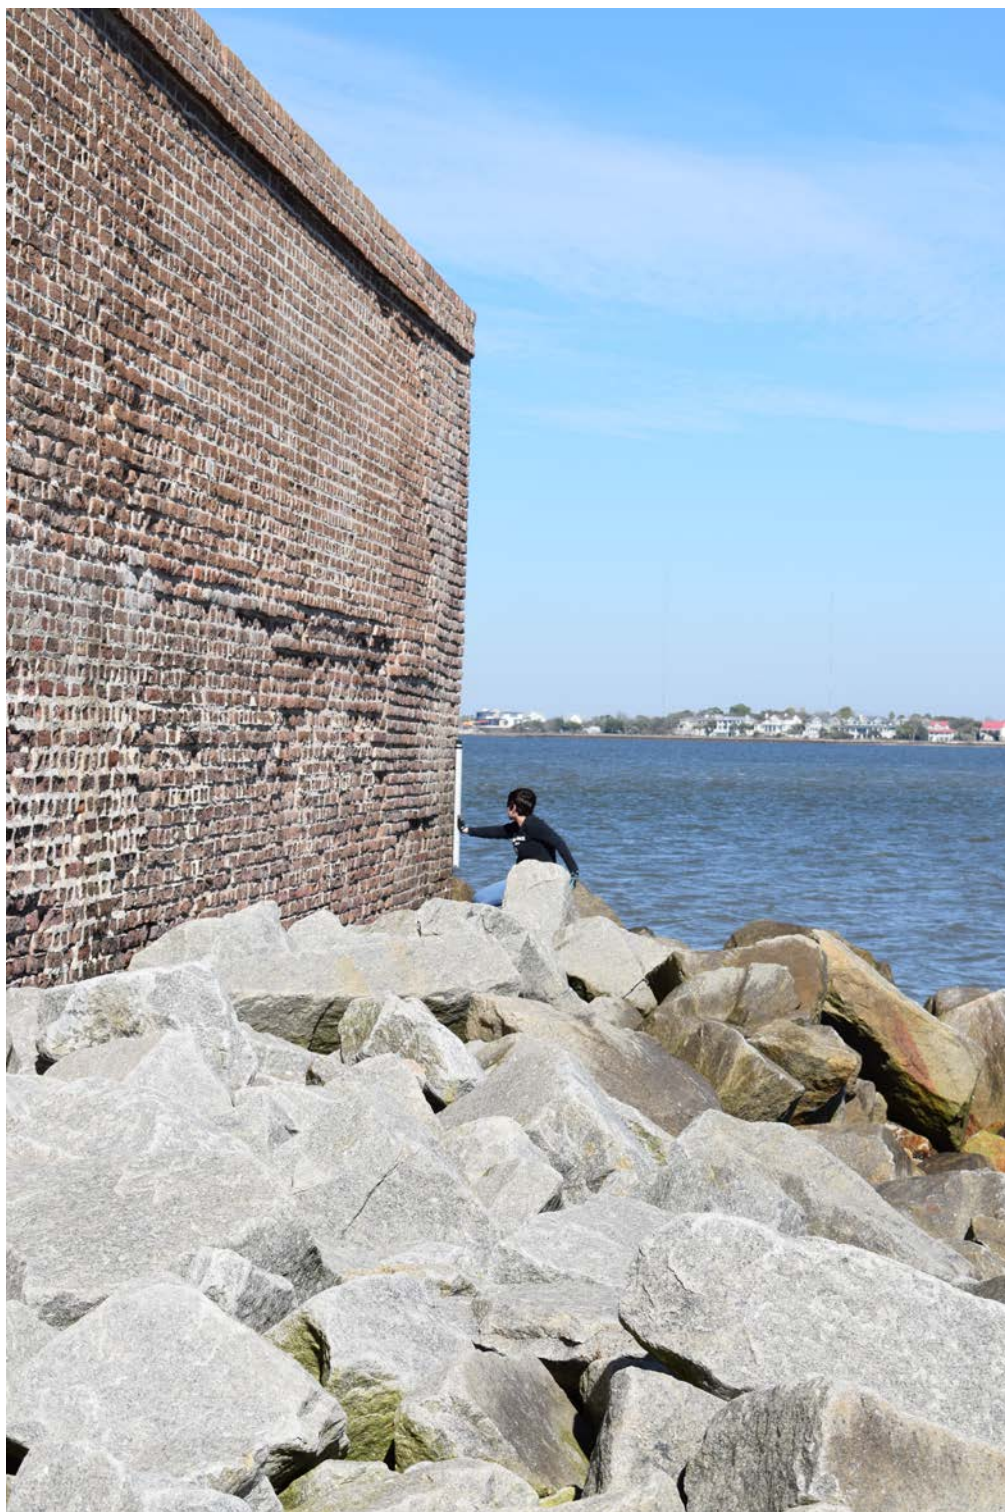
Figure A.70 – *Fort Sumter damaged harbor wall* A damaged wall at Fort Sumter (Image from Meghan Olson).
