Out of the Woods: Facilitating Stewardship of Historic Resources in the National Forest Service

OUT OF THE WOODS: FACILITATING STEWARDSHIP OF HISTORIC
RESOURCES IN THE NATIONAL FOREST SERVICE

A Thesis
Presented to
the Graduate School of
Clemson University and the College of Charleston

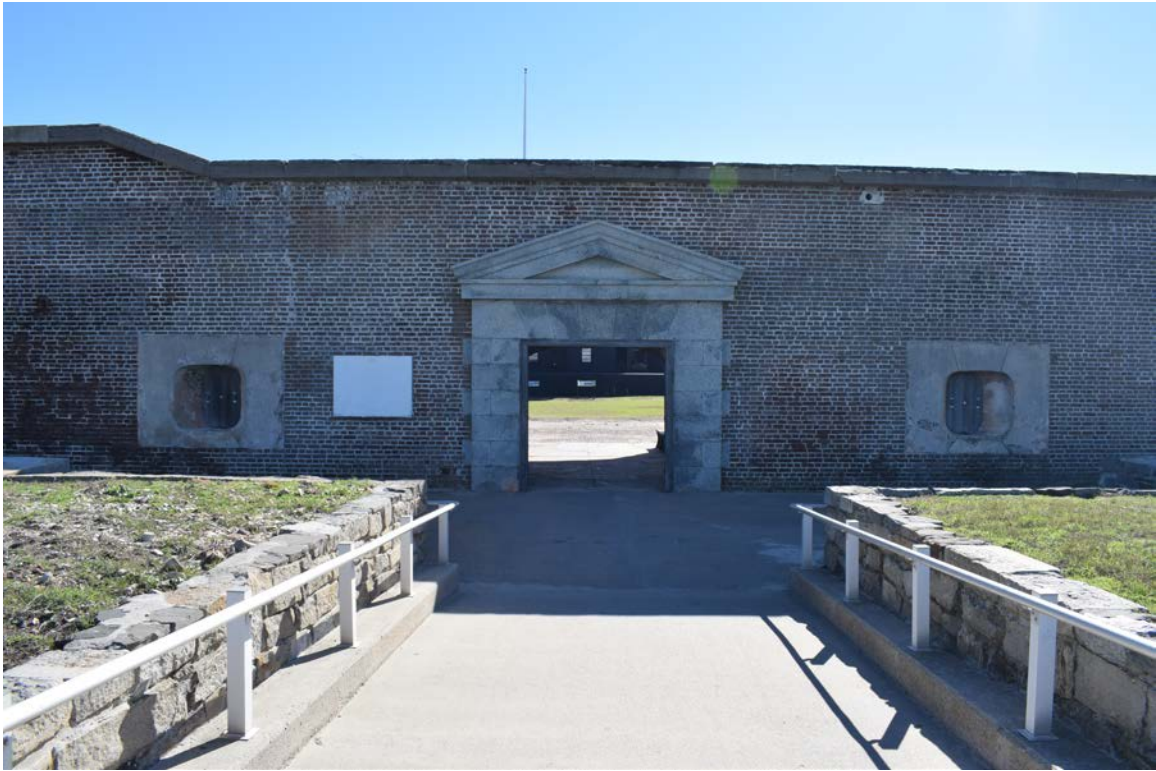
Figure A.71 – *Fort Sumter entrance* The restored, decorative stone entrance at Fort Sumter (*Image from Meghan Olson*).

- 4. Porch (n/a)** fortification; no porches
- 5. Decorative Elements (5)** the simple, decorative elements that are in place (triangular pediments above Fort entrance) are in excellent condition and have clearly been restored

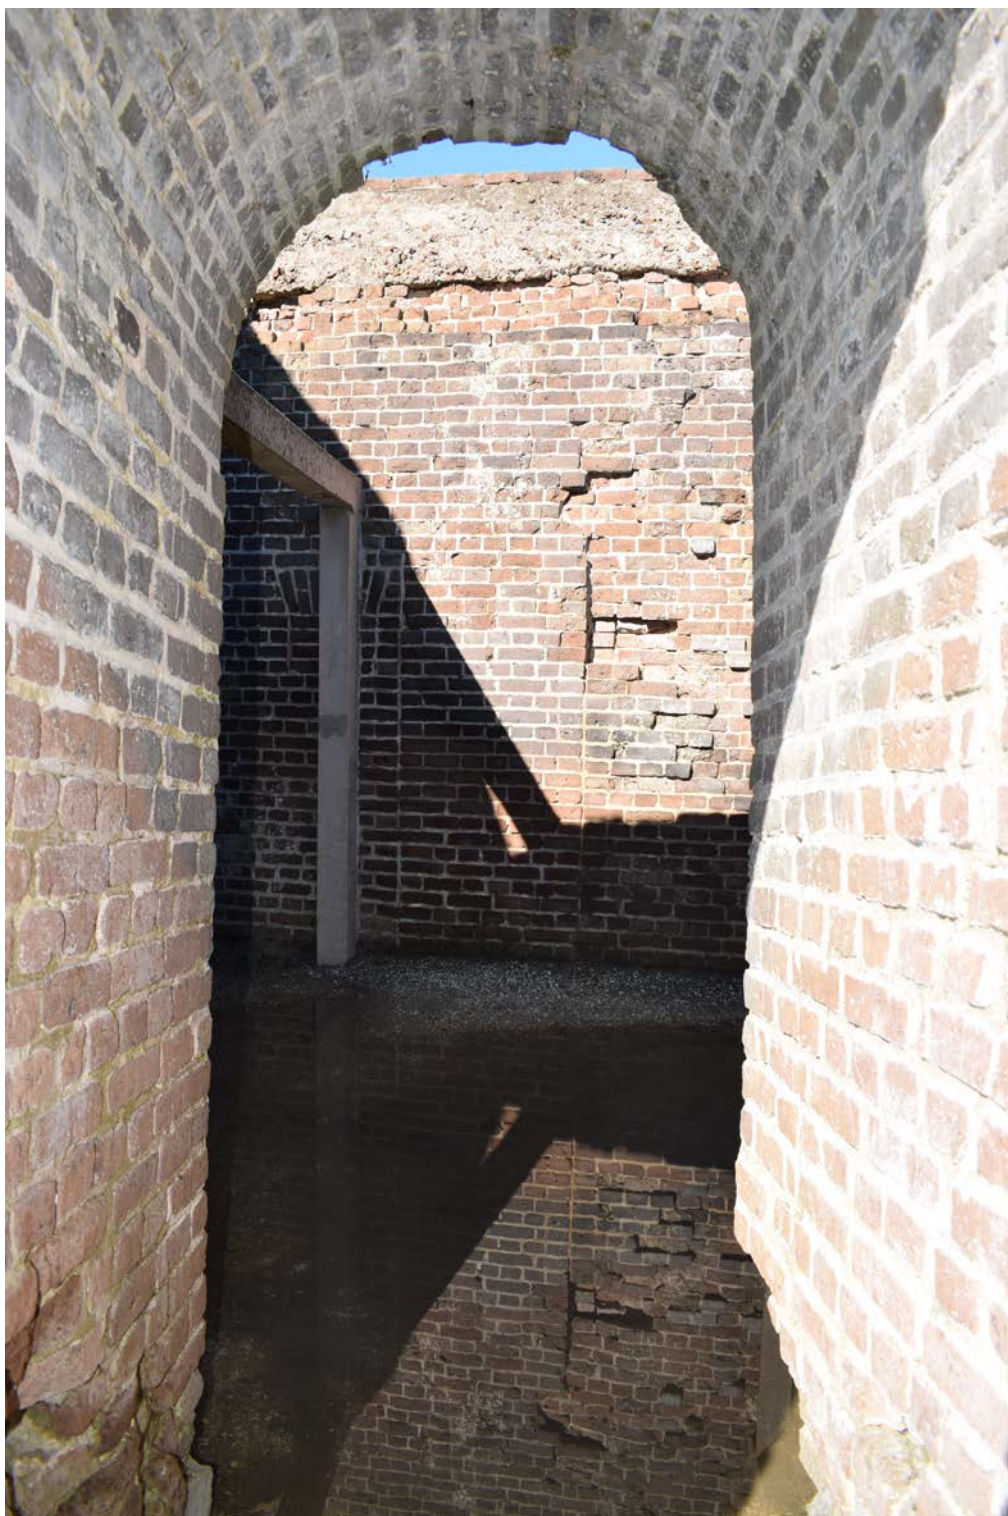
Figure A.72 – Flooding at Fort Sumter Interior flooding at Fort Sumter (Image from Meghan Olson).

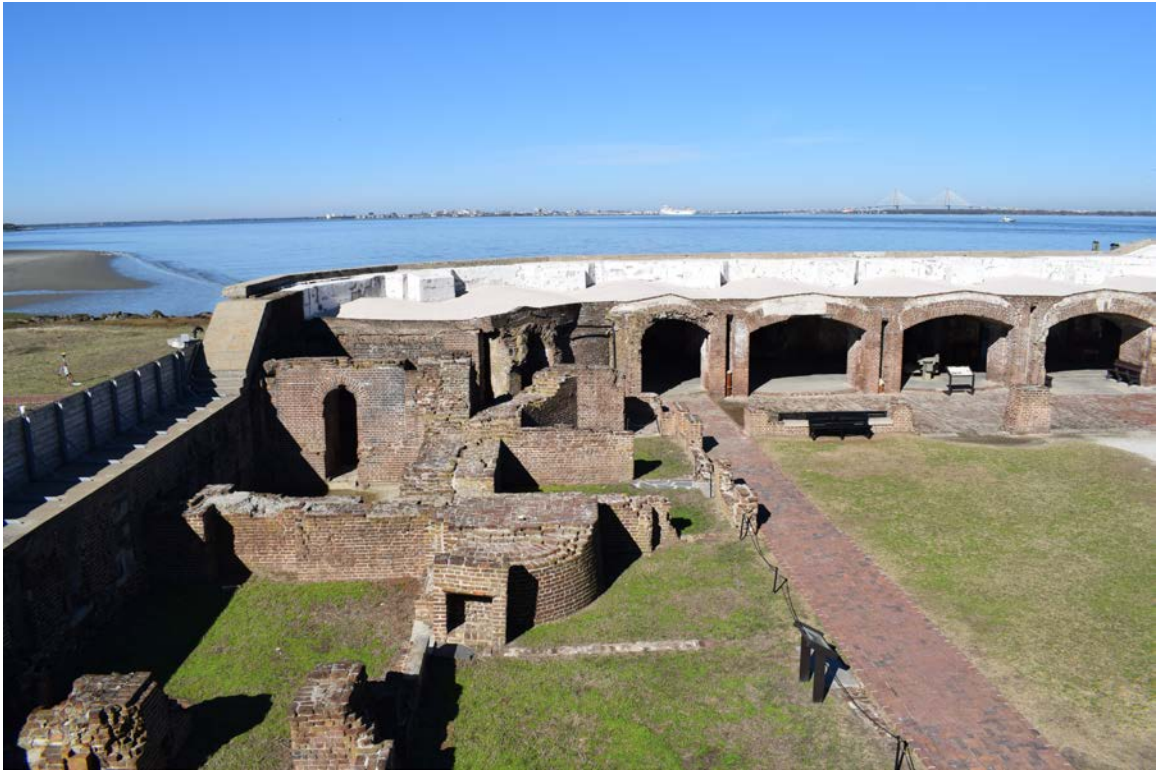
Figure A.73 – *Fort Sumter roof* Notice the repaired roof over the arched first floor (*Image from Meghan Olson*).

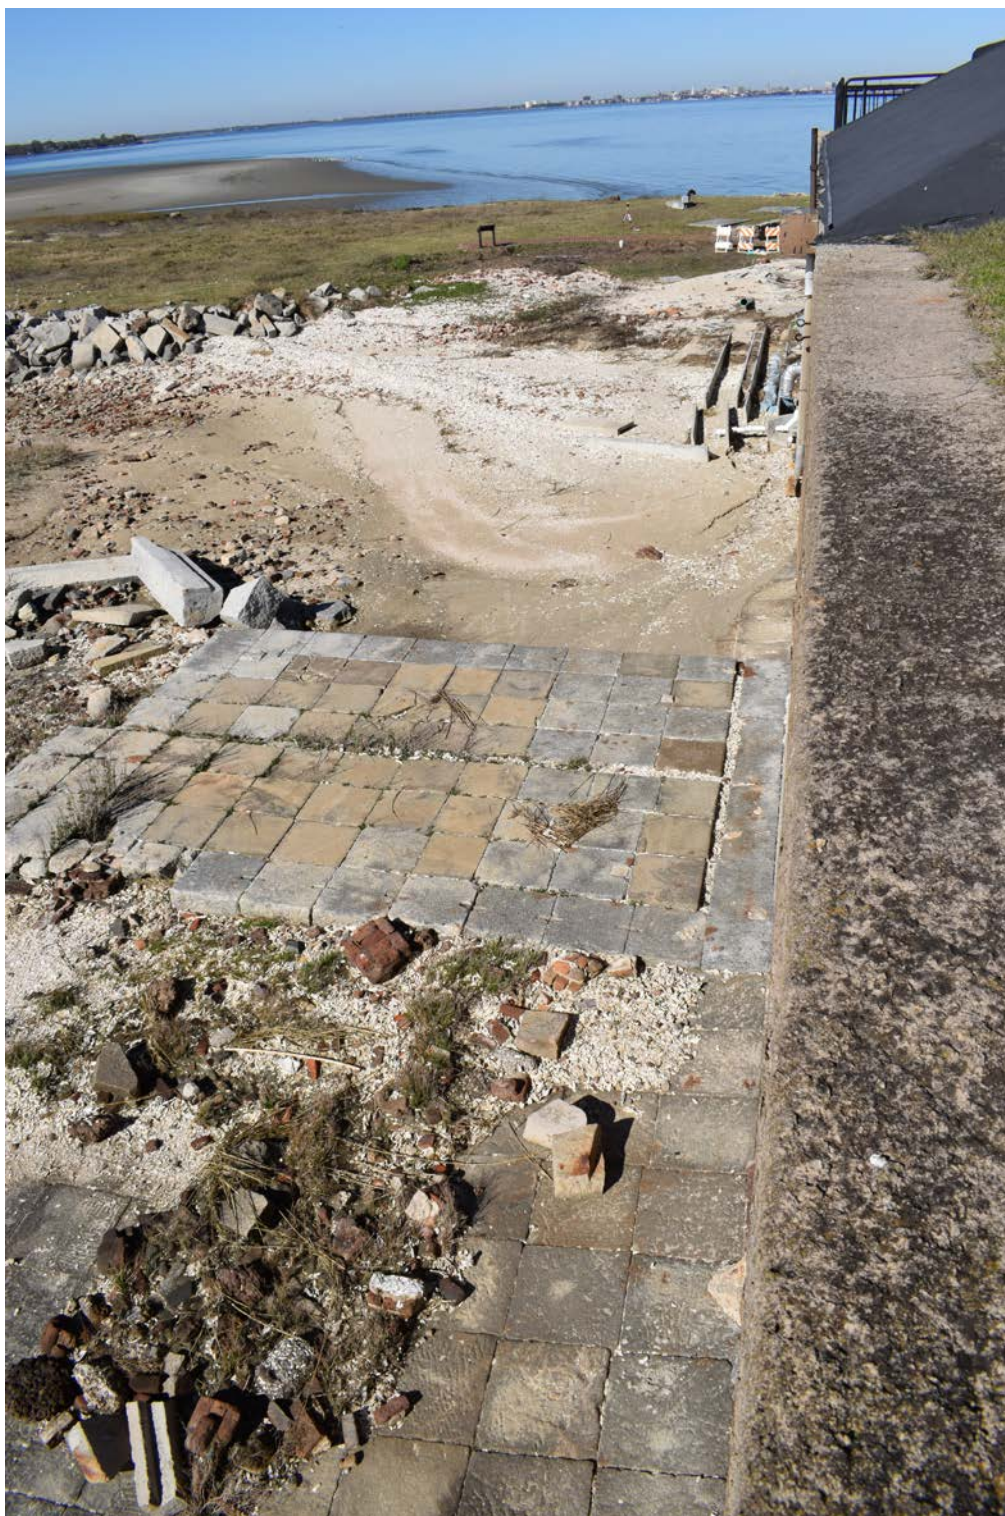
Figure A.74 – Debris at Fort Sumter Debris beside Battery Huger at Fort Sumter (*Image from Meghan Olson*).

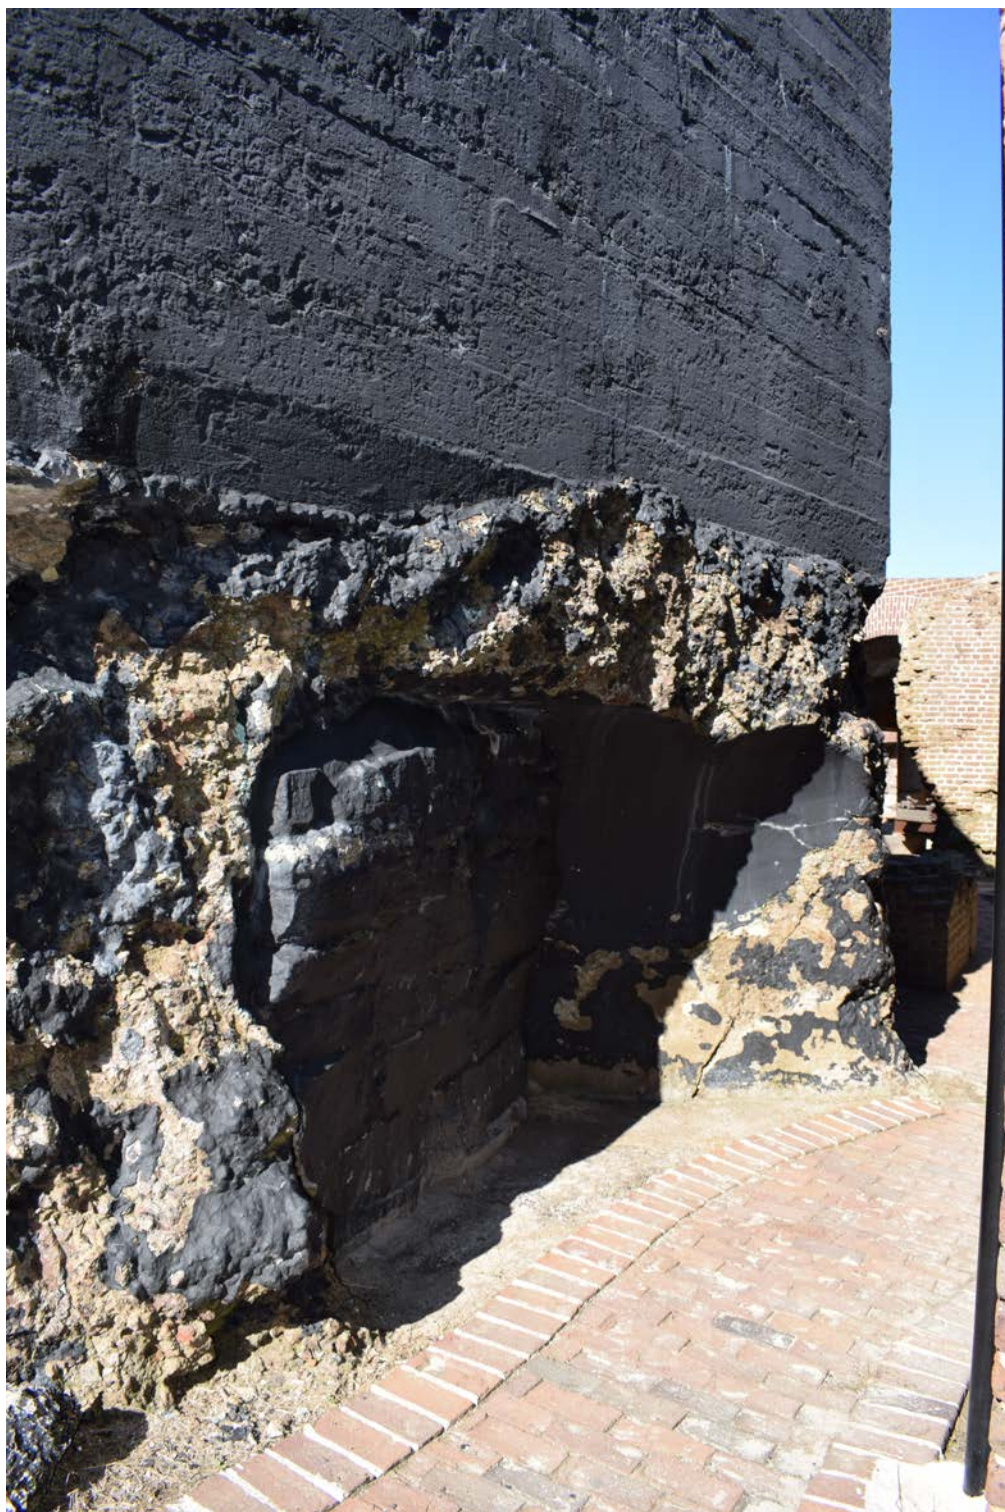
Figure A.75 – *Damaged Battery Huger at Fort Sumter* Visible structural damage to Battery Huger at Fort Sumter (Image from Meghan Olson).

The Charles Pinckney House, Fort Moultrie, and Scruggs Cabin all scored averages of 5 on existing conditions, whereas Fort Sumter received a 4.42 average score due to its structural damage of exterior walls as well as damage to Battery Huger. The Charles Pinckney House, Fort Moultrie, and Scruggs Cabin have all been fully restored.⁴²

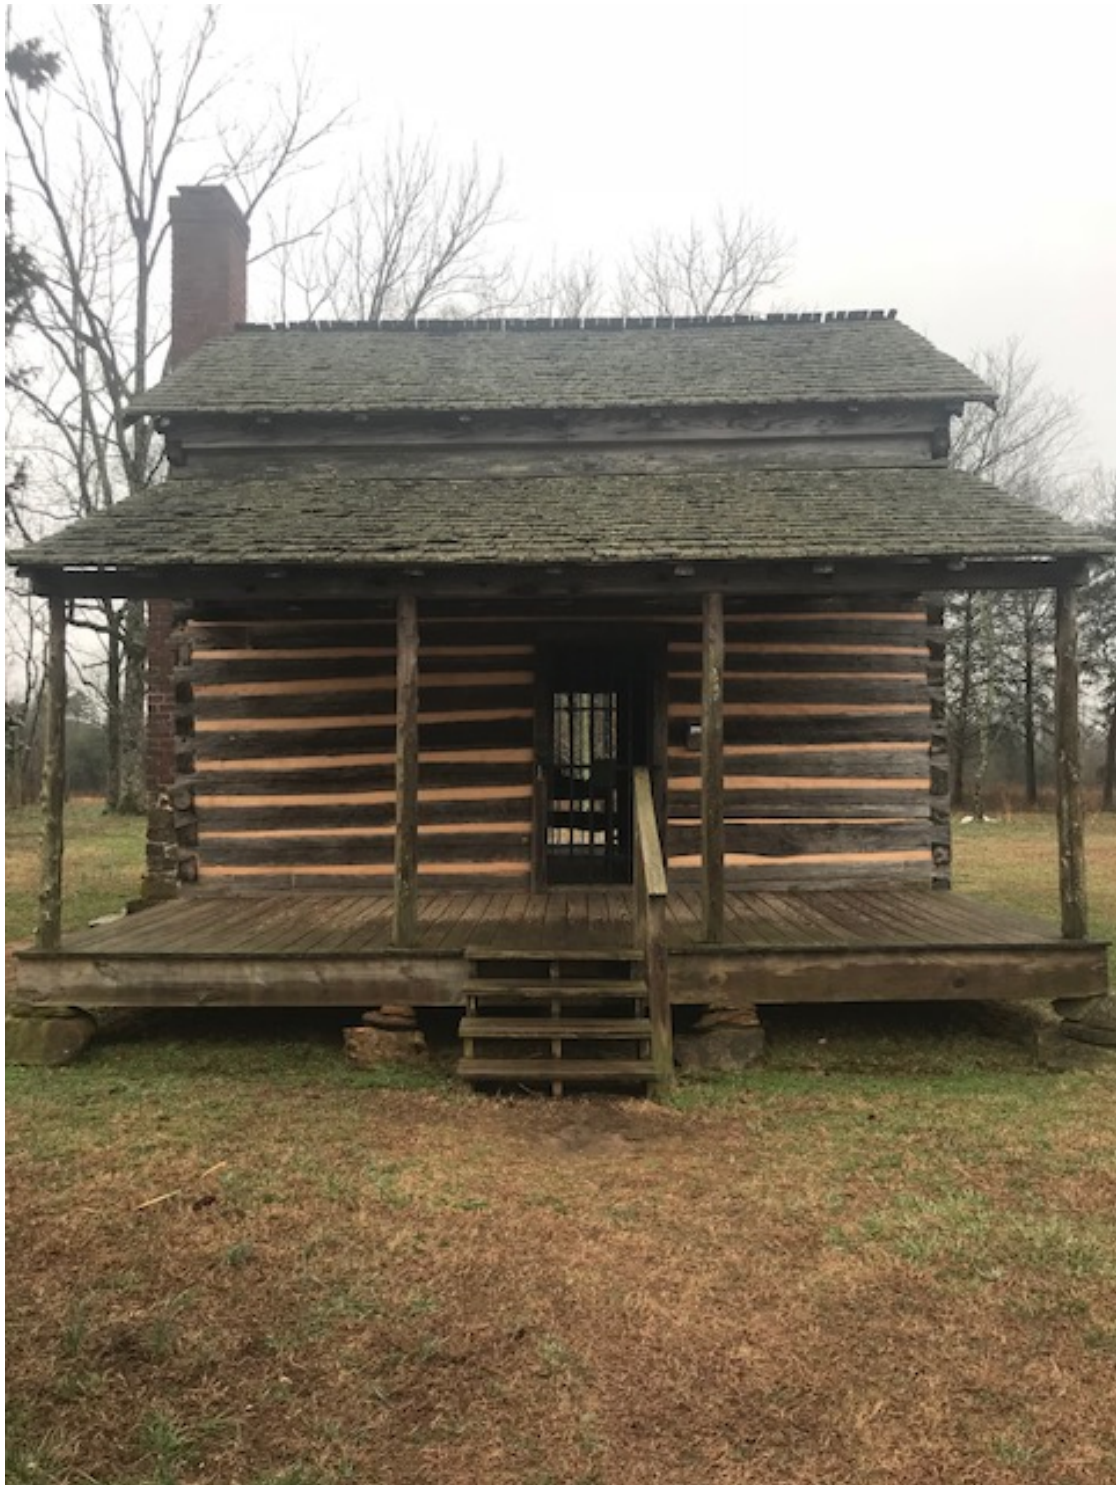
Figure A.76 –*Scruggs Cabin front facade* The restored front elevation of Scruggs Cabin at Cowpens National Battlefield (*Image from author*).

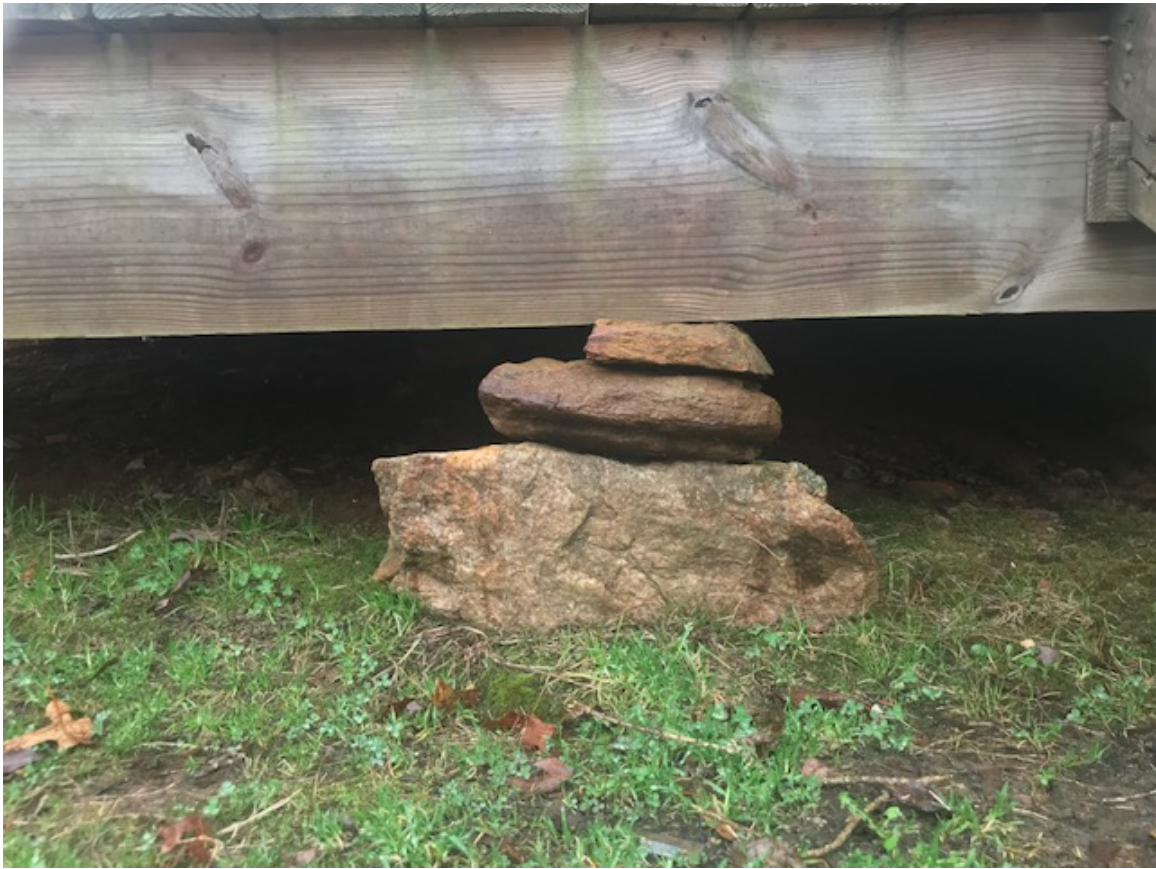
Figure A.77 –*Scruggs Cabin rock foundation* The restored Scruggs Cabin is elevated from the ground by piles of stones (*Image from author*).

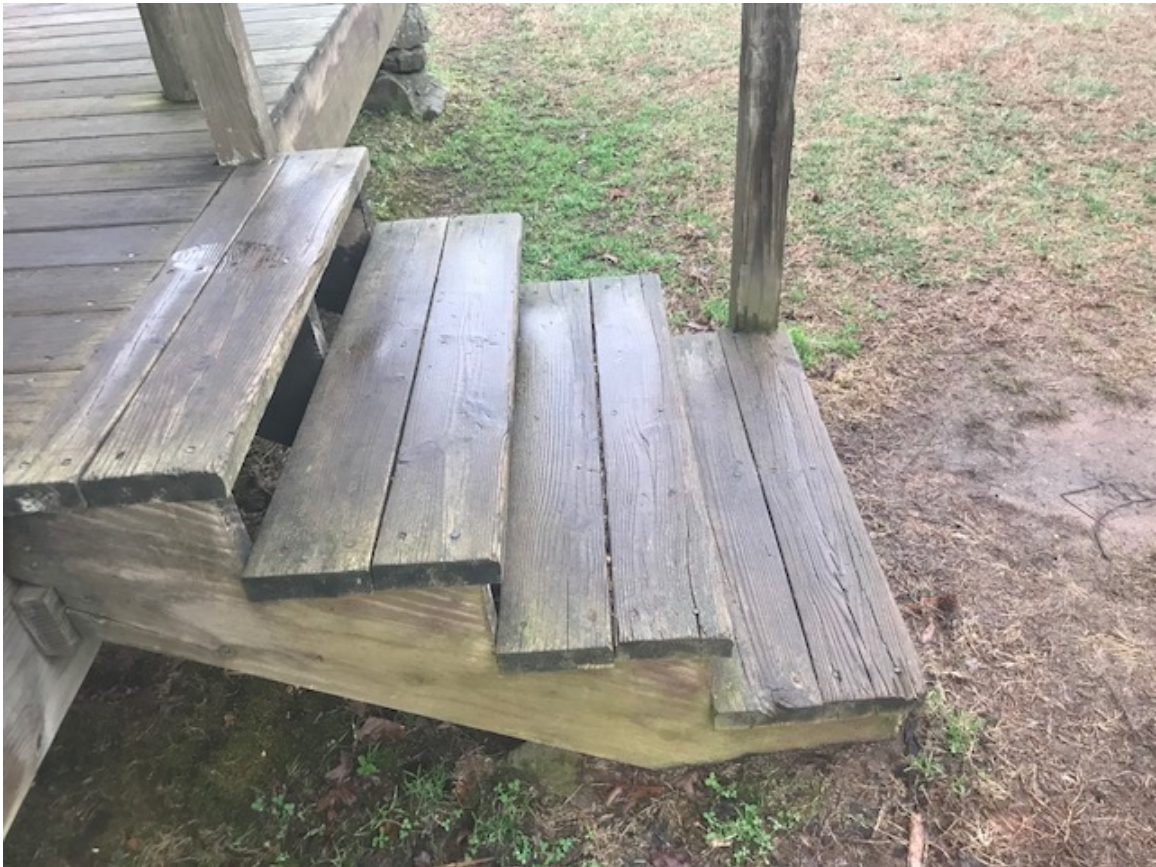
Figure A.78 –*Scruggs Cabin newly built stairs* Stairs were added to the porch at Scruggs Cabin to allow for ease of access by visitors (*Image from author*).

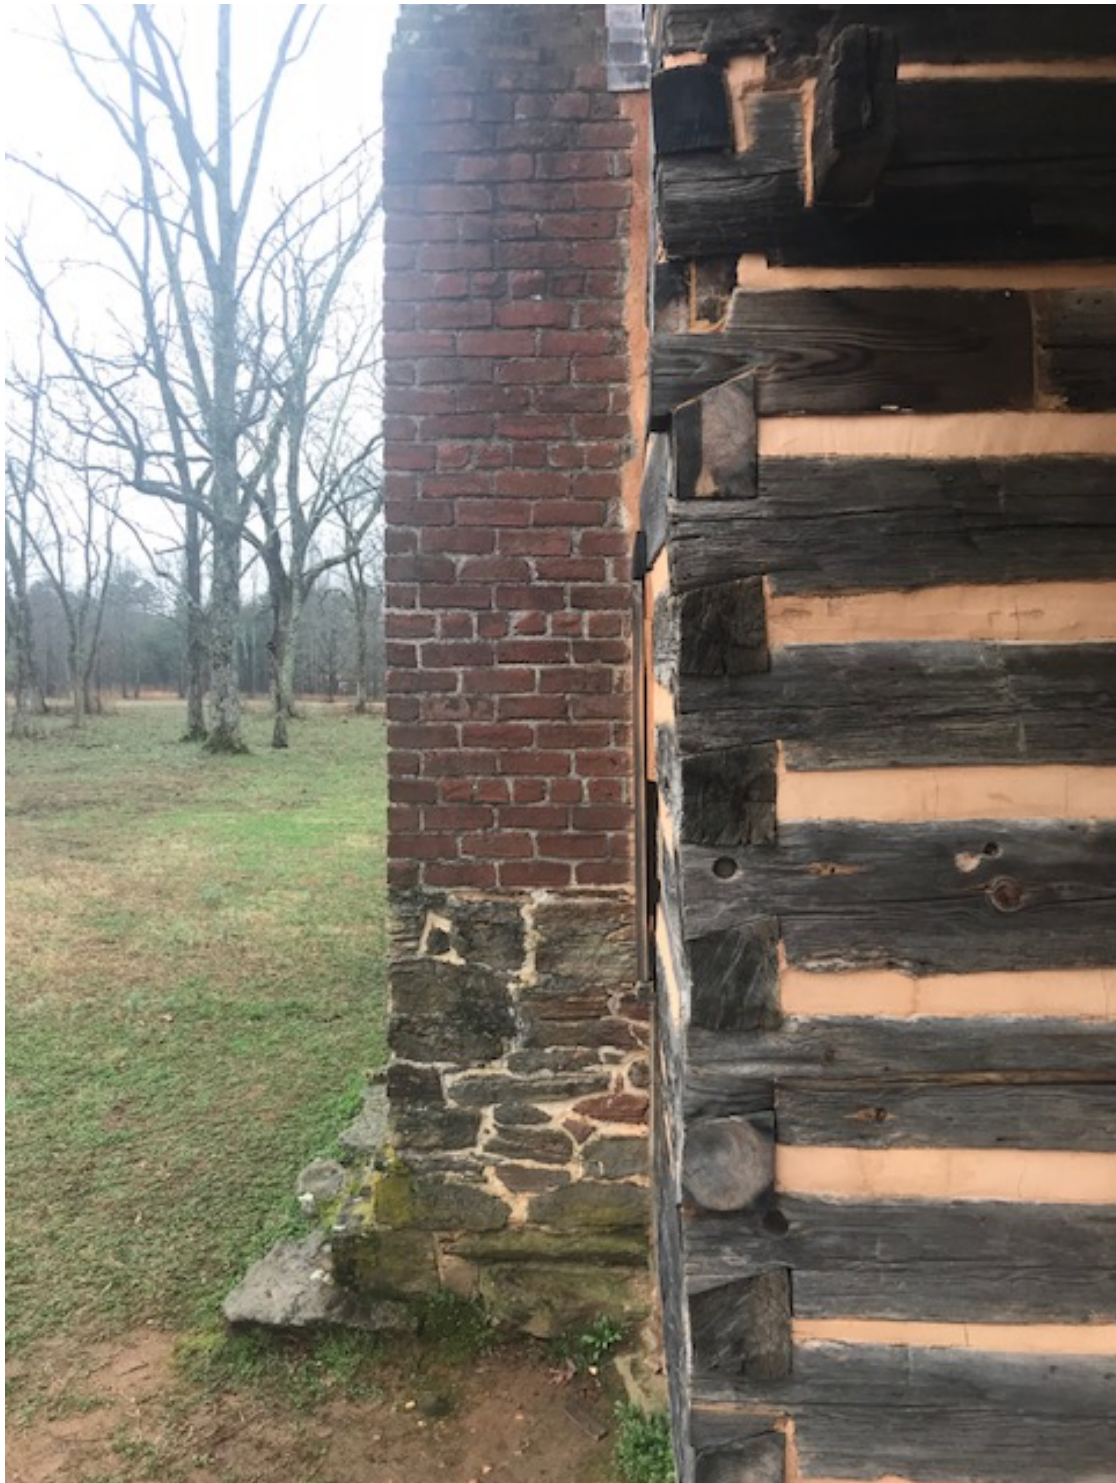
Figure A.79 –*Scruggs Cabin chimney* The restored chimney and log exterior at Scruggs Cabin; note the stone base and rebuilt brick chimney (*Image from author*).

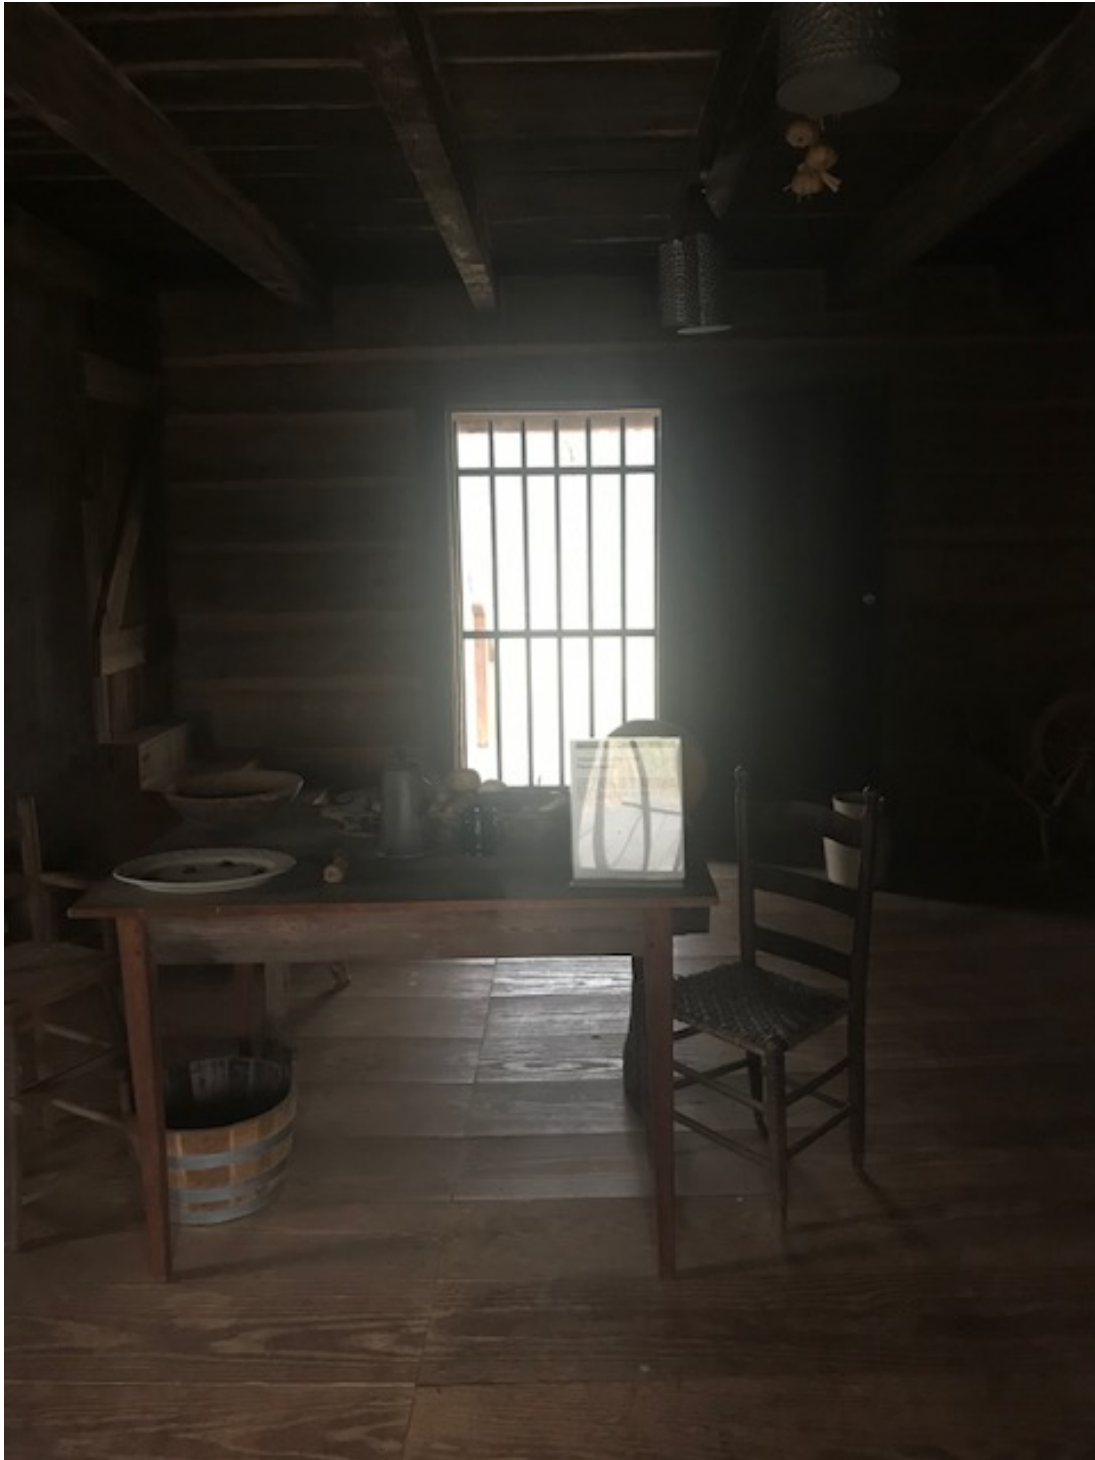
Figure A.80 –*Scruggs Cabin interior* The restored interior at Scruggs Cabin is not physically accessible to the public but is restored (*Image from author*).

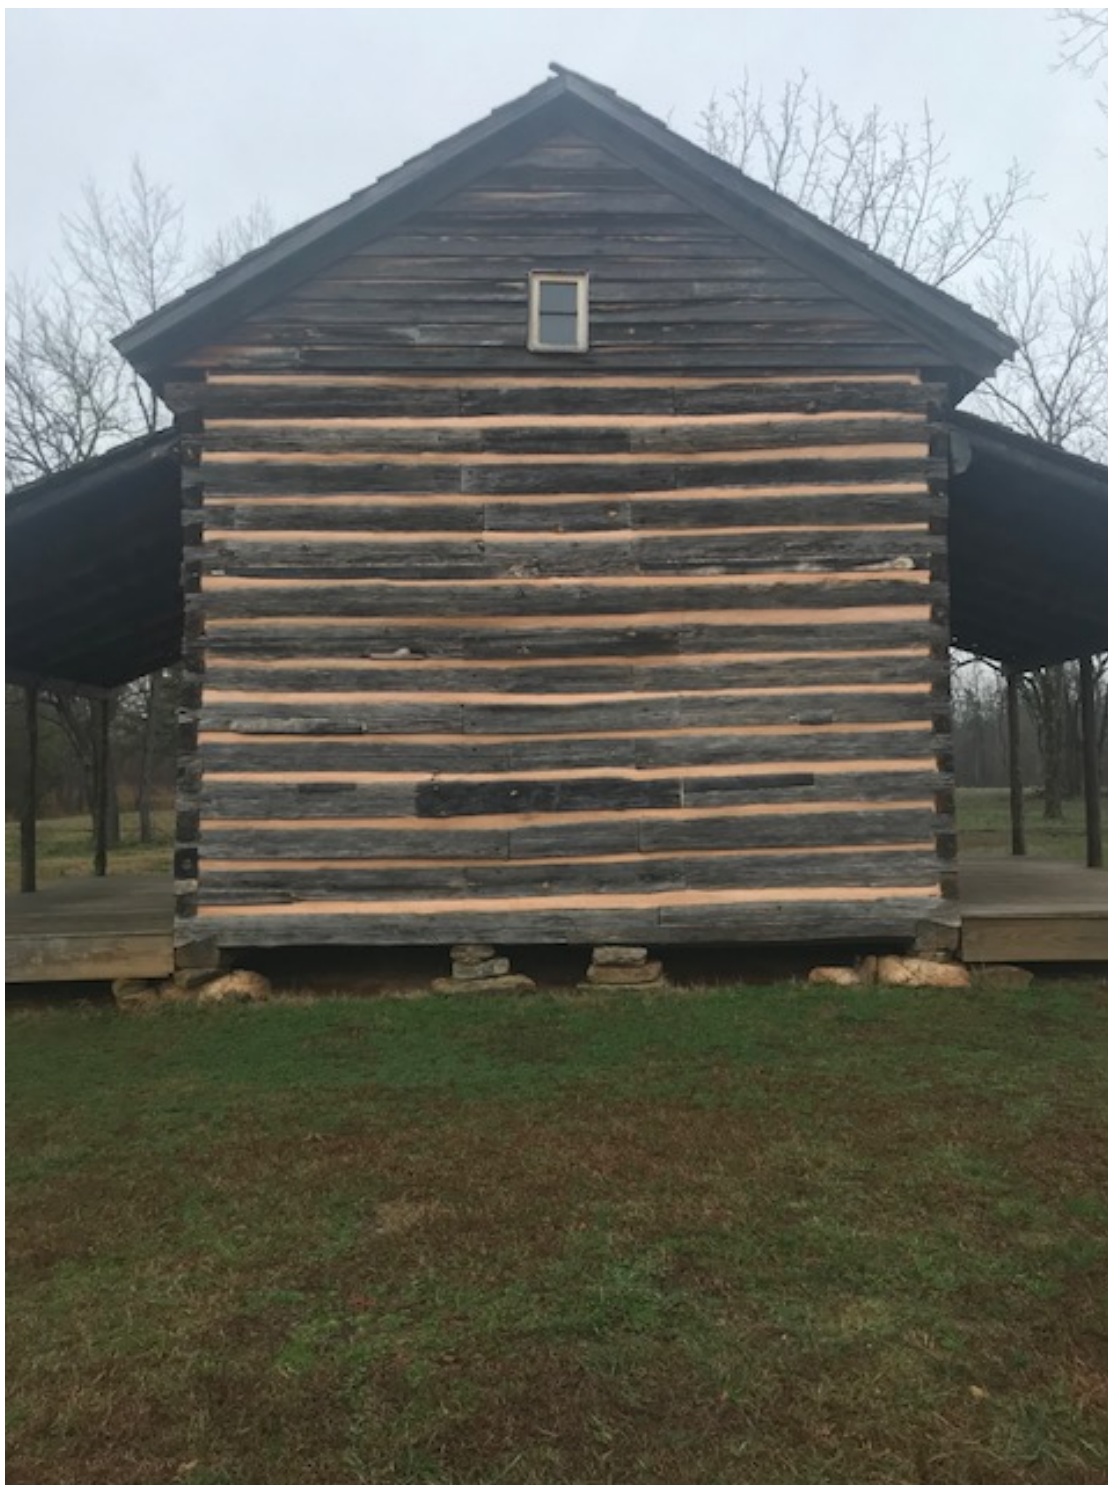
Figure A.81 –*Scruggs Cabin side elevation* The restored side elevation of Scruggs Cabin at Cowpens National Battlefield (*Image from author*).

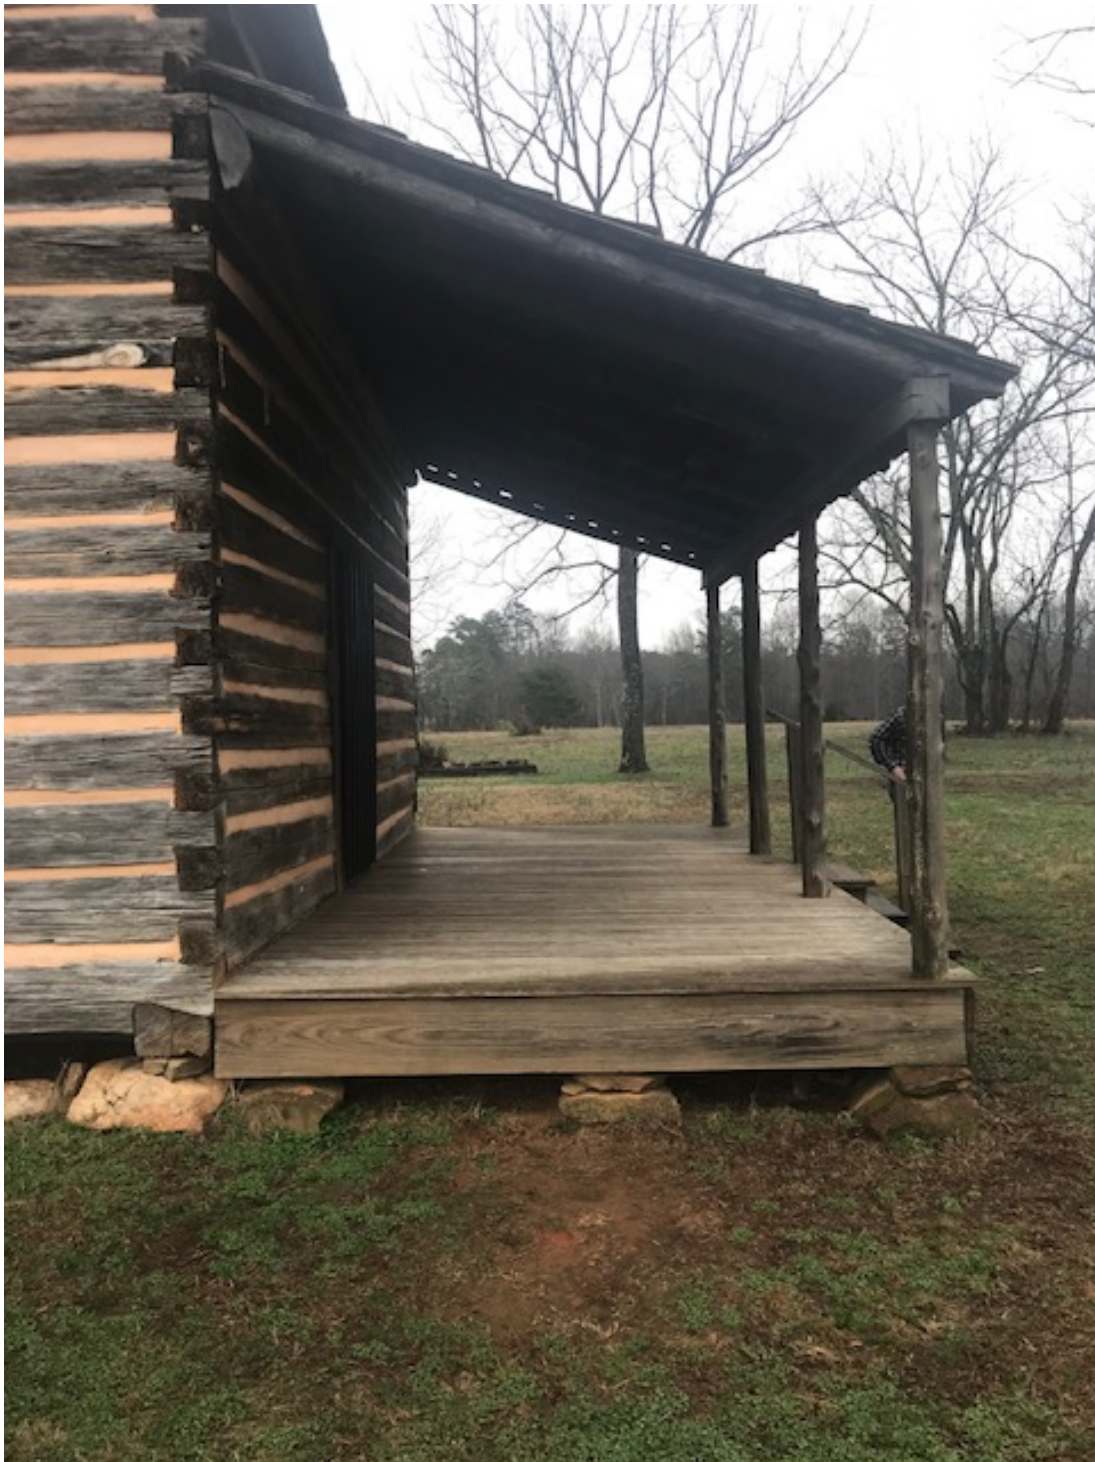
Figure A.82 –Scruggs Cabin porch addition Porches were added to Scruggs Cabin to allow for ease of access by visitors, but according to NPS staff, most likely existed on the original cabin footprint (*Image from author*).

- 3. Building Envelope (5)** in excellent condition; no visible holes or tears in building envelope
- 4. Porch (5)** both in excellent condition; have been rebuilt to allow visitors ability to walk up to the open house; structurally sound

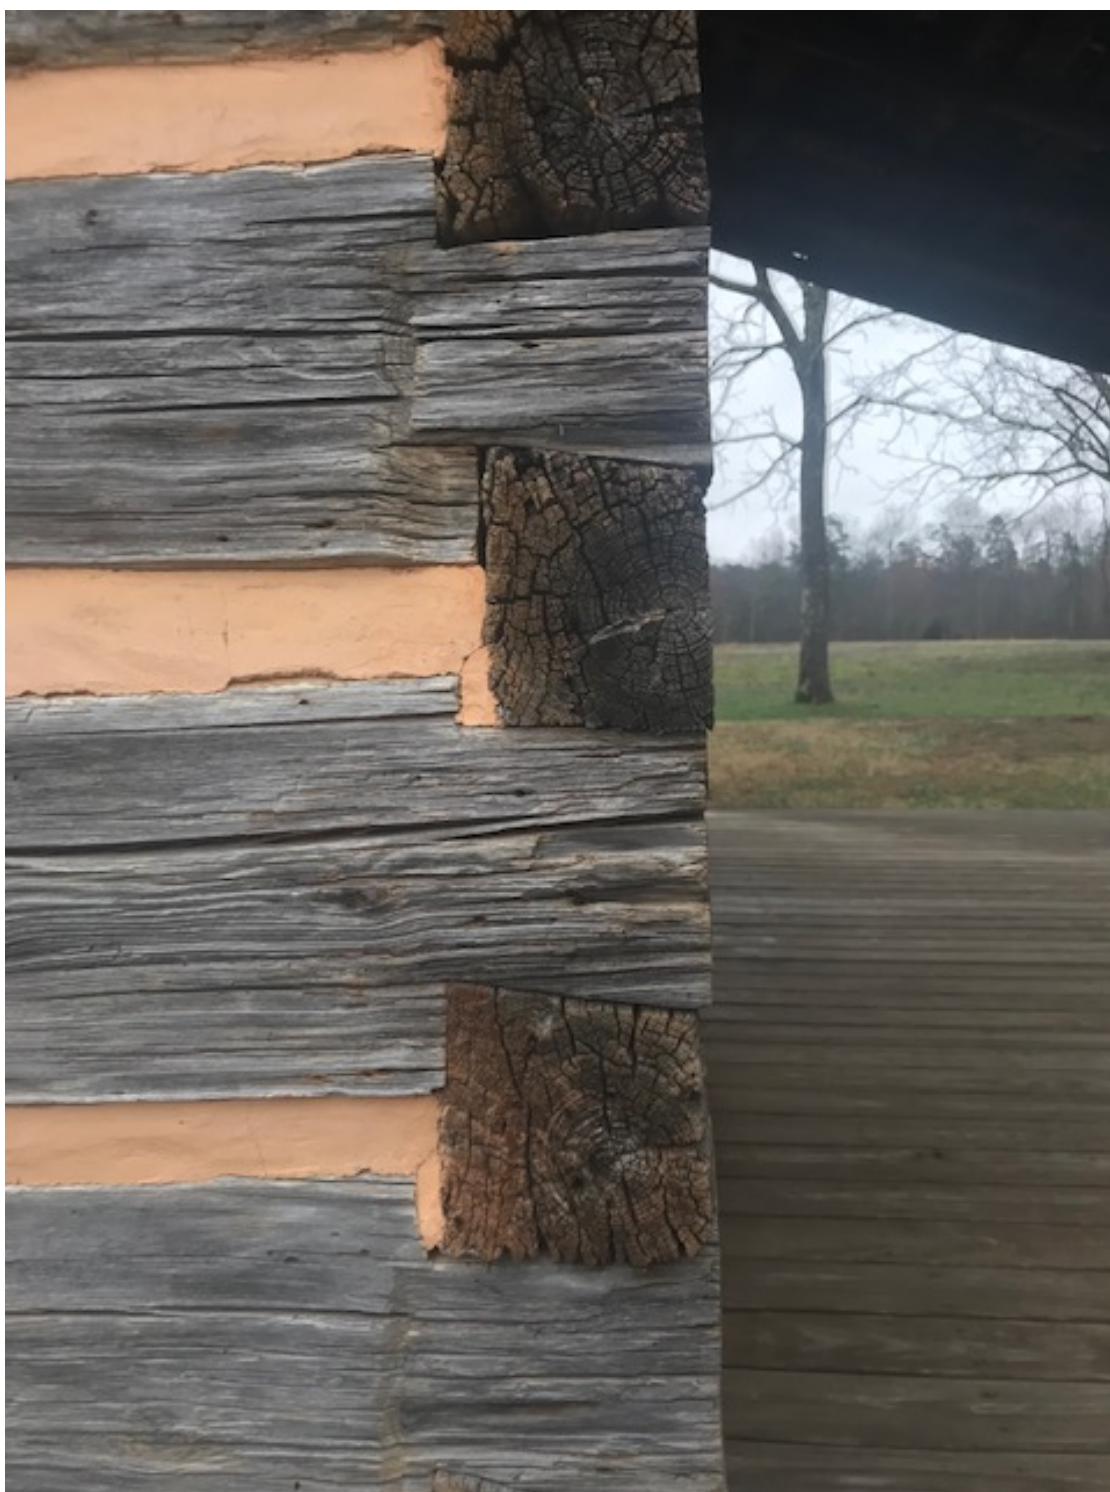
Figure A.83 –*Scruggs Cabin restored log siding* A close-up of the restored log siding of Scruggs Cabin at Cowpens National Battlefield (*Image from author*).

- 7. Walls (5)** in excellent condition; logs fit snugly together and no visible holes or damage to walls
- 8. Staircase(s) (n/a)** since interior access was restricted, unable to assess staircase condition although from afar, it appears to be in good shape
