Fostering Community: Spatial Arrangements of Early Nineteenth Century Camp Meeting Grounds in South Carolina

FOSTERING COMMUNITY:
SPATIAL ARRANGEMENTS OF EARLY
NINETEENTH CENTURY CAMP MEETING GROUNDS
IN SOUTH CAROLINA

A Thesis Presented to the Graduate Schools of Clemson University
and the College of Charleston

In Partial Fulfillment of the Requirements for the Degree
Master of Science in Historic Preservation

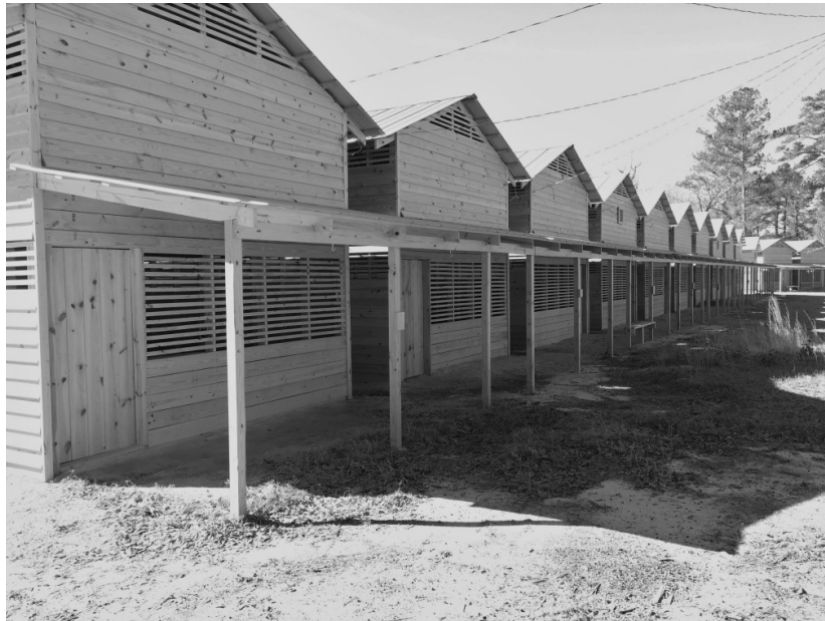
Image 4.14 Tents 19-32 were rebuilt in 2017 after a fire. November 2017. Image by author.

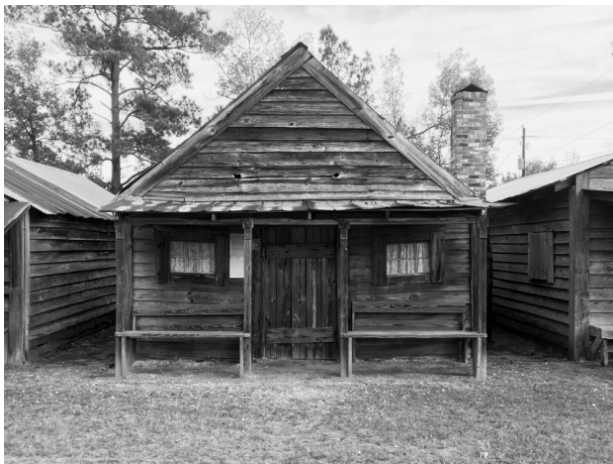
*Image 4.17 Typical Tent at Cypress Campground.
November 2017. Image by author.*

Many tents retain elements of their original hand hewn framing which is faced with rough sawn lumber siding. Earthen floors are found inside each tent as well as an attached and enclosed kitchen structure at the back. Historically, tent kitchens were a separate structure that was placed a sufficient distance away from the main tent to minimize heat transfer and fire hazards. Above the ground floor, most tents have a half-story sleeping loft.

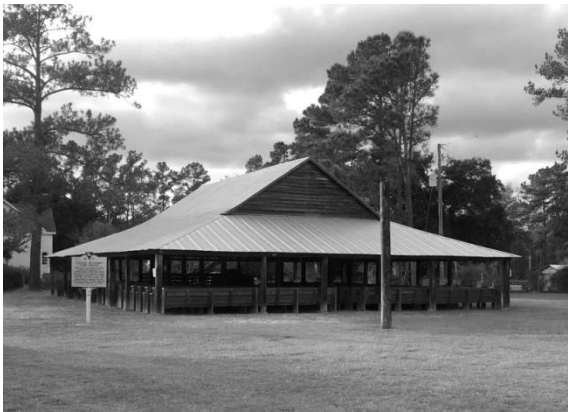
*Image 4.19 Tabernacle at Cypress.
November 2017. Image by author.*

hand hewn lumber and, though it has undergone repairs throughout the years, much of the original structure is still used. The pulpit is placed along the structure's West side, and is elevated to project the speaker's voice to the listeners below. A time capsule lies under the pulpit that was buried in October of 1984 and will remain so until October 2034.

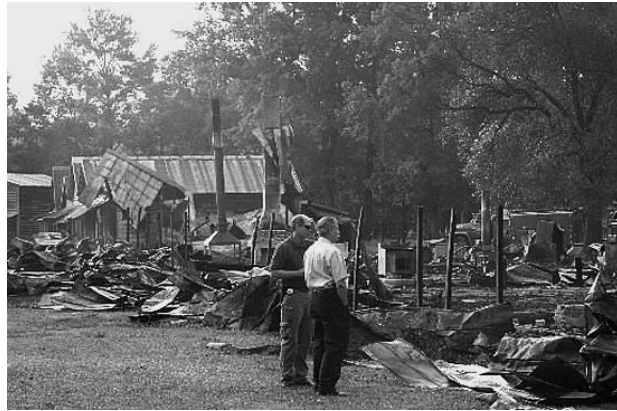
Image 4.22 Aftermath of burned tents at Cypress Campground on fire June 20, 2008. Image from Post and Courier.⁶¹

fires within months of each other destroyed the majority of tents along the camp’s southern row. The first fire took place on April 29, 2008, and took five tents and damaged the sixth. On July 19, 2008 the second fire began where the first fire ended, and spread down the row to Tent 22. This tent’s concrete walls helped stop the fire from spreading further down the line of tents.⁶⁴ Two fire and arson mitigation mechanisms are in use at the camp. The first strategy is that tent 31 has been constructed out of concrete masonry units (CMU) and then faced with wood siding. This construction material is what helped prevent the fire from spreading further in July of 2008. The

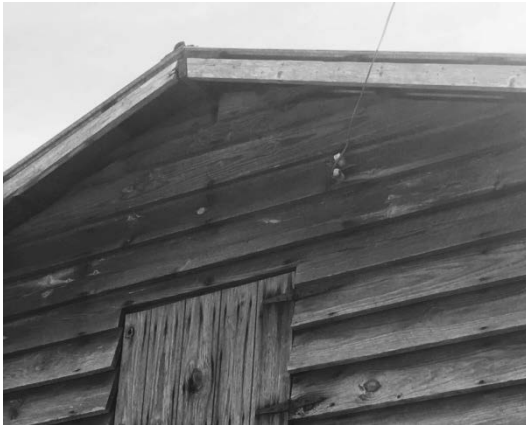
*Image 4.31 Knob and tube wiring still remains on many tents throughout the camp.. November 2017.
Image by author.*

1938, much of the camp was lit through the use of electricity.⁸⁰ Evidence of knob and tube wiring still remains around much of the site today. The Board of Trustee members limit the quantity of electrical service to each tent through their bylaws in order to minimize modernization of the tents through extensive electrification. Most tent owners use their electricity to run a small number of lights throughout the tent at night. Some tent owners have delegated their electricity for cooking and refrigeration purposes, but the majority of tent families utilize their wood burning stove (or ‘furnace’) for their primary means of cooking.

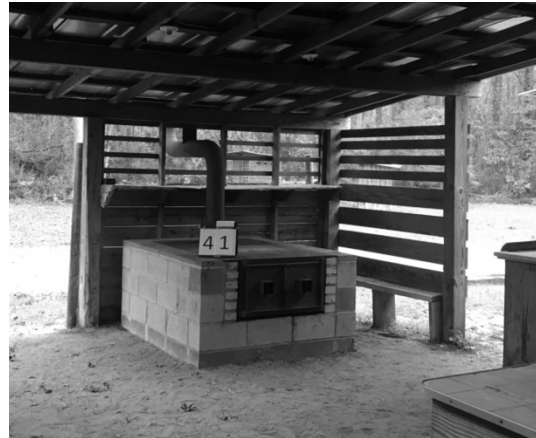
*Image 4.32 Most tents use wood burning furnaces to cook food for the week. November 2017.
Image by author.*

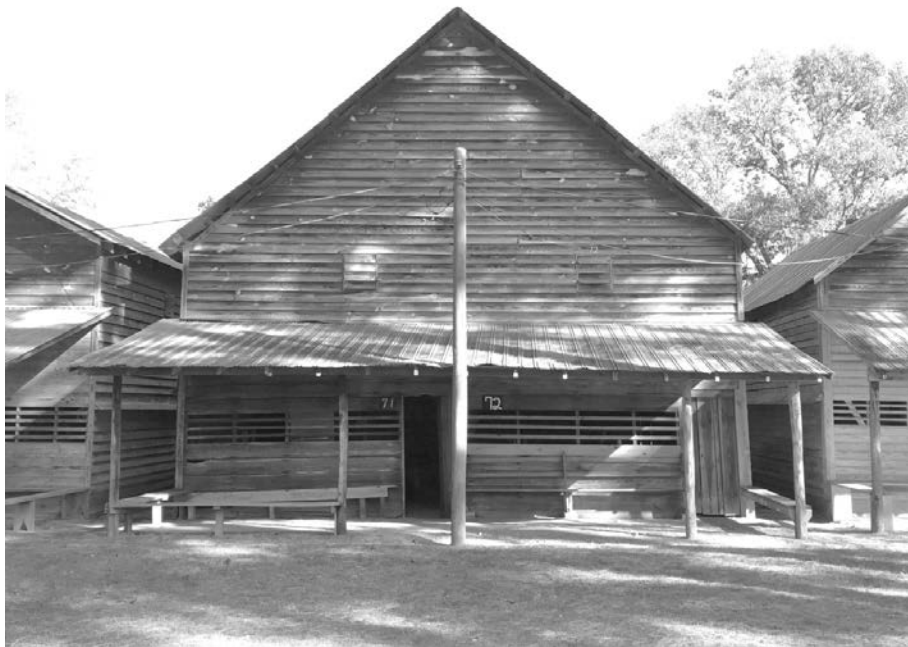
Image 7.17 Double Tent 71 and 72 is of a unique typology only found at Indian Field Campground. November 2017. Image by author.

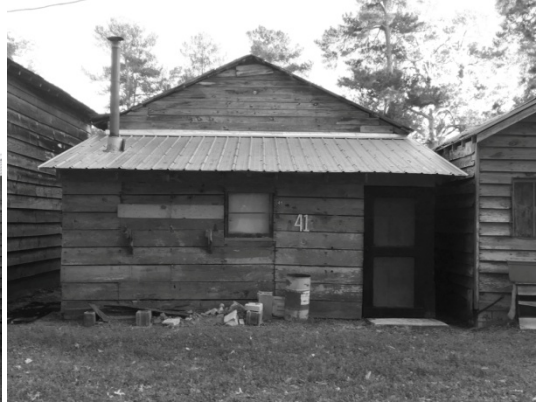
Image 7.23 The kitchen in St. Paul Campground tent 41 has a separate roof system and is treated more as an addition to the main tent. November 2017. Image by author.

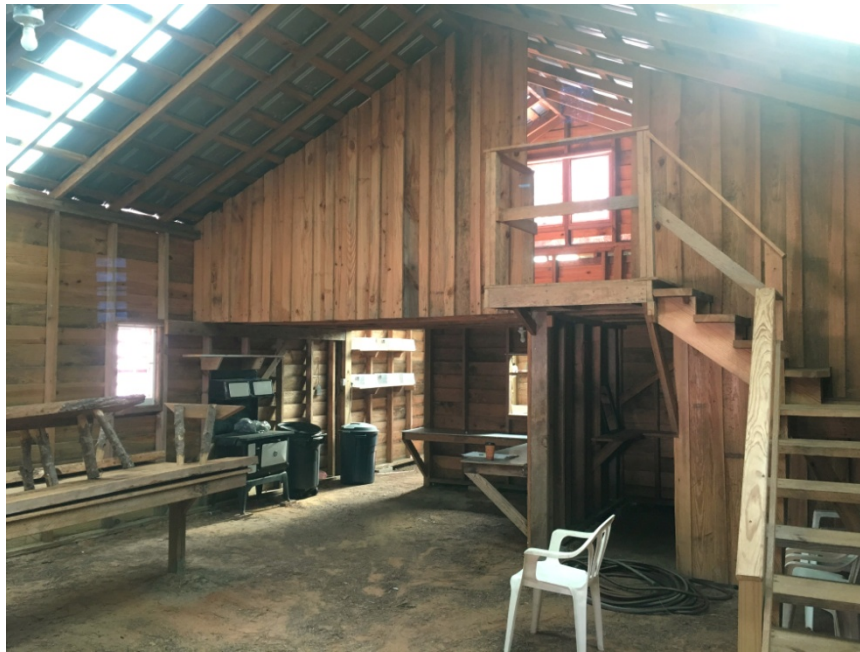
Image 7.28 Front room inside Tent 9 at Cypress Campground. At Cypress, skylights fill the spaces with an abundance of natural light. December 2017. Image by author.

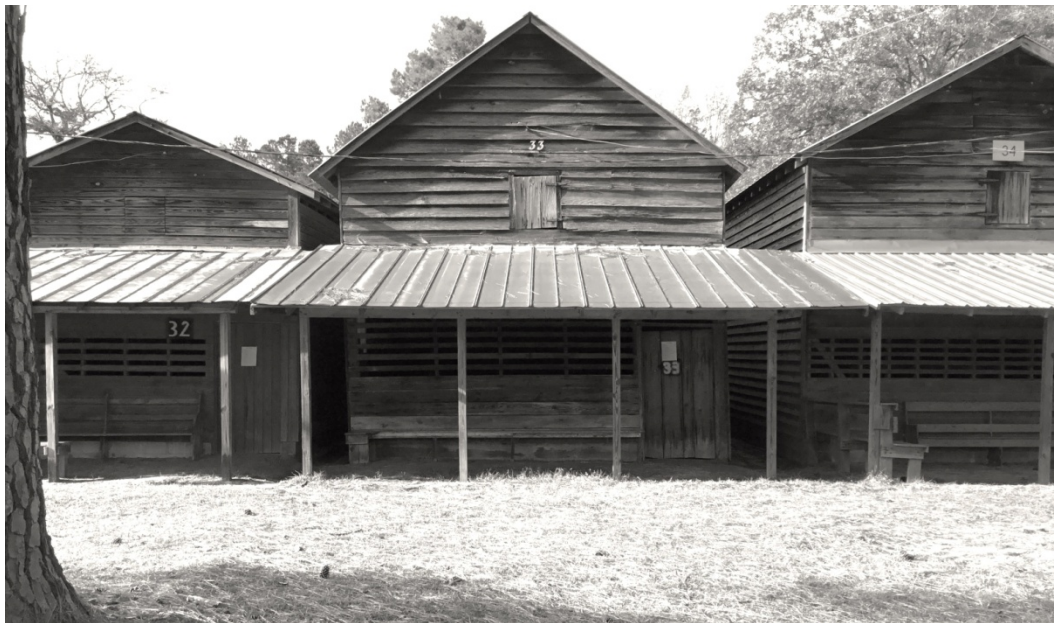
Image 7.29 Porch roofs at Indian field are joined between Tents 32, 33, and 34. November 2017. Image by author.

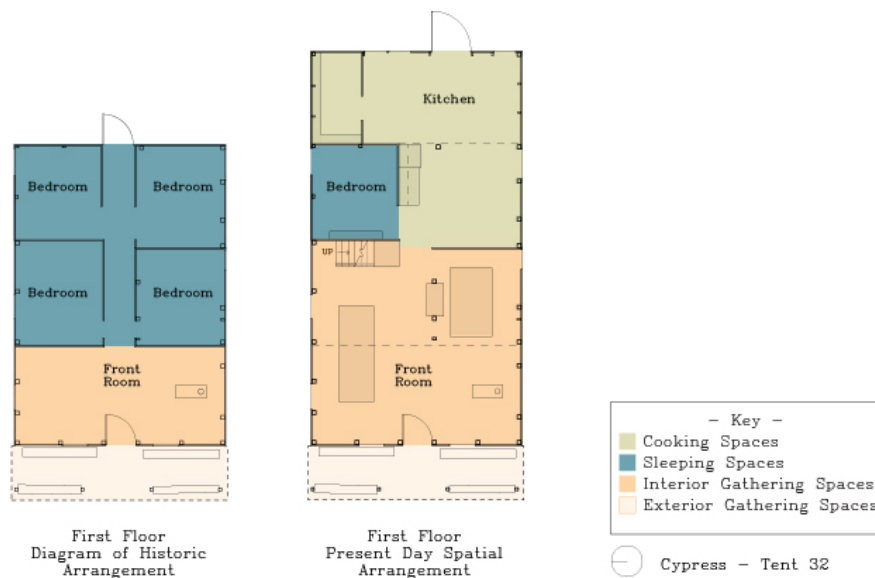
*Figure 8.1 Change in spatial organization over time.
Illustration and diagram by author.*
