Analysis of Slope Failure on Cochrane Road, Dominica Prior to Hurricane Maria

A Thesis
Presented to
the Graduate School of
Clemson University

In Partial Fulfillment
of the Requirements for the Degree
Master of Science
Hydrogeology

by
Audrey Fisher
May 2018

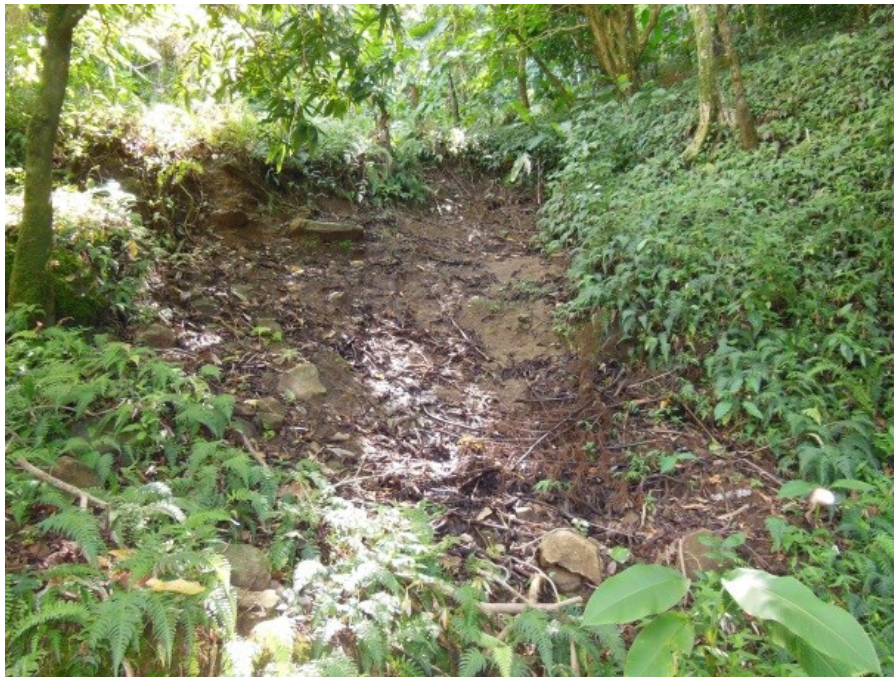
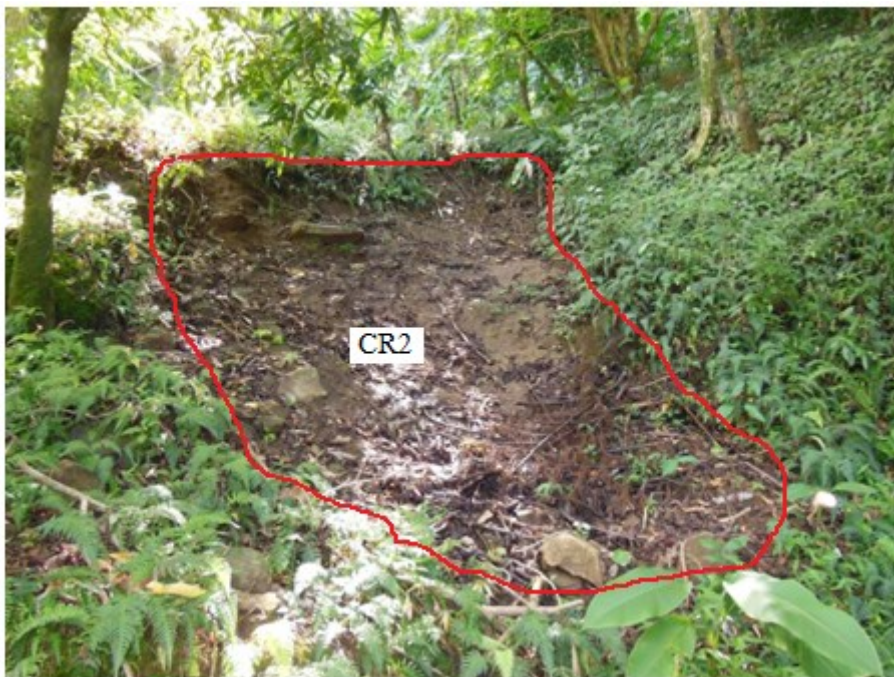
CR2 and CR3 are slides about 1000 ft (305 m) further up the road from CR1. CR2 is a more recent slide that occurred on the older CR3 slide (Figure 3.9). CR2 had an un-vegetated failure surface which implies it failed during Hurricane Erica in 2015 (Figure 3.10). In contrast, the vegetation on CR3 (Figure 3.11) had completely grown back. Thus CR3 predates Hurricane Erika. CR2 had a length of 43 feet from the base to the highest point and a width of 18 feet at its widest point, which was about 15 feet above the bottom of the slide surface. The depth of the landslide was approximately 3 feet at the top and then reduced to 2 feet over the remaining failure surface. The slope angle at both sites is 36 degrees, with a 30 degree angle at the bottom where the failure surface ended. The material on CR2 and CR3 ranges from clay size to cobble (Figure 3.12).

Figure 3.10 Direct view of slide CR2. Slide CR2 is the un-vegetated surface. The top photo is the original photograph while the bottom photo is an annotated version showing the outline (red) of the CR2 slide surface.

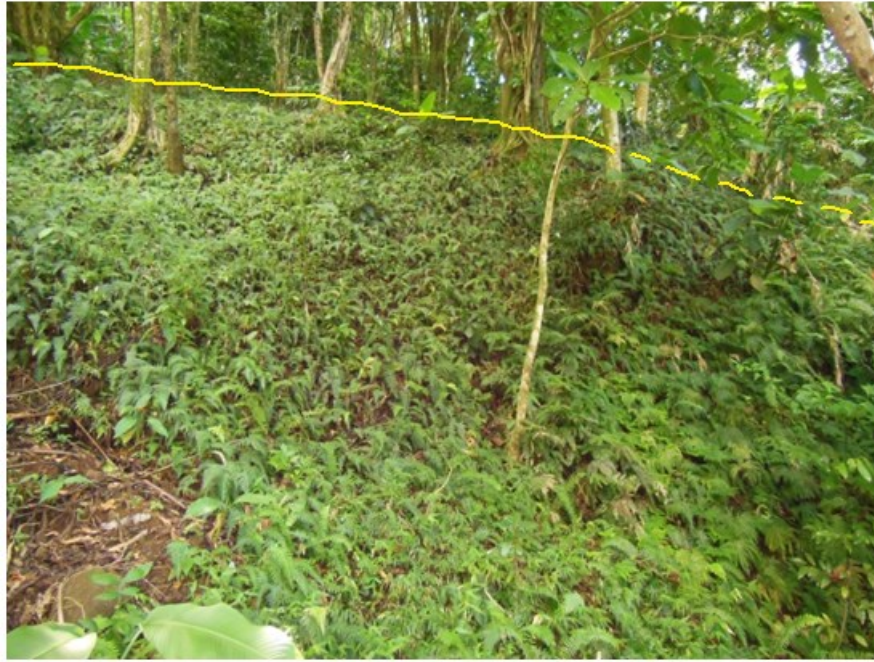
Figure 3.11 Slide CR3 covered in vegetation consisting of tropical brush and trees. There is a small scarp further uphill (yellow) completely covered in brush.

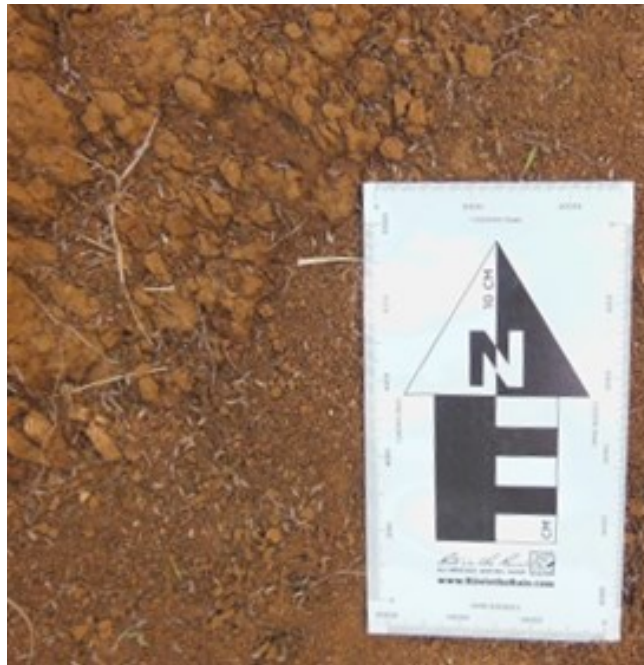
Figure 3.20: Material from CR6 consisting of clay clasts and rocks about 3 cm or less in diameter shown with a 3x6 inch scale (outline of card).

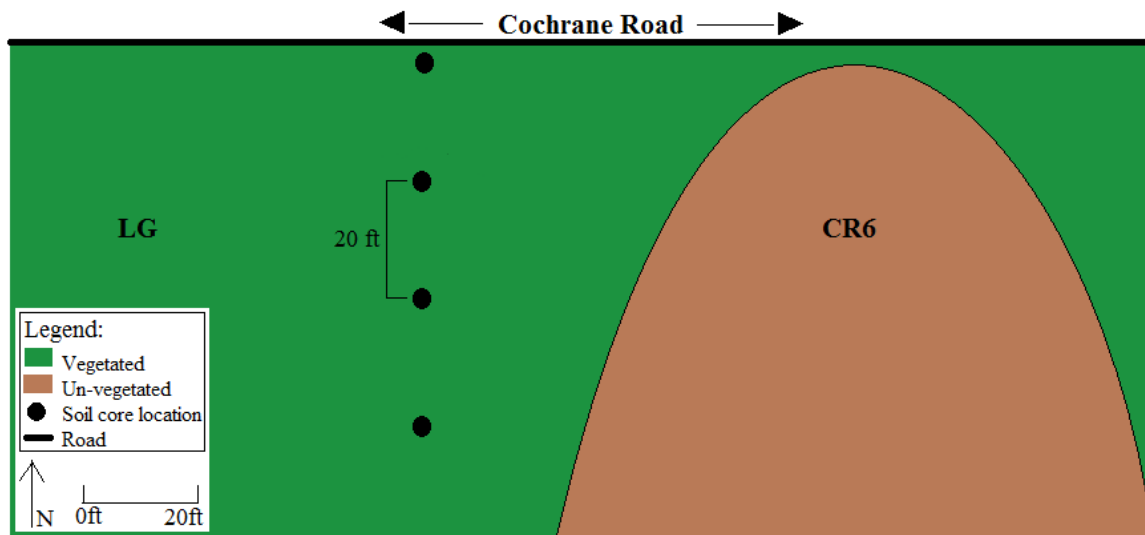
At the Lemongrass Site, ½ inch diameter soil cores were collected from the surface to a depth of 8 ft at the top of the slope near the road (LGa) and at three other locations in a transect down the slope named LGb, LGc, and LGd (Figure 3.24). These locations were approximately 20 feet apart as measured along the slope. These soil cores were bagged and taken back to Clemson for soil characterization and XRD analysis. Soil cores were attempted at the Forested Site, but due to high rock density and tree roots it was impossible to penetrate more than a few inches. Samples were instead collected from close to the surface.

Figure 3.24: Location of the ½ inch diameter soil cores in relation to LG and CR6.

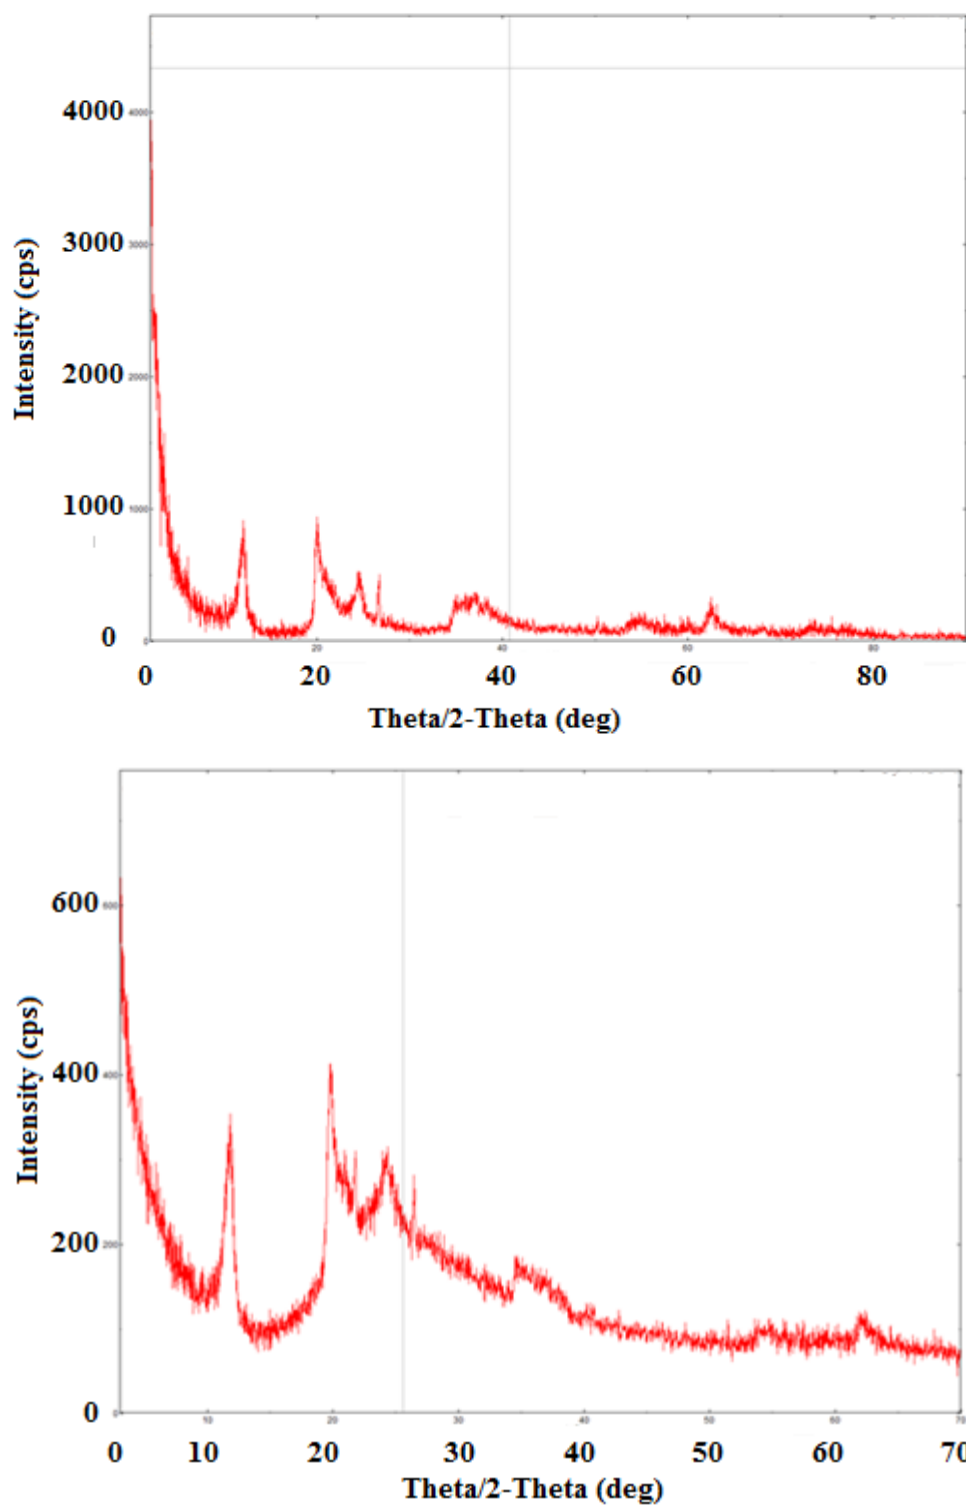
XRD analysis yielded similar results for all three samples. The untreated tests and the slurry treated tests had peaks at the same 2-theta values, but the slurry treated tests had lower intensities (Figures 4.1, 4.2, and 4.3). By comparing the peaks from the results to typical peaks of halloysite, montmorillonite, kaolinite, and allophane, the clay mineralogy present at the study area could be determined. Both samples from the Lemongrass Site, as well as the sample from the Forested Site, had large peaks at 12 Å and 20 Å. Smaller peaks tended to occur at 25, 27, 35, 55, and 63 Å. The mineral halloysite has large peaks at 12 and 20 Å, with smaller peaks at 25, 27, 35, 50, 55, and 63 Å (Figures 4.4 and 4.5). The mineral kaolinite has a large peak at 12 Å with smaller peaks at 20, 22, 23, and 25 Å (Figure 4.6). The mineral montmorillonite can have a large peak somewhere between 5 and 9 Å, with smaller peaks at 15, 18, and 27 Å (Figure 4.7). The mineral allophane has large peaks at 20 and 25 Å with smaller peaks at 11, 18, and 40 Å (Figure 4.8). After deliberation, it was found that the peaks from the samples most closely match those of halloysite, which indicates the presence of kandoid soil at both study sites.

Figure 4.1: XRD results for both the untreated (top) and slurry treated sample (bottom) taken from a depth of 1-2 ft at LGa.

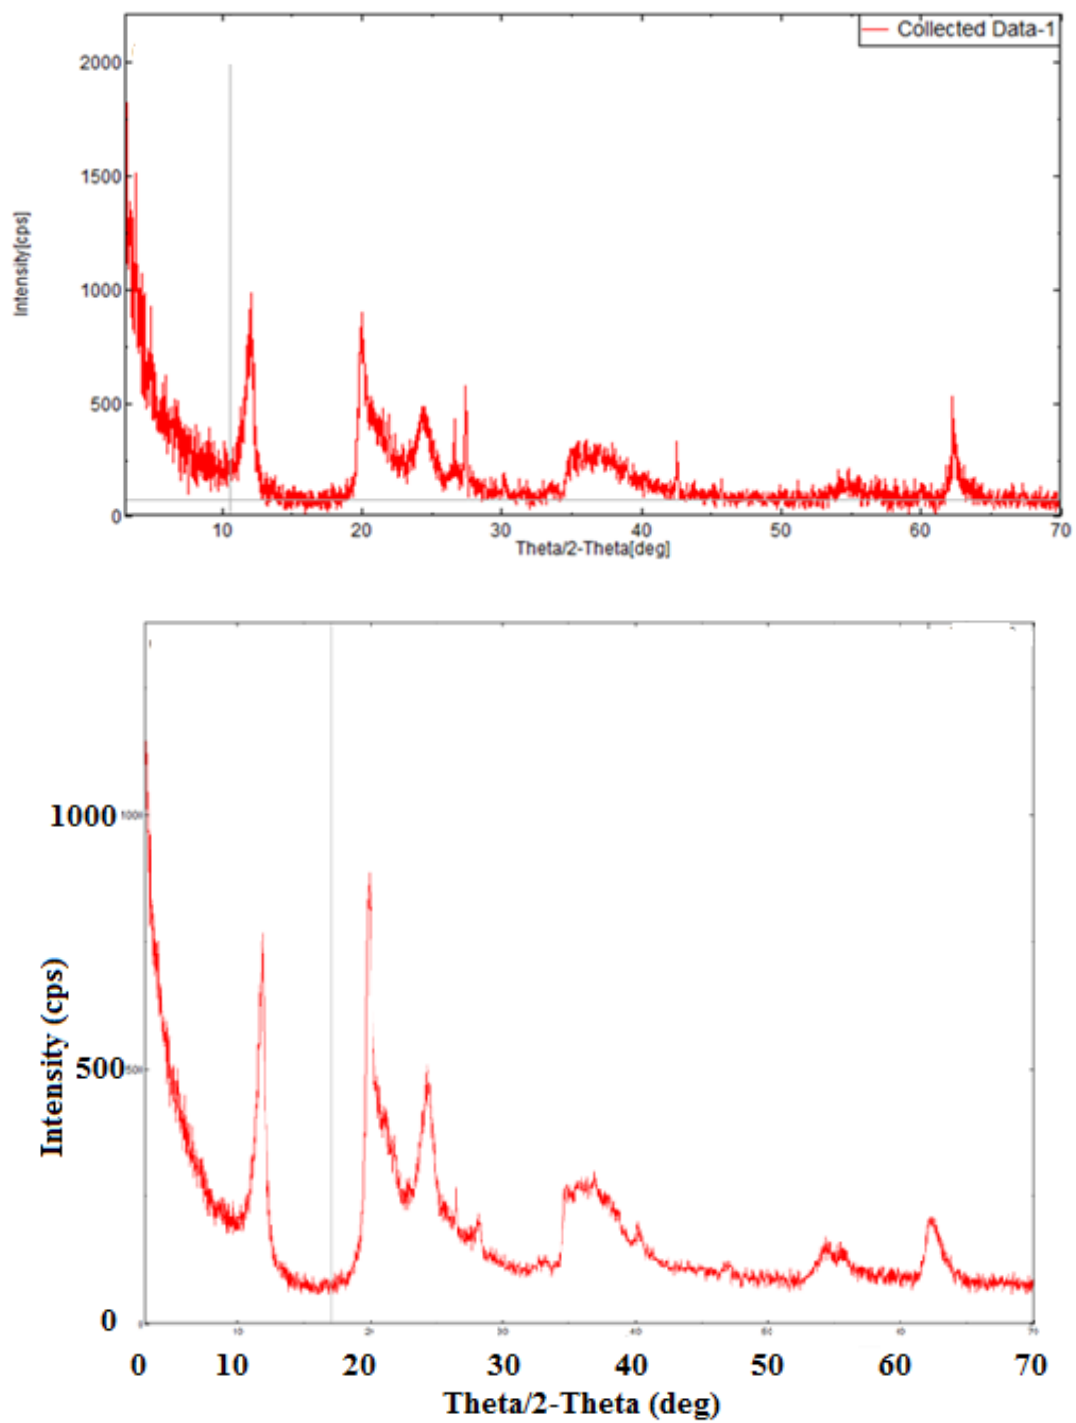
Figure 4.2: XRD results for both the untreated (top) and slurry treated sample (bottom) taken from a depth of 7-8 ft at LGa.

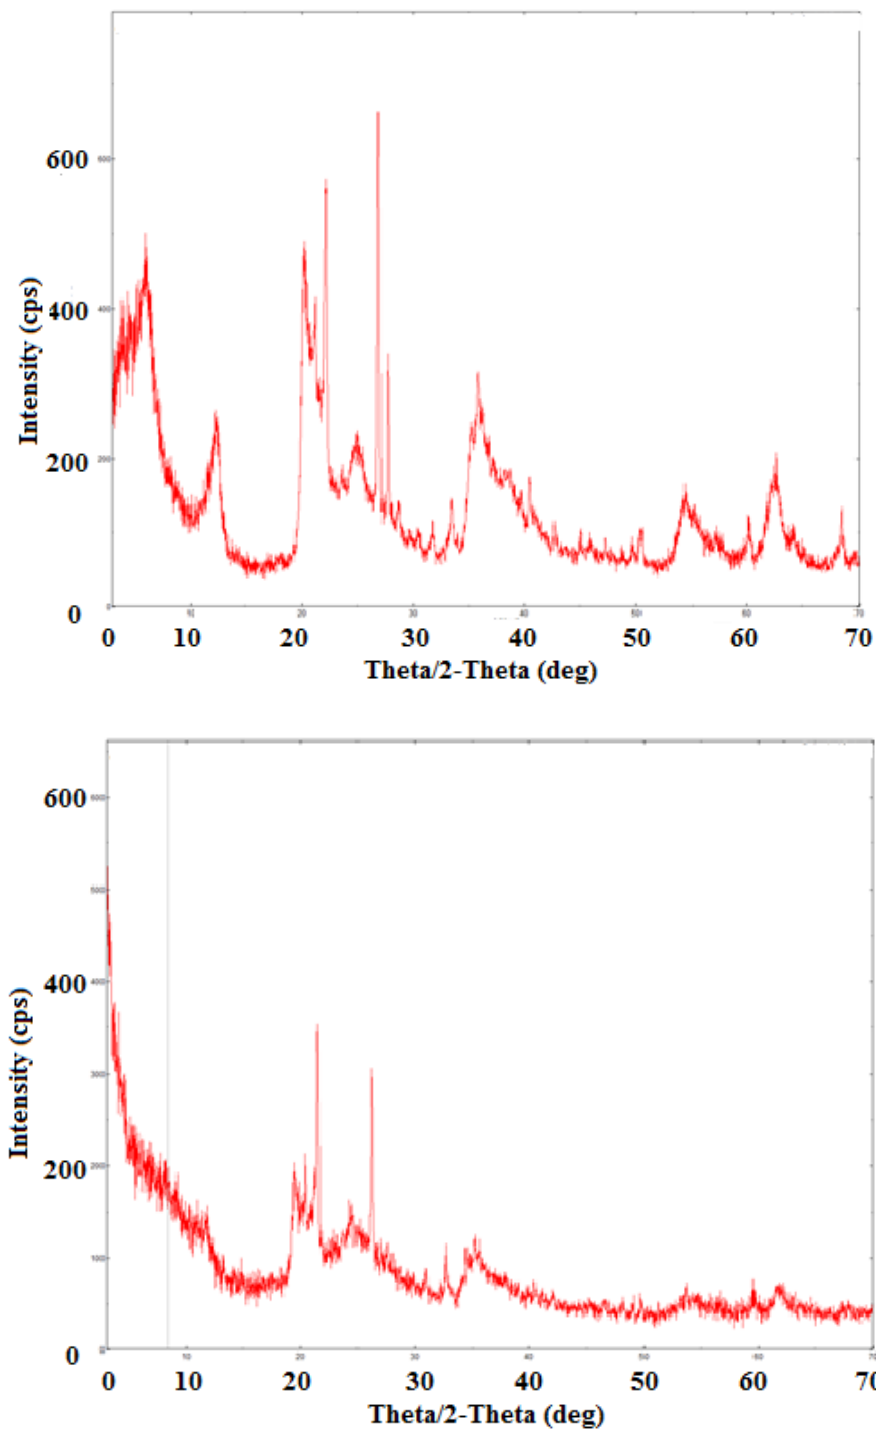
Figure 4.3: XRD results for both the untreated (top) and slurry treated sample (bottom) taken from a depth of 1.4 ft at CR3.

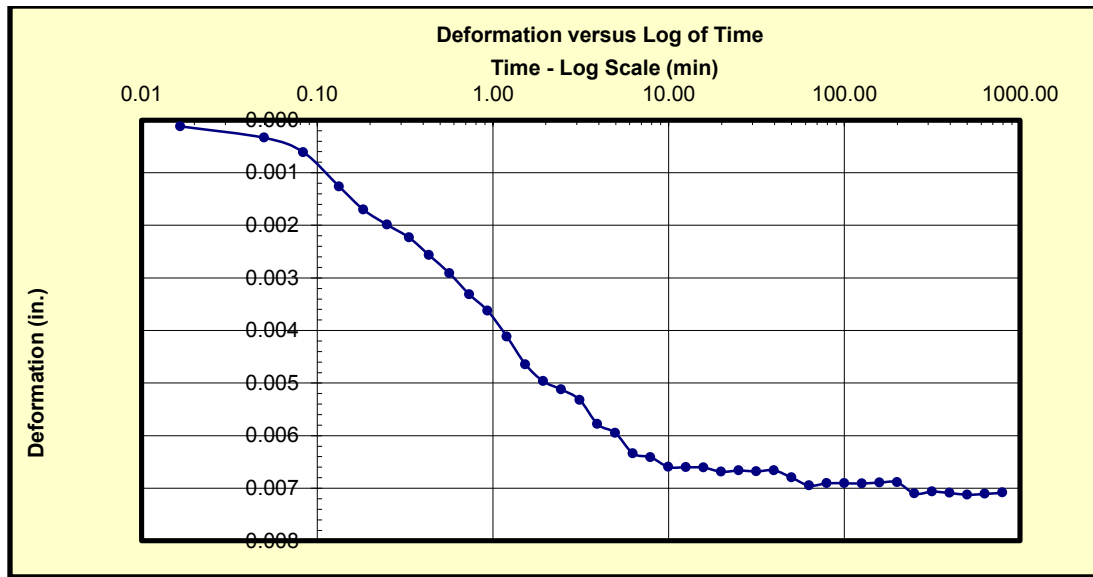
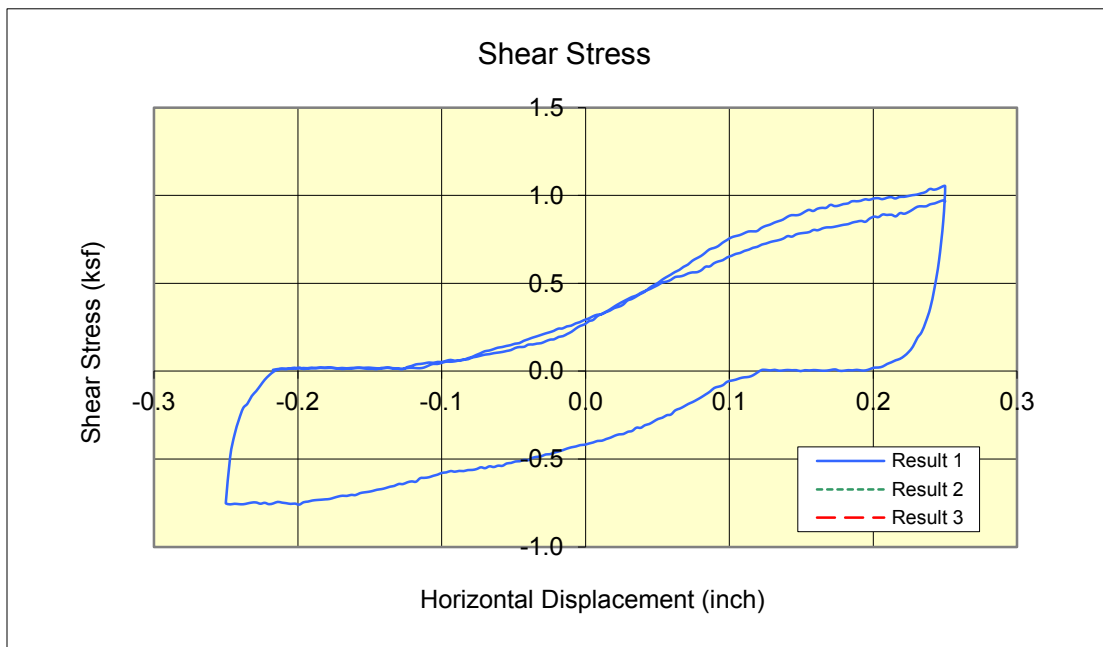
Figure 4.9: Deformation vs time and shear stress vs horizontal displacement graphs produced during direct shear testing of sample CR2 with a normal load of 500 lbs/ft² (lbs/ft² = psf and 1000 psf = 1 ksf).

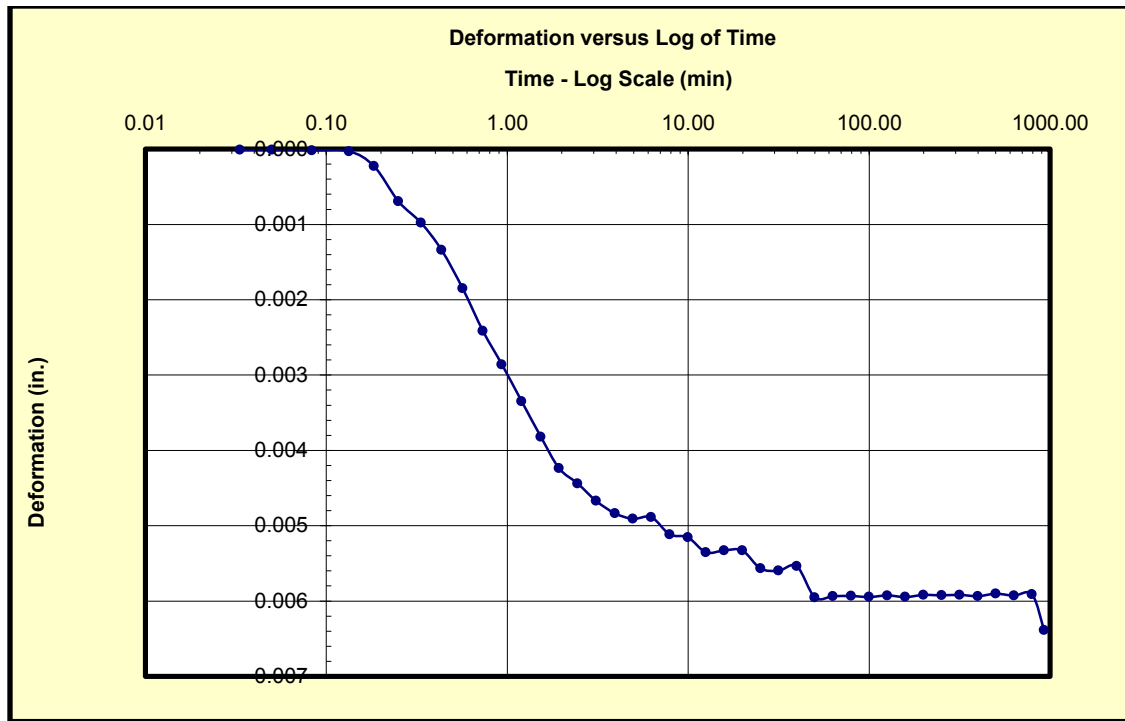
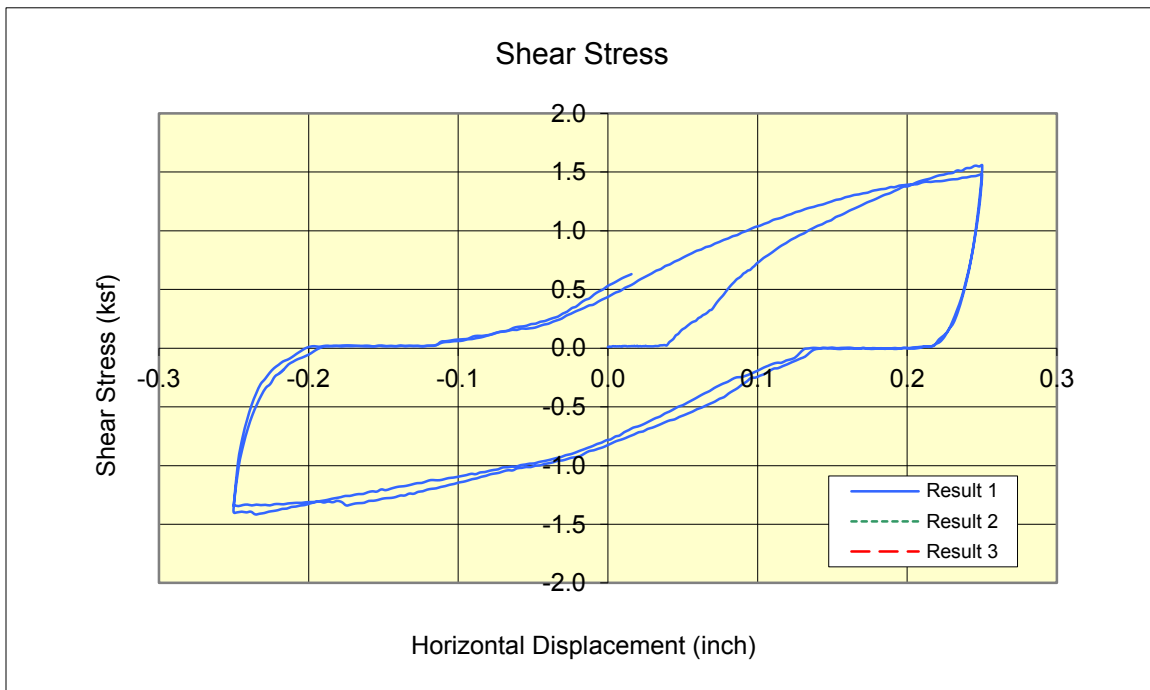
Figure 4.10: Deformation vs time and shear stress vs horizontal displacement graphs produced during direct shear testing of sample CR2 with a normal load of 1000 lbs/ft² (lbs/ft² = psf and 1000 psf = 1 ksf).

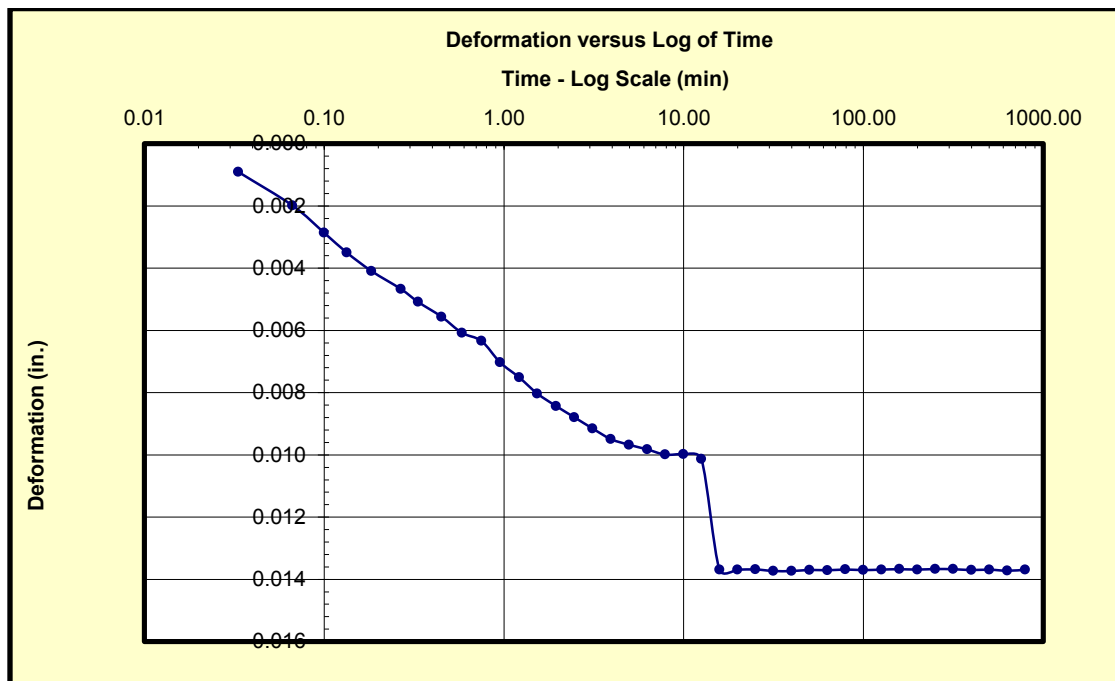
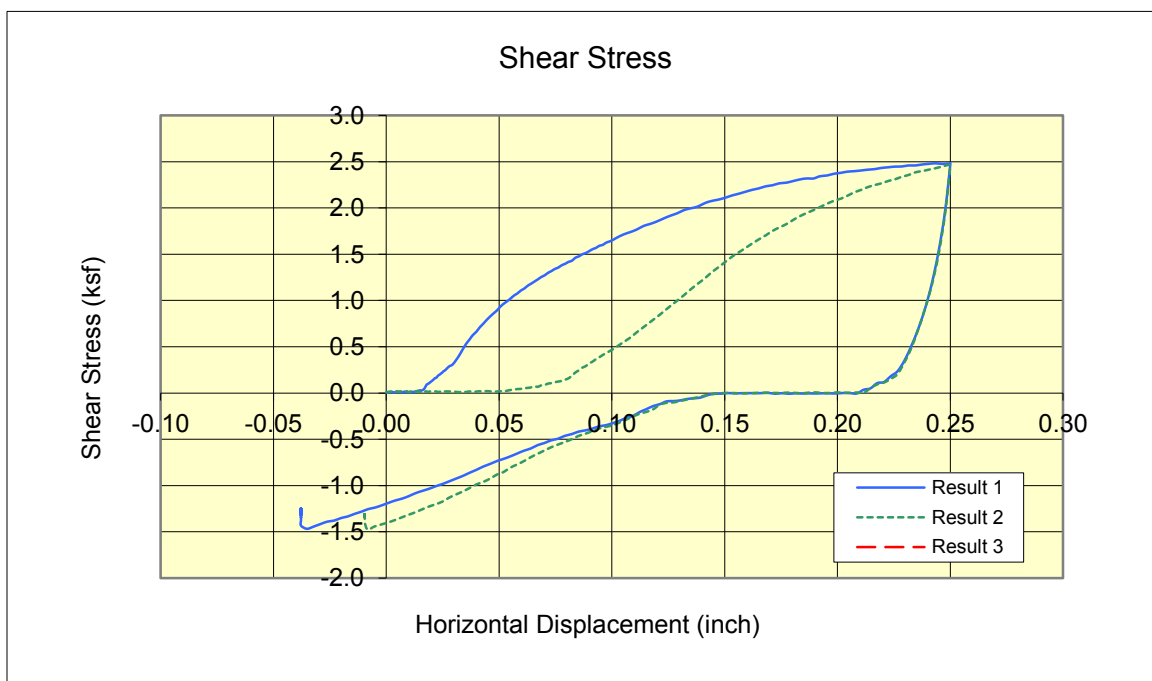
Figure 4.11: Deformation vs time and shear stress vs horizontal displacement graphs produced during direct shear testing of sample CR2 with a normal load of 2000 lbs/ft² (lbs/ft² = psf and 1000 psf = 1 ksf).

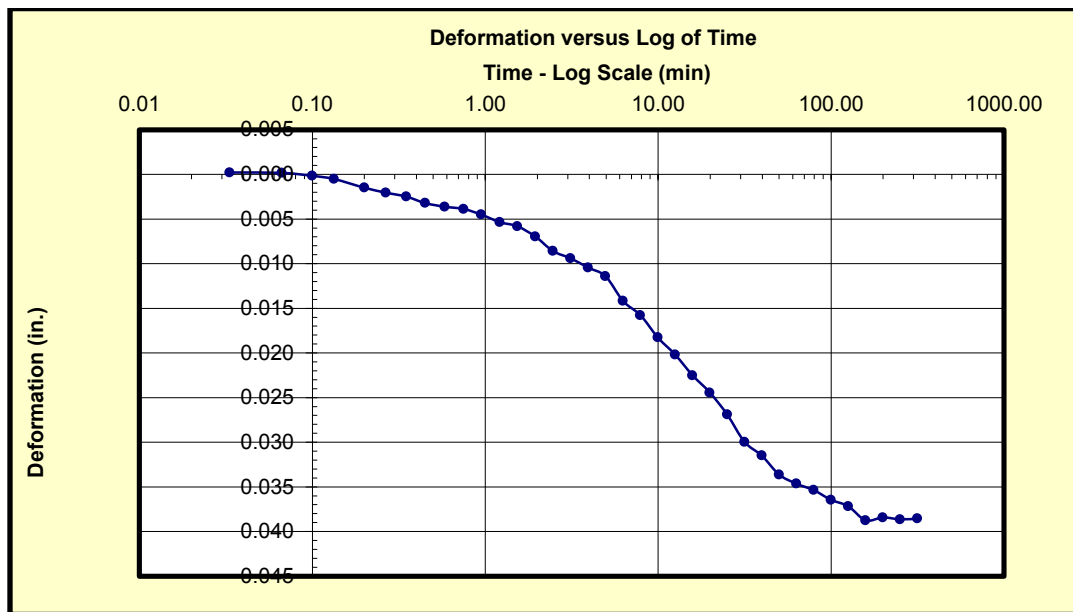
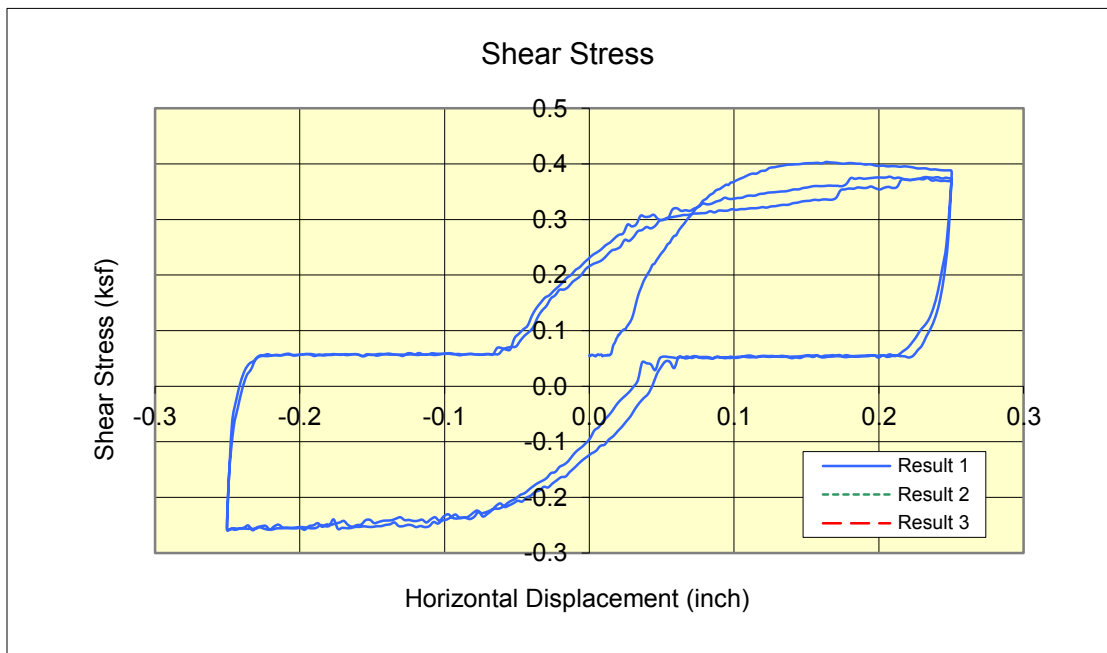
Figure 4.12: Deformation vs time and shear stress vs horizontal displacement graphs produced during direct shear testing of sample CR3 with a normal load of 500 lbs/ft² (lbs/ft² = psf and 1000 psf = 1 ksf).

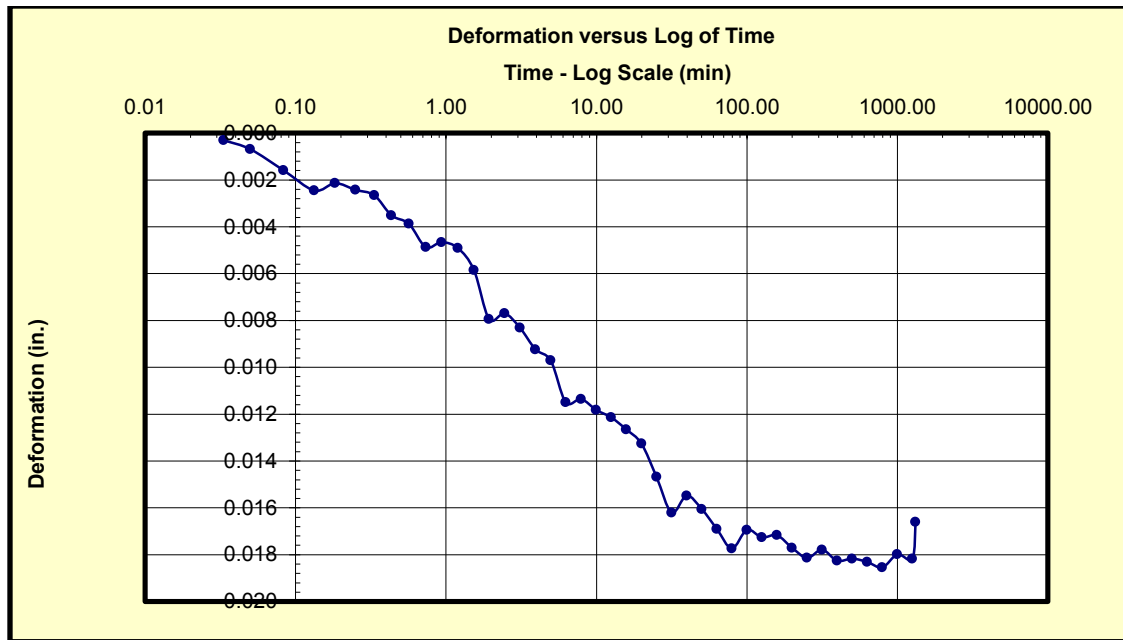
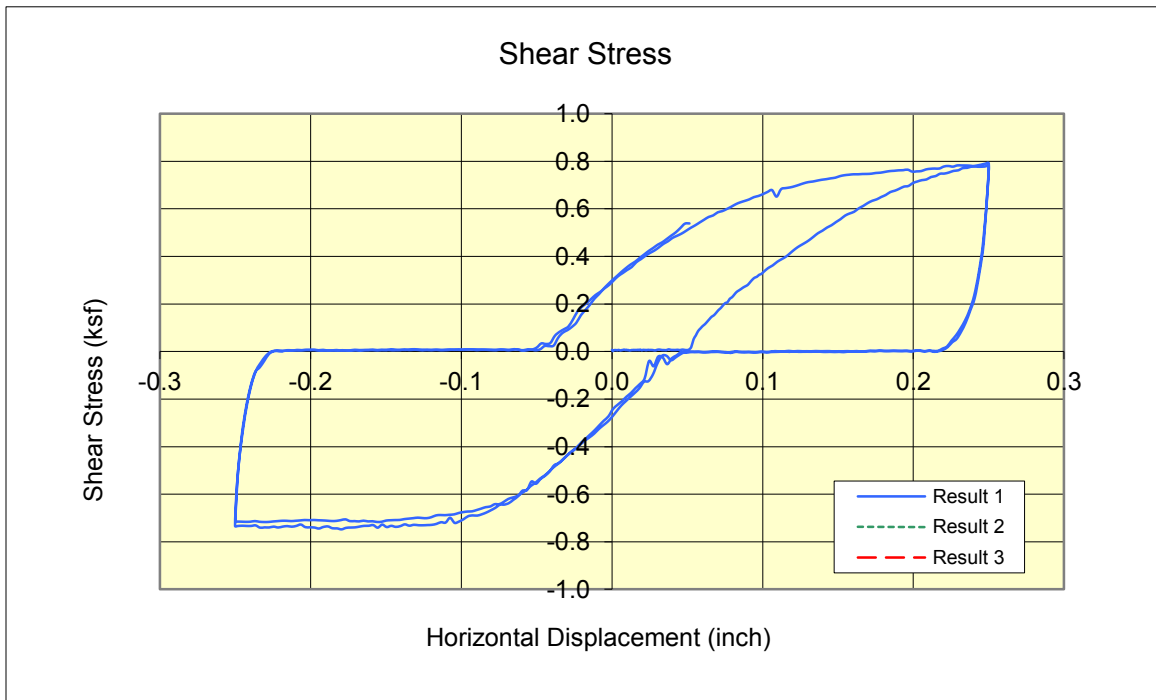
Figure 4.13: Deformation vs time and shear stress vs horizontal displacement graphs produced during direct shear testing of sample CR3 with a normal load of 1000 lbs/ft² (lbs/ft² = psf and 1000 psf = 1 ksf).

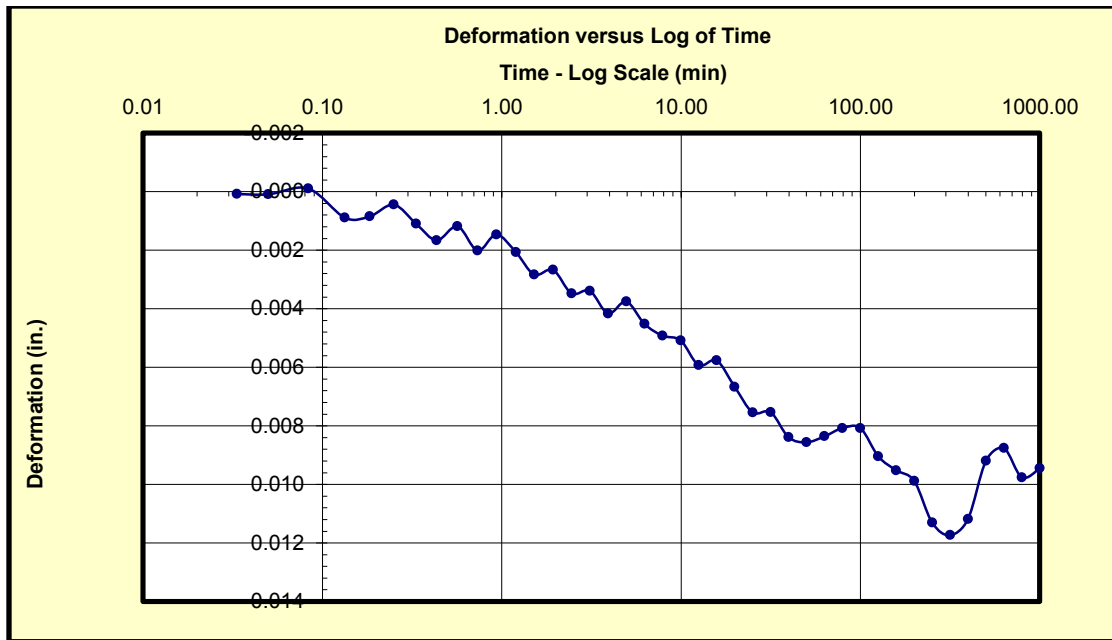
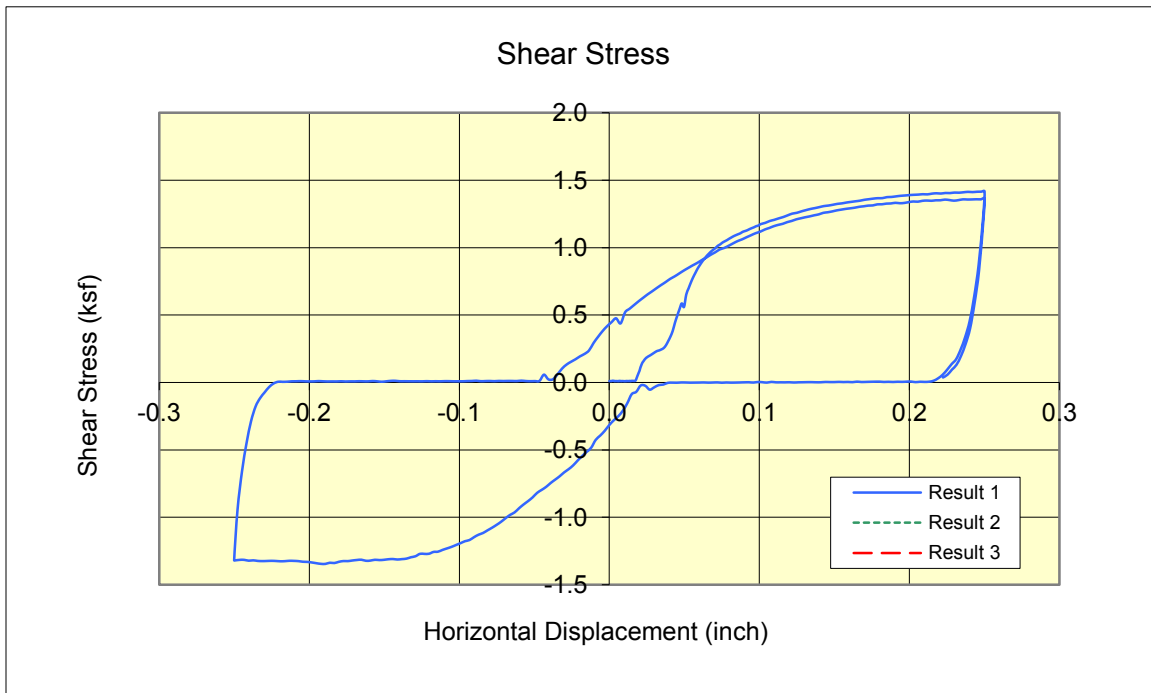
Figure 4.14: Deformation vs time and shear stress vs horizontal displacement graphs produced during direct shear testing of sample CR3 with a normal load of 2000 lbs/ft² (lbs/ft² = psf and 1000 psf = 1 ksf).

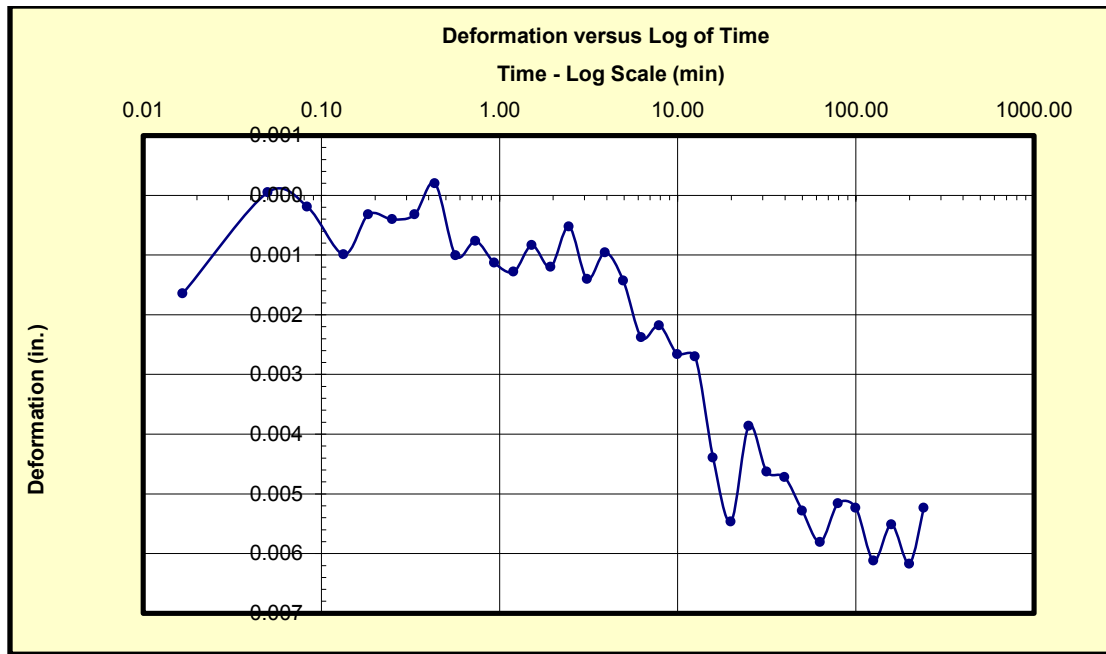
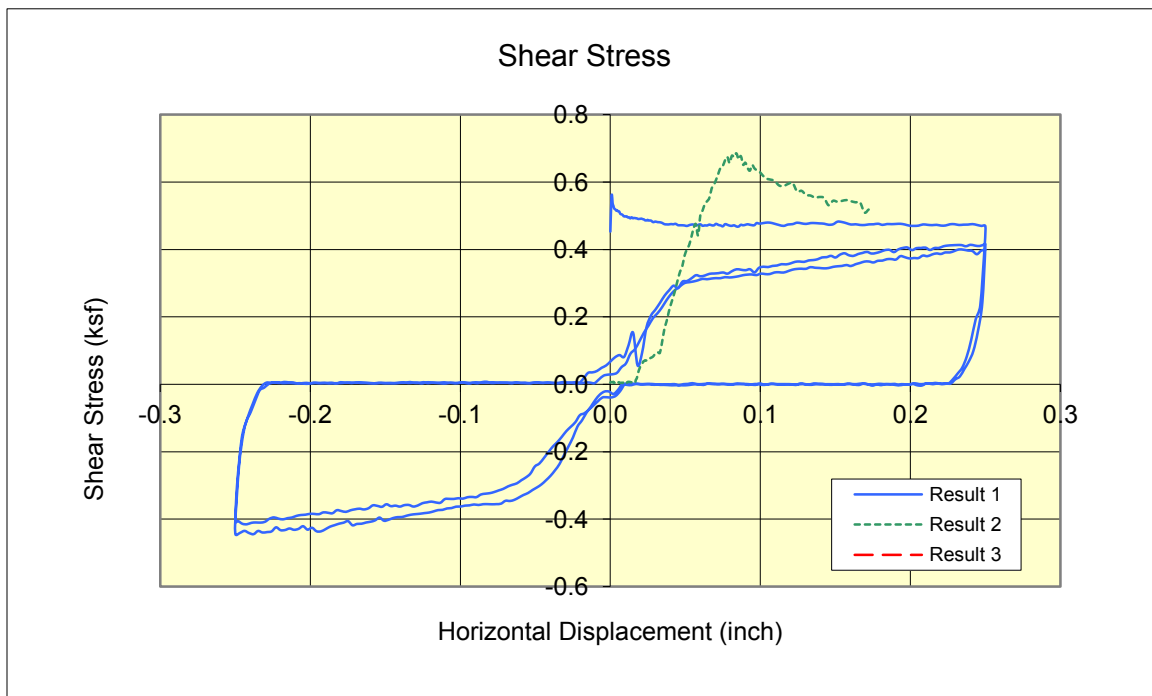
Figure 4.15: Deformation vs time and shear stress vs horizontal displacement graphs produced during direct shear testing of sample LG with a normal load of 500 lbs/ft² (lbs/ft² = psf and 1000 psf = 1 ksf).

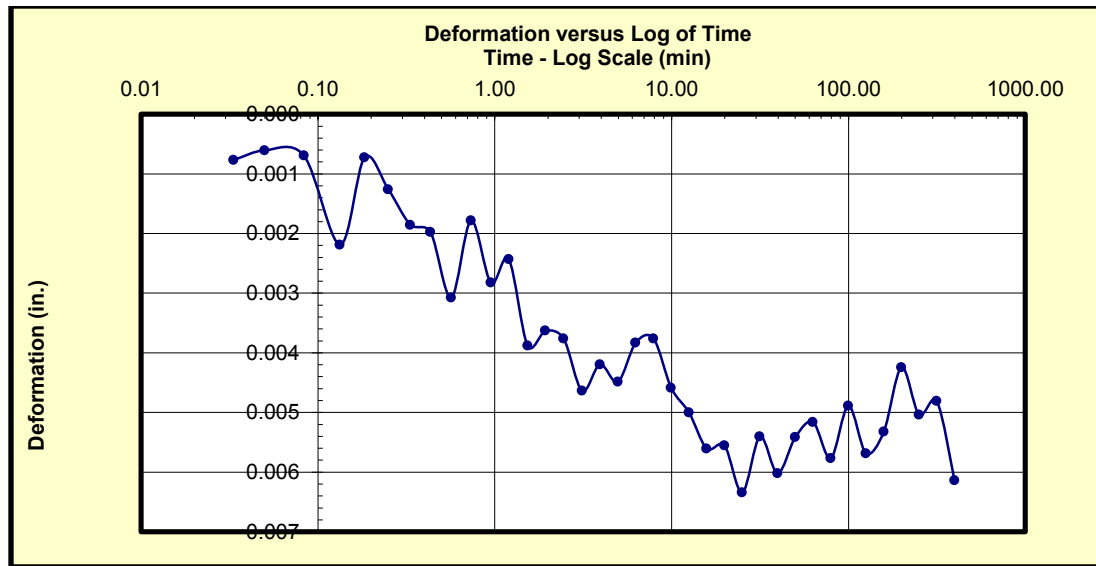
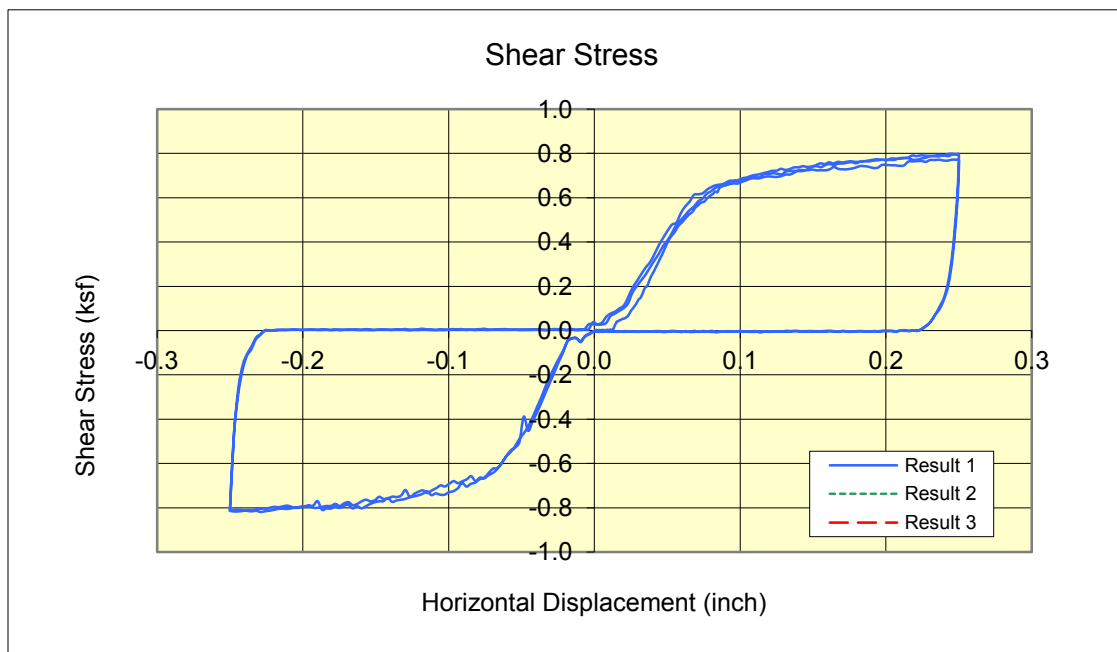
Figure 4.16: Deformation vs time and shear stress vs horizontal displacement graphs produced during direct shear testing of sample LG with a normal load of 1000 lbs/ft² (lbs/ft² = psf and 1000 psf = 1 ksf).

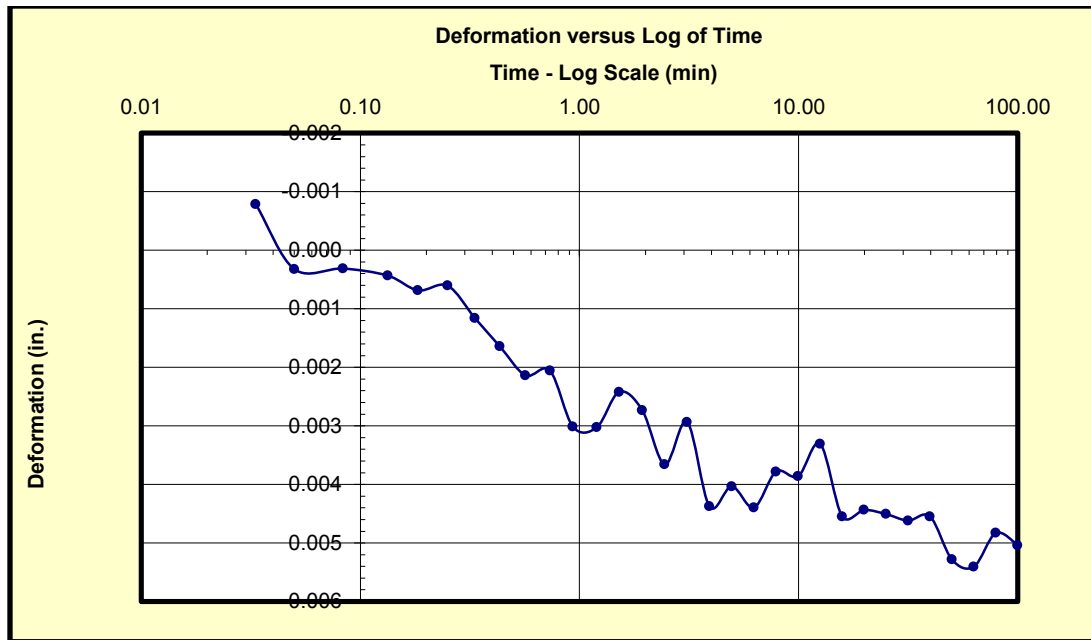
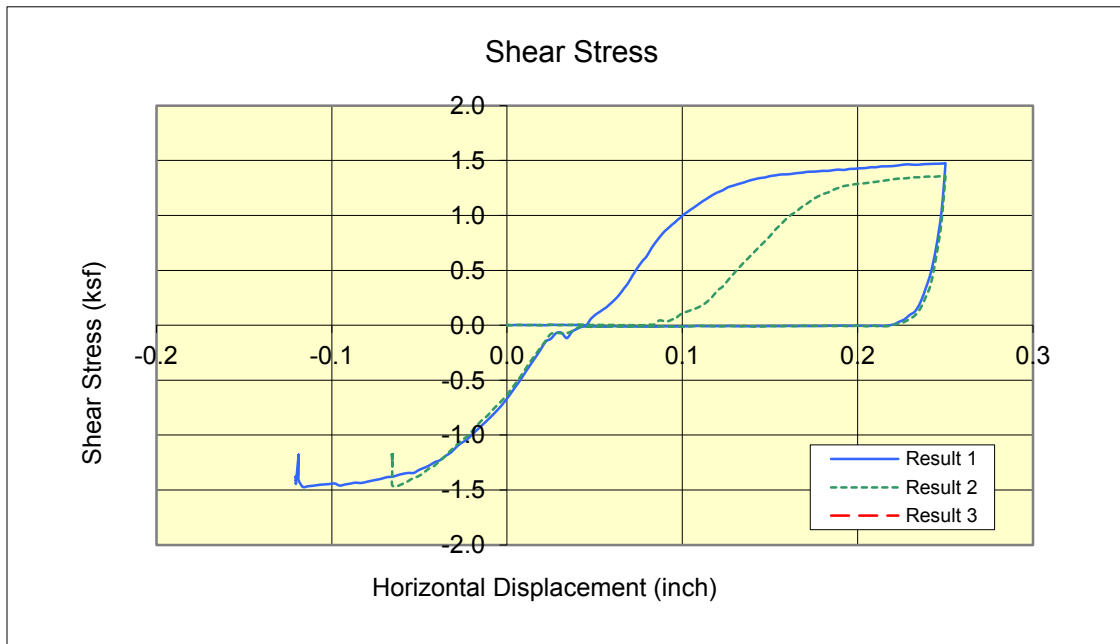
Figure 4.17: Deformation vs time and shear stress vs horizontal displacement graphs produced during direct shear testing of sample LG with a normal load of 2000 lbs/ft² (lbs/ft² = psf and 1000 psf = 1 ksf).
