Analysis of Slope Failure on Cochrane Road, Dominica Prior to Hurricane Maria

A Thesis
Presented to
the Graduate School of
Clemson University

In Partial Fulfillment
of the Requirements for the Degree
Master of Science
Hydrogeology

by
Audrey Fisher
May 2018

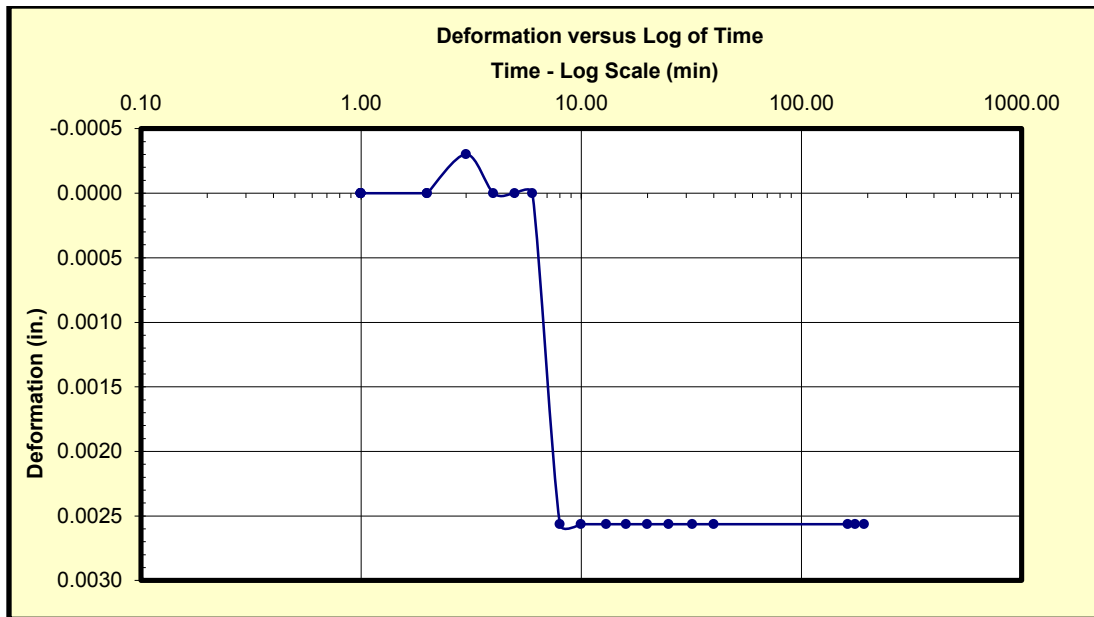
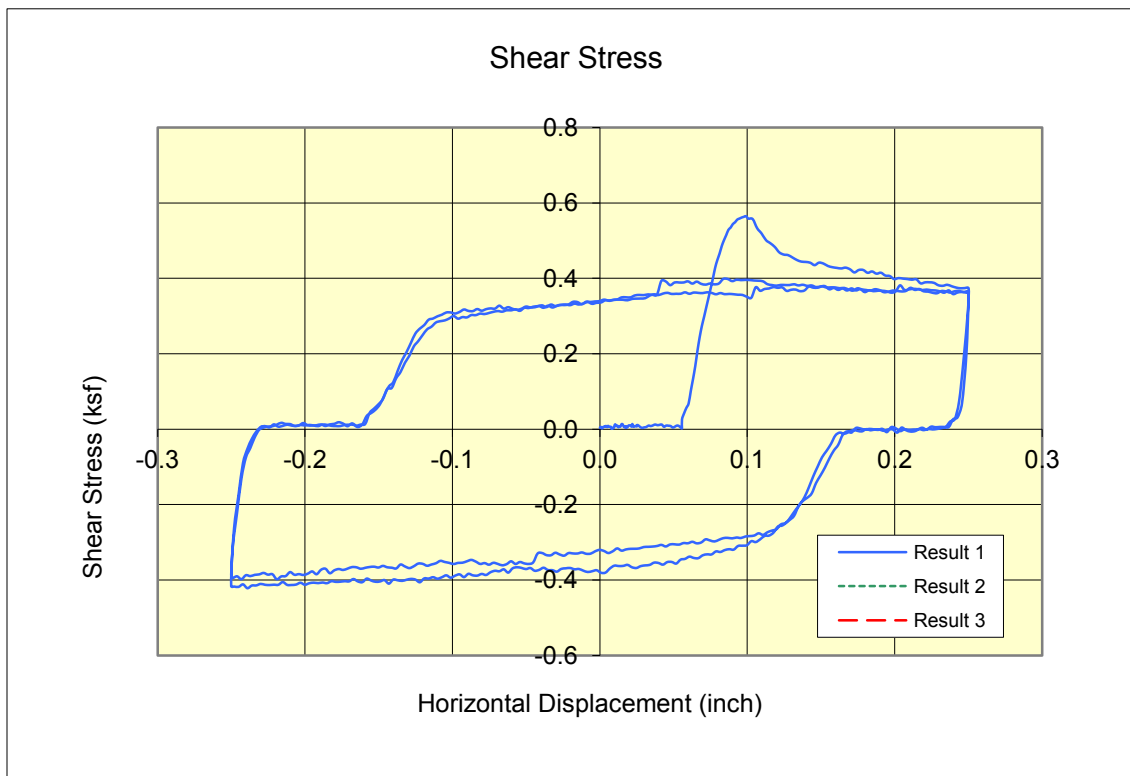
Figure 4.18: Deformation vs time and shear stress vs horizontal displacement graphs produced during direct shear testing of sample CR6 with a normal load of 500 lbs/ft² (lbs/ft² = psf and 1000 psf = 1 ksf).

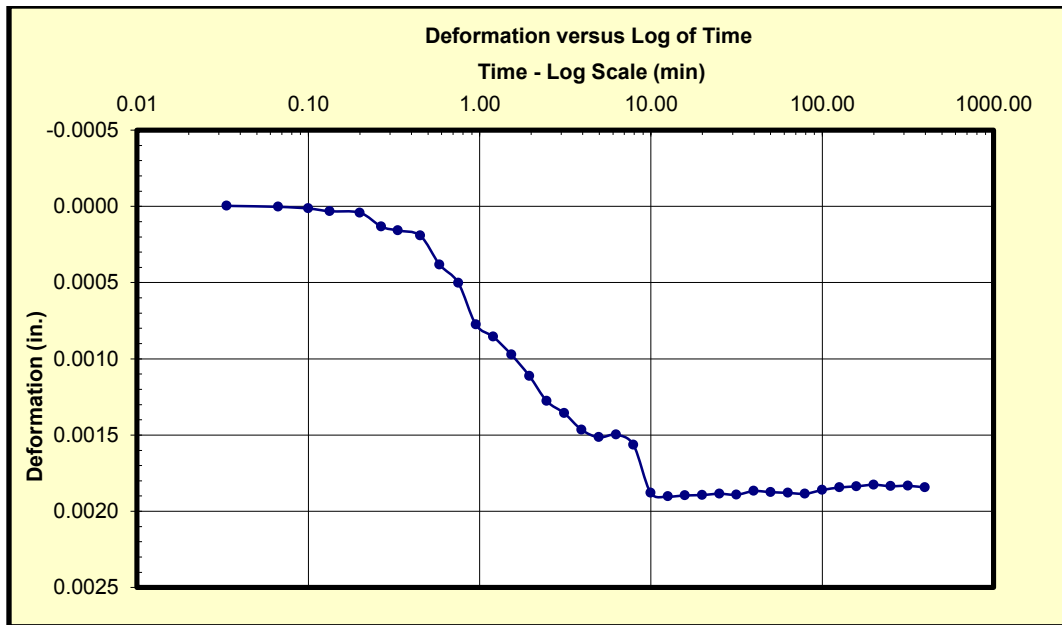
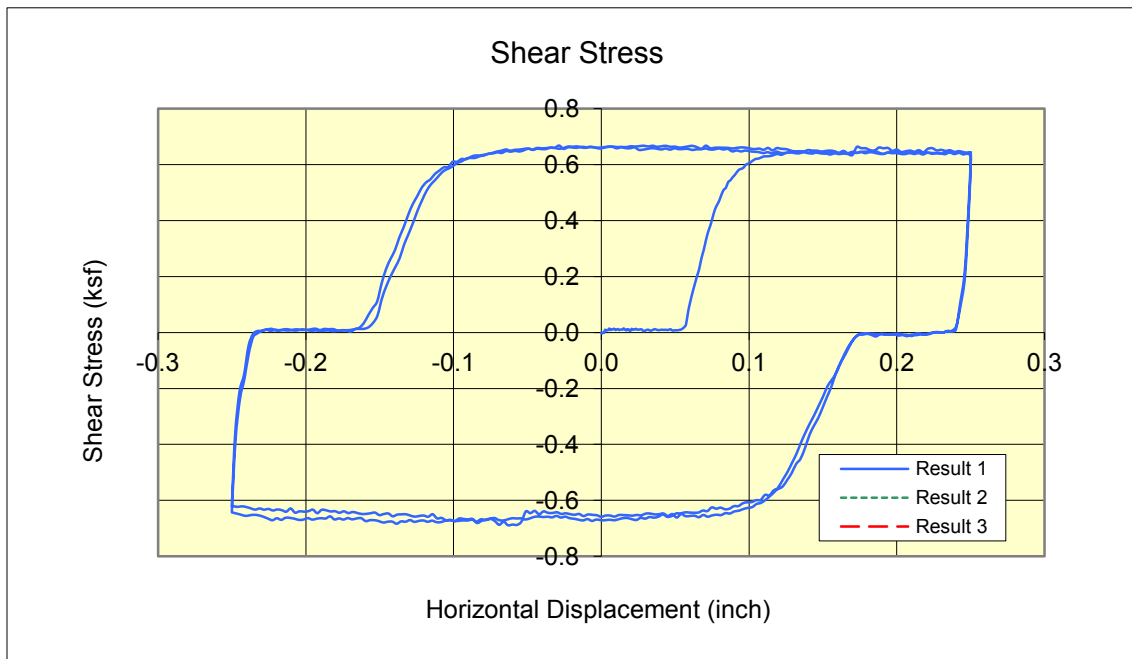
Figure 4.19: Deformation vs time and shear stress vs horizontal displacement graphs produced during direct shear testing of sample CR6 with a normal load of 1000 lbs/ft² (lbs/ft² = psf and 1000 psf = 1 ksf).

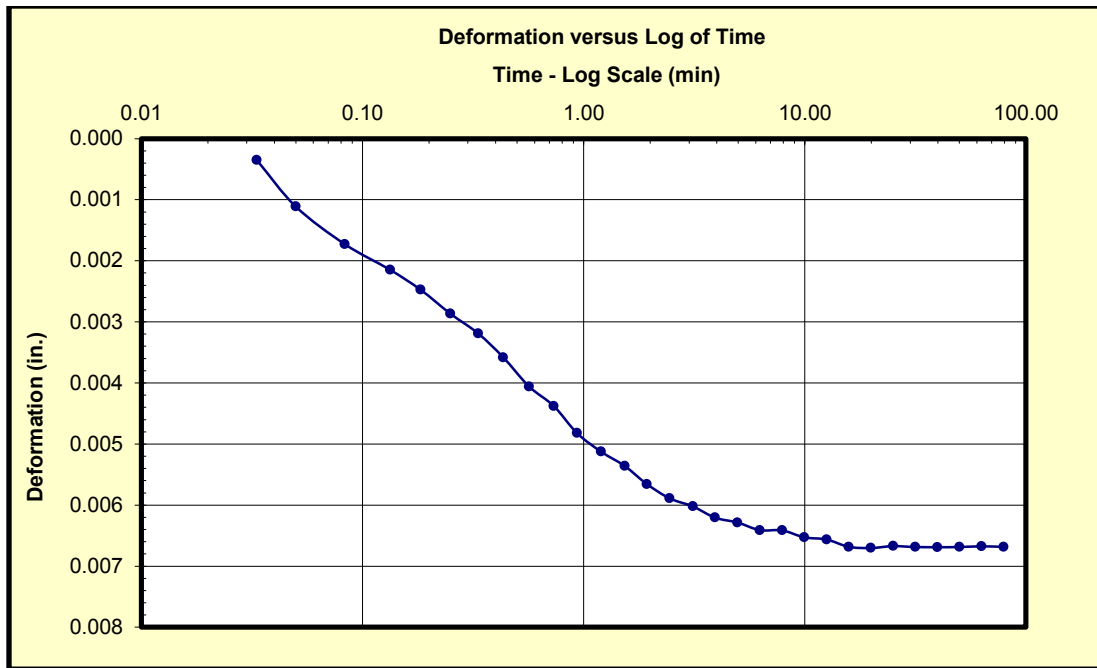
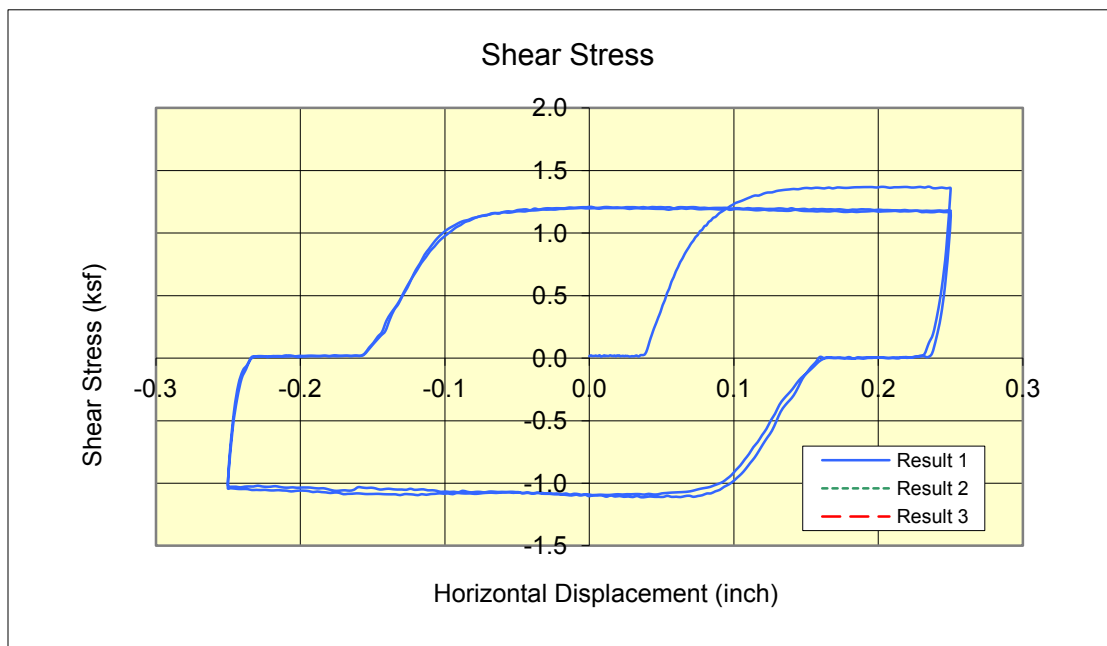
Figure 4.20: Deformation vs time and shear stress vs horizontal displacement graphs produced during direct shear testing of sample CR6 with a normal load of 2000 lbs/ft² (lbs/ft² = psf and 1000 psf = 1 ksf).

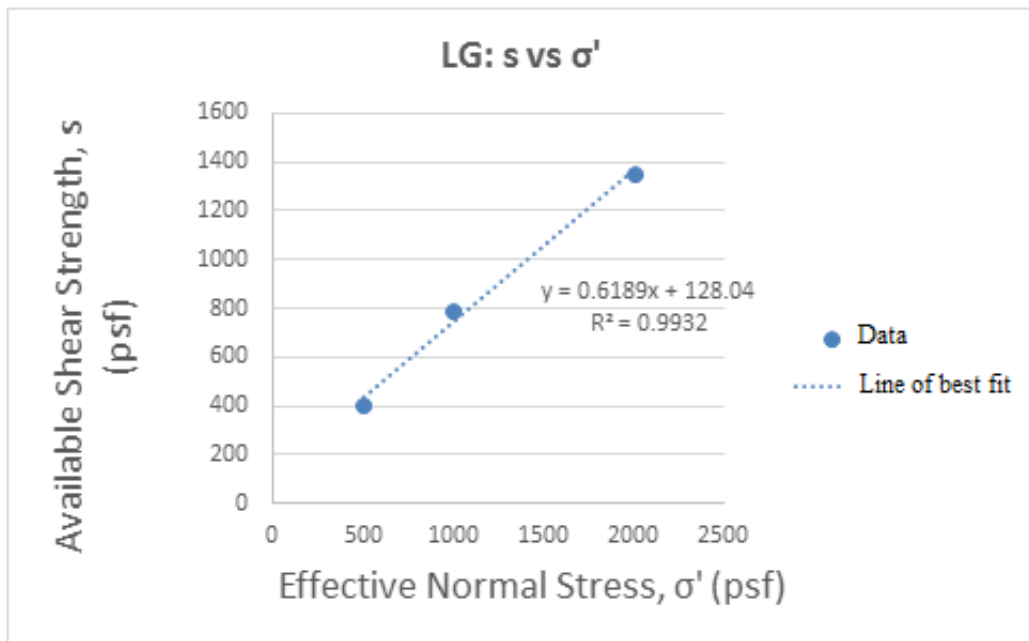
Figure 4.21: Plot of shear strength versus effective normal stress for LG.

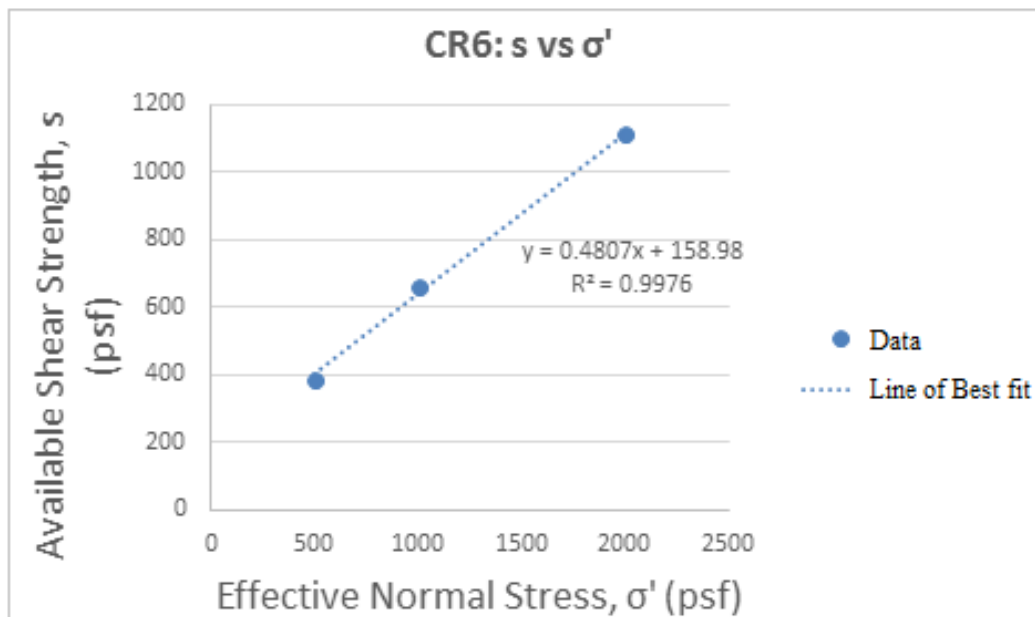
Figure 4.22: Plot of shear strength versus effective normal stress for CR6.

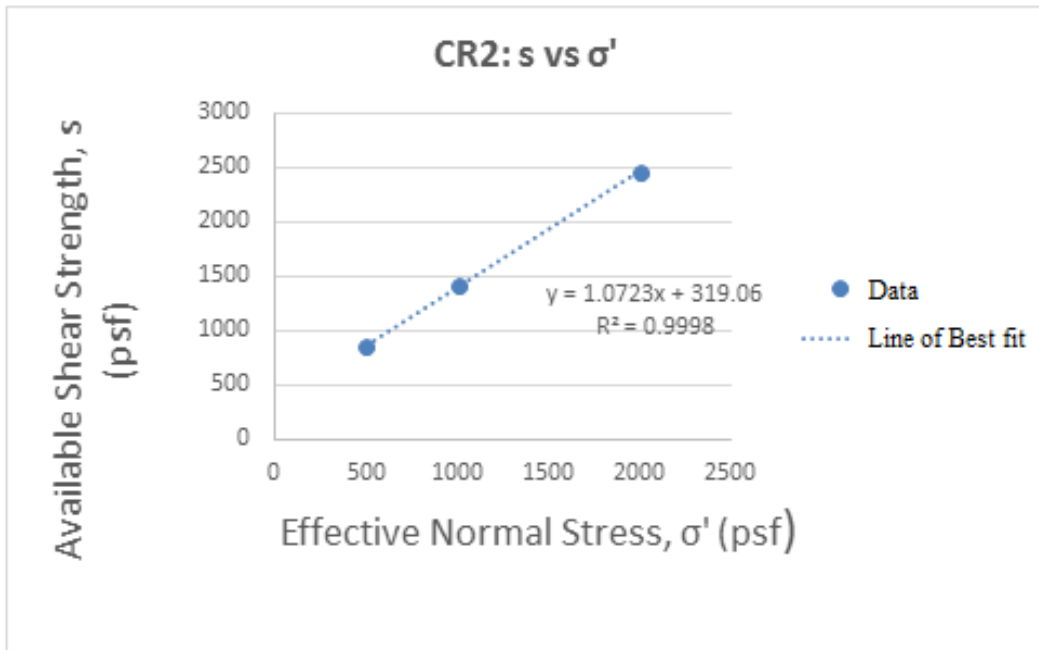
Figure 4.23: Plot of shear strength versus effective normal stress for CR2.

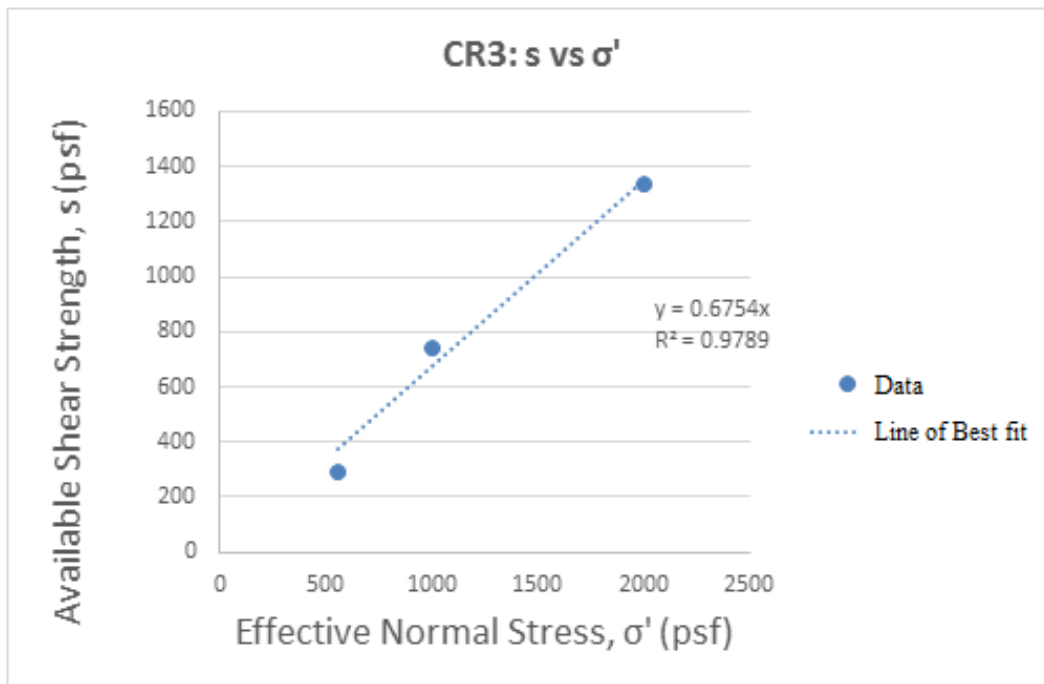
Figure 4.24: Plot of shear strength versus effective normal stress for CR3.
