A Conditions Assessment and Preservation Guidelines for Second Presbyterian Church's Graveyard Charleston, South Carolina

A Thesis
Presented to
the Graduate Schools of
Clemson University and the College of Charleston

In Partial Fulfillment
of the Requirements for the Degree
Master of Historic Preservation

by
William Preston Hamilton
May 2008

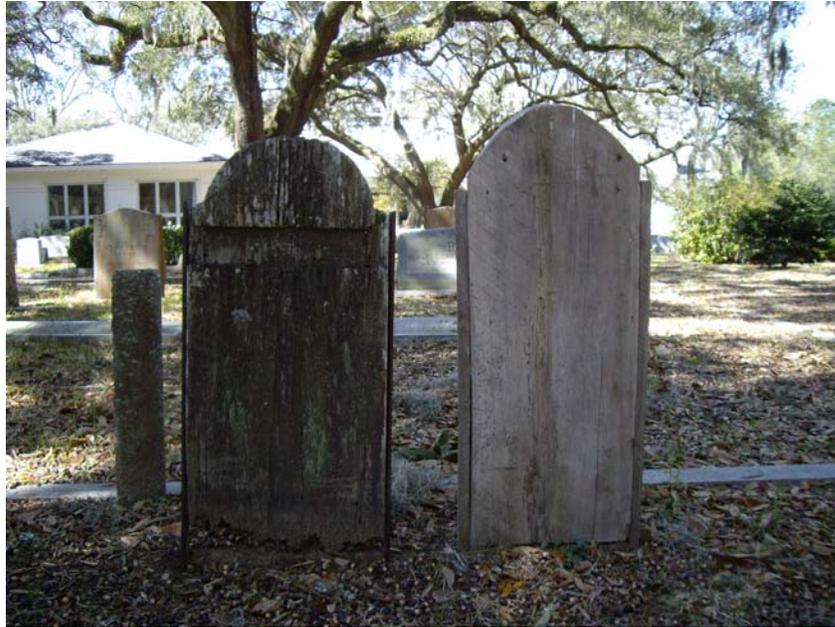
headboards, and footboards. Because they are easily subject to decay, there are few wooden grave markers left in Charleston.¹¹

Figure 1.2 – Example of wooden headboards at St. James’ Church. West Ashley, South Carolina

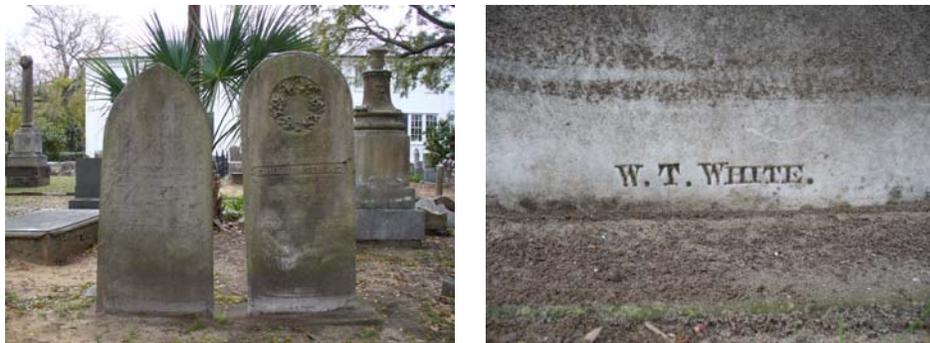
Numerous carvers such as John Stevens and John Bull of Newport, Henry Emmes and William Codner of Boston, and Gabriel Allen of Providence shipped their grave stones to Charleston from the 1740s to the 1780s. However, the most extravagantly carved grave stones came from England and Scotland. At Second Presbyterian Church, the majority of the grave markers can be attributed to the firm of W.T. White who worked in Charleston.¹⁴

Figure 1.3 & 1.4 – An example of two headstones at Second Presbyterian Church's graveyard carved by W.T. White.
