# A Conditions Assessment and Preservation Guidelines for Second Presbyterian Church's Graveyard Charleston, South Carolina

A Thesis  
Presented to  
the Graduate Schools of  
Clemson University and the College of Charleston

by  
William Preston Hamilton  
May 2008

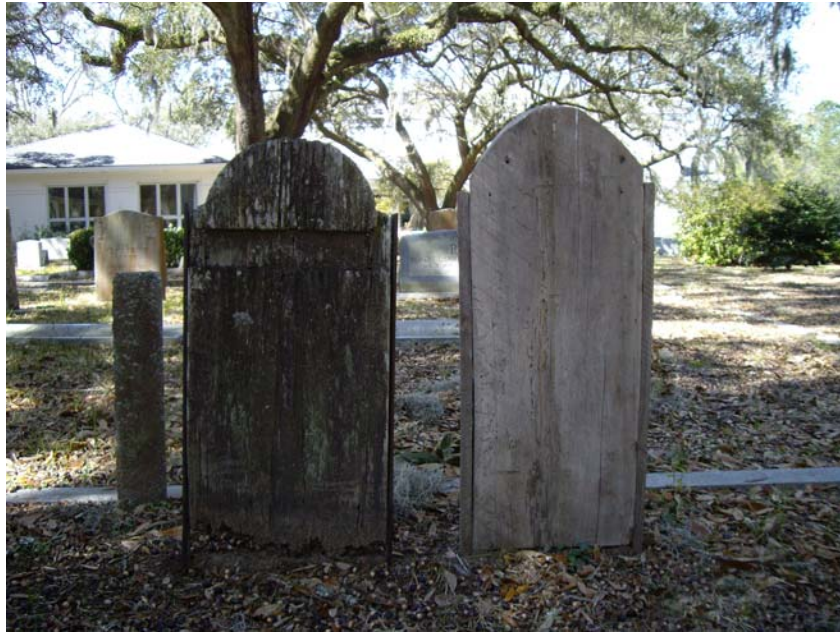
headboards, and footboards. Because they are easily subject to decay, there are few wooden grave markers left in Charleston.<sup>11</sup>

**Figure 1.2** – Example of wooden headboards at St. James’ Church. West Ashley, South Carolina

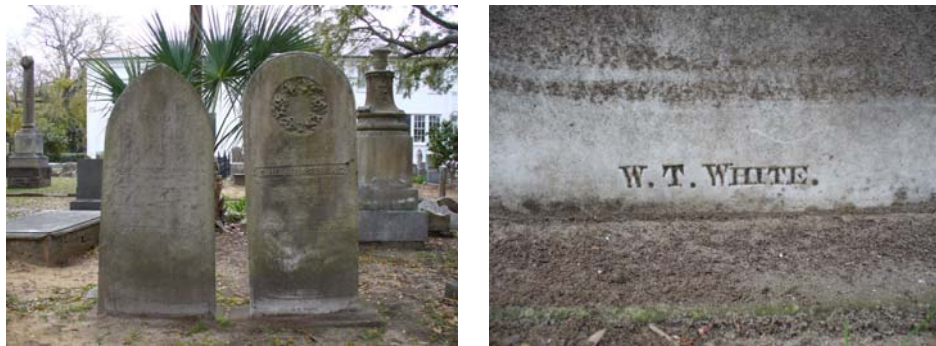
**Figure 1.3 & 1.4** – An example of two headstones at Second Presbyterian Church's graveyard carved by W.T. White.
